## Virtual Field Exercise (VFE) A: Road Safety Audit Workshop: Bicycle and Pedestrian

Virtual Workshop: 4/27–4/29

This study area is along Main Street from Peak St. to Carroll St. in the city of Dallas, northeast of downtown. Travel direction is from SW to NE along the 6-lane, minor arterial, with 3-lanes in each direction, separated by a grass median.

## Virtual Field Exercise (VFE) B: Road Safety Audit Virtual Workshop: Bicycle and Pedestrian

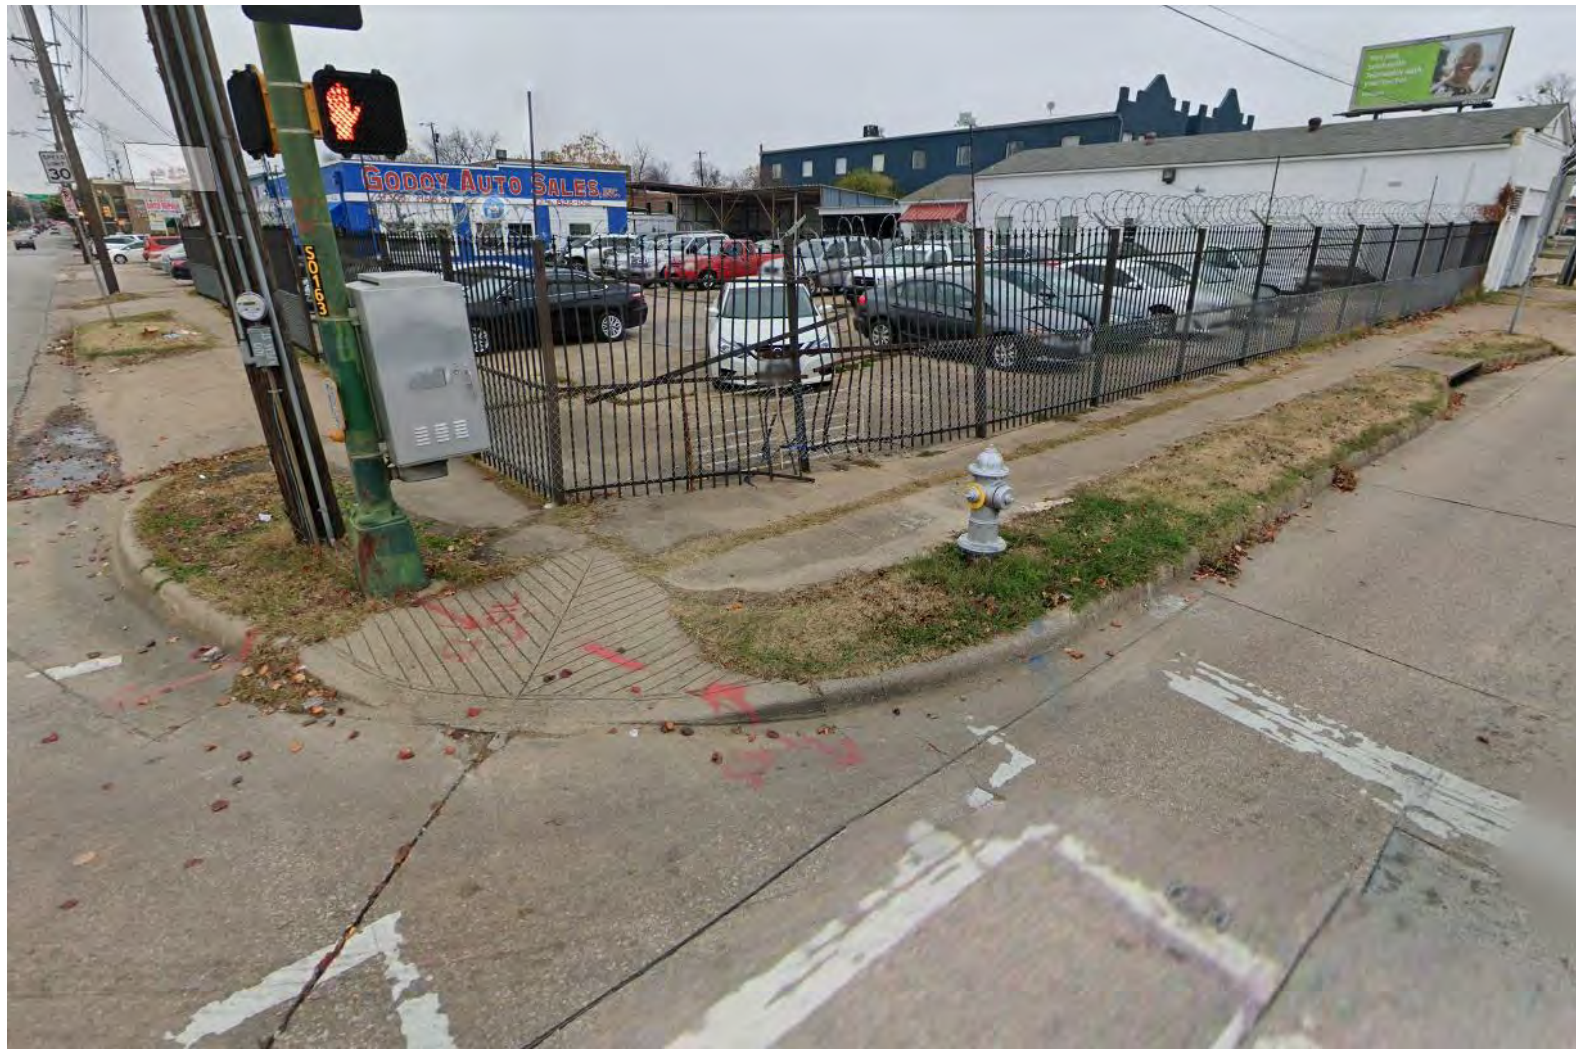
**Figure 1:** Intersection at Main St and Peak. Poor sidewalk conditions, cross walk striping, ADA compliance issues, utilities need to be moved, limited right-of-way, etc.

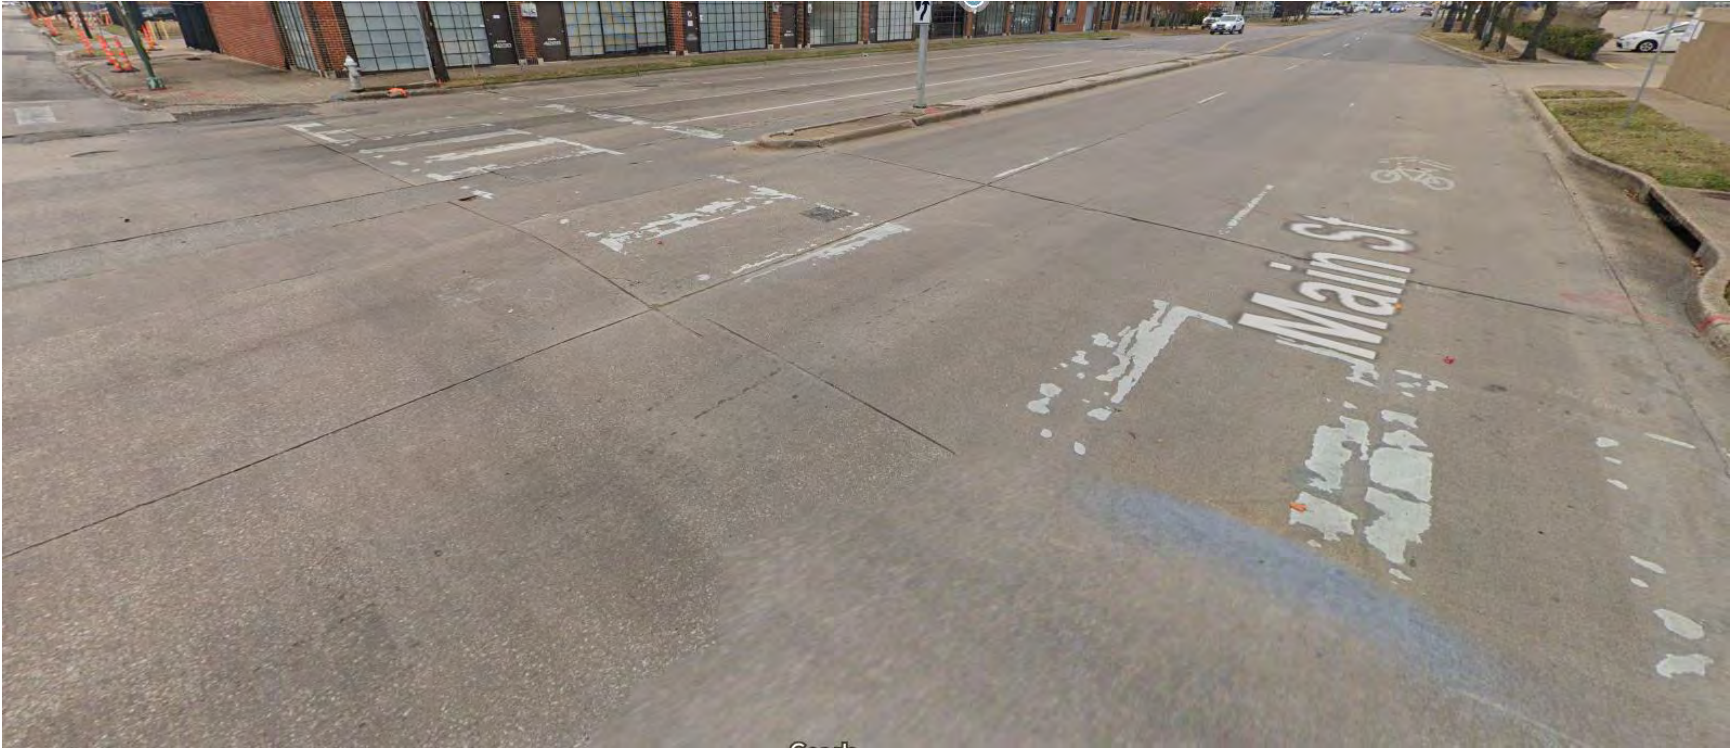
Figure 2: Intersection at Main St and Peak. Poor sidewalk conditions, cross walk striping, ADA compliance issues, utilities need to be moved, limited right-of-way, etc.

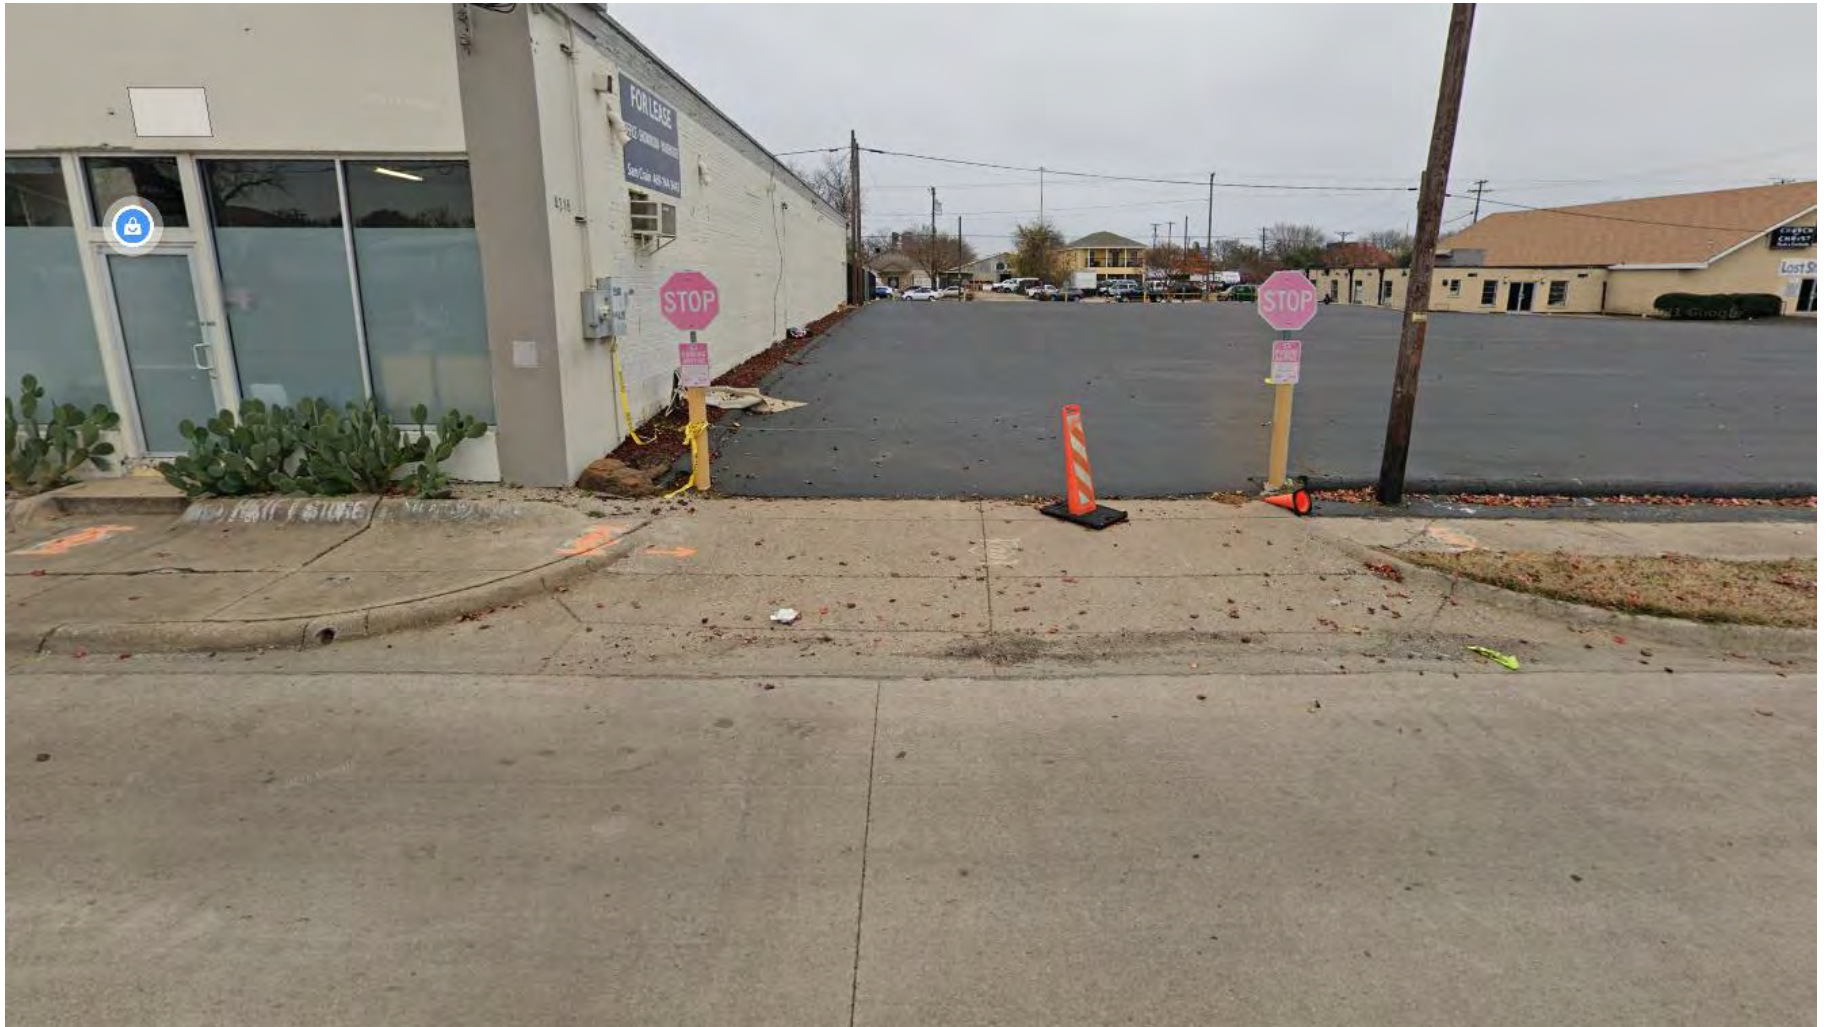
Figure 3: Driveways and access points with ADA compliance issues along segment.

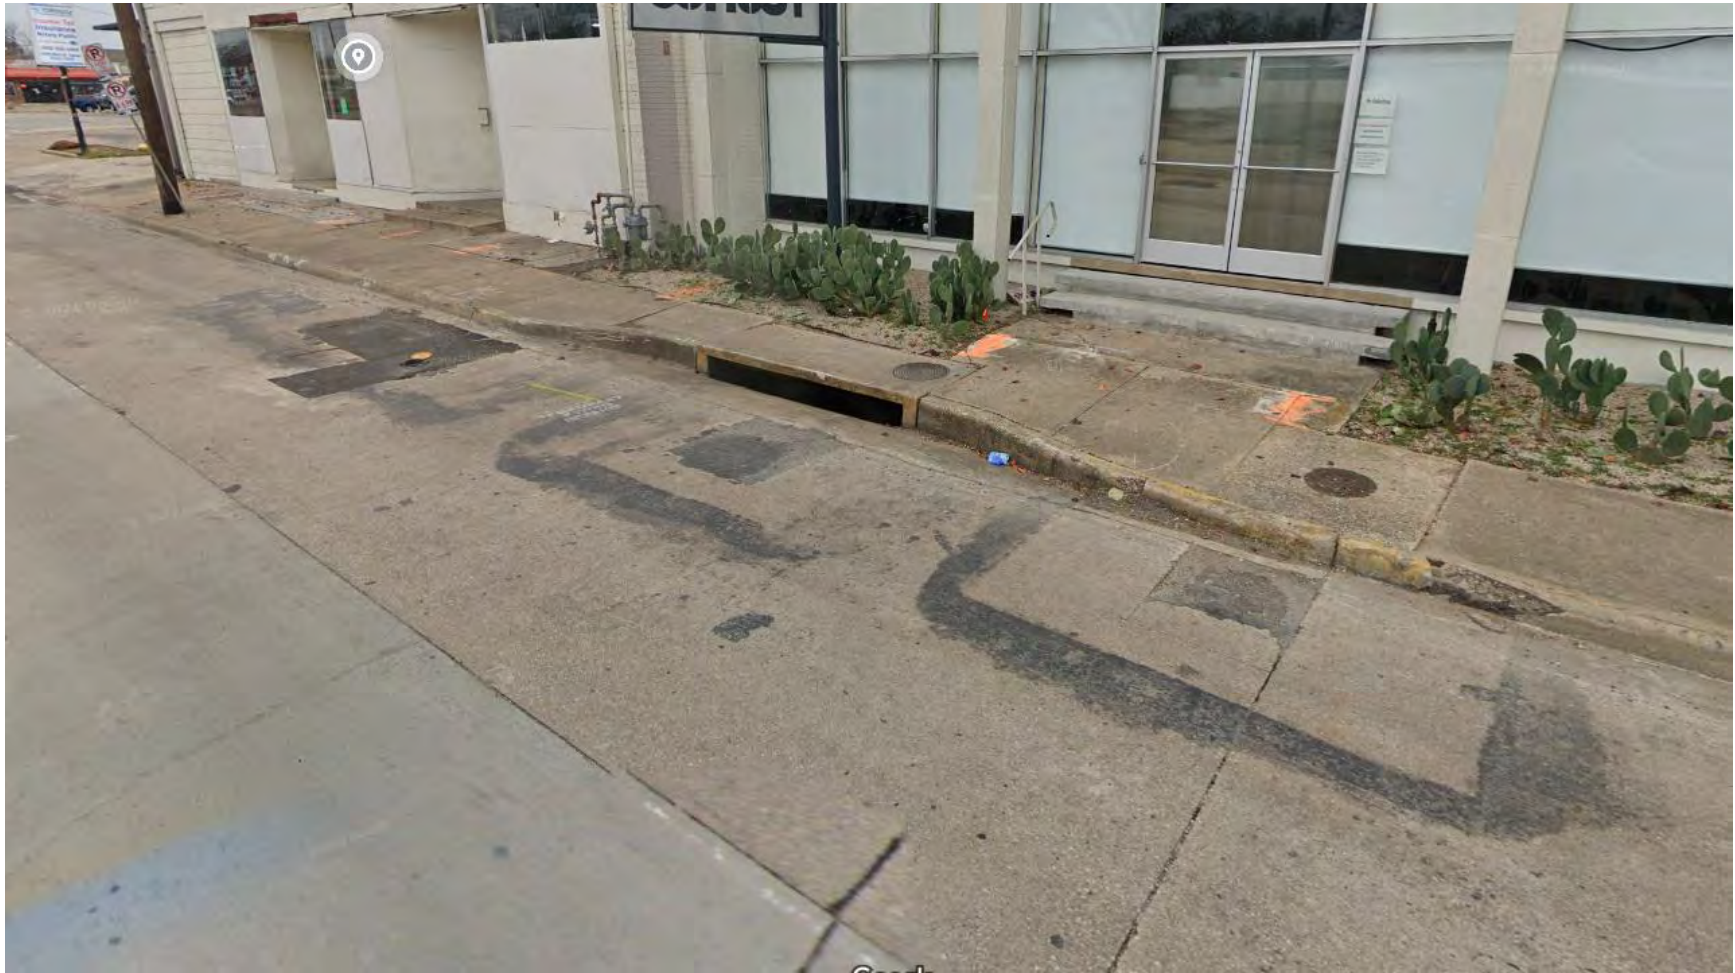
Figure 4: Narrow sidewalk sections and poor pavement conditions along segment.

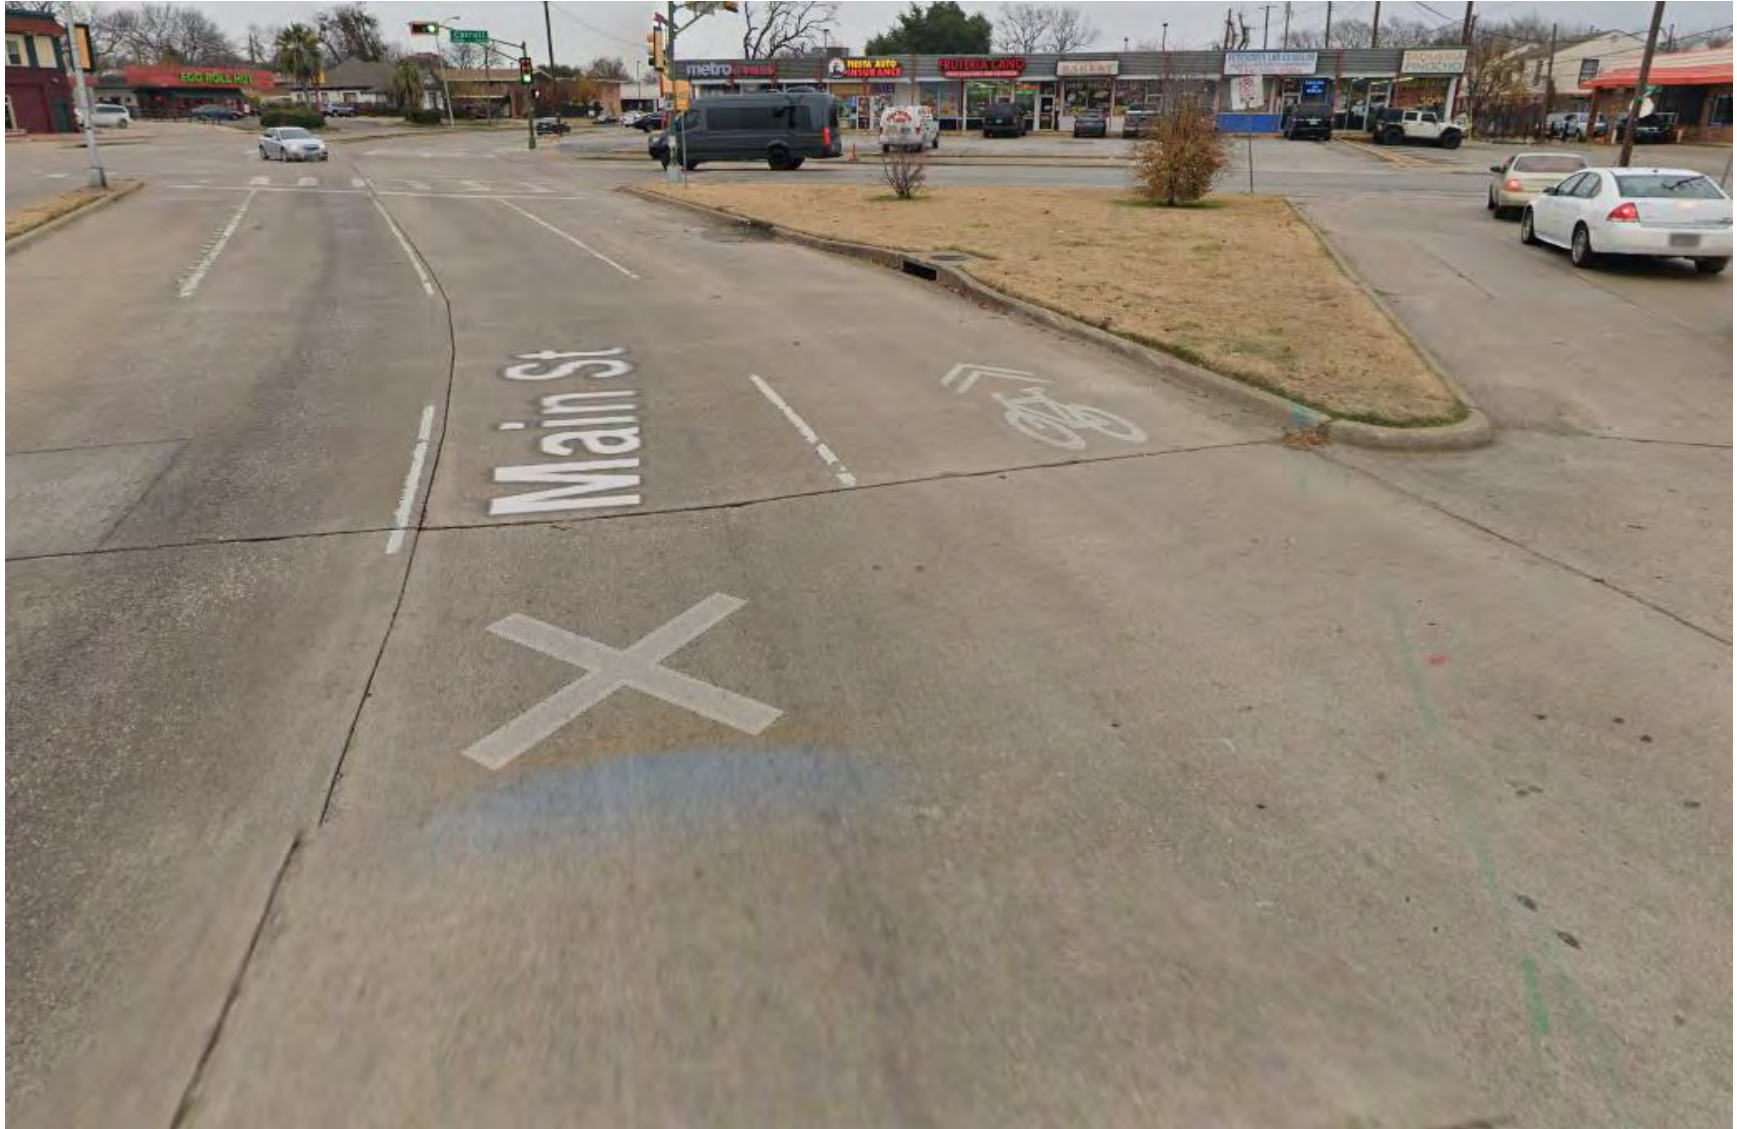
Figure 5: Shared bicycle route – consider level of service with lane widths and posted speeds.

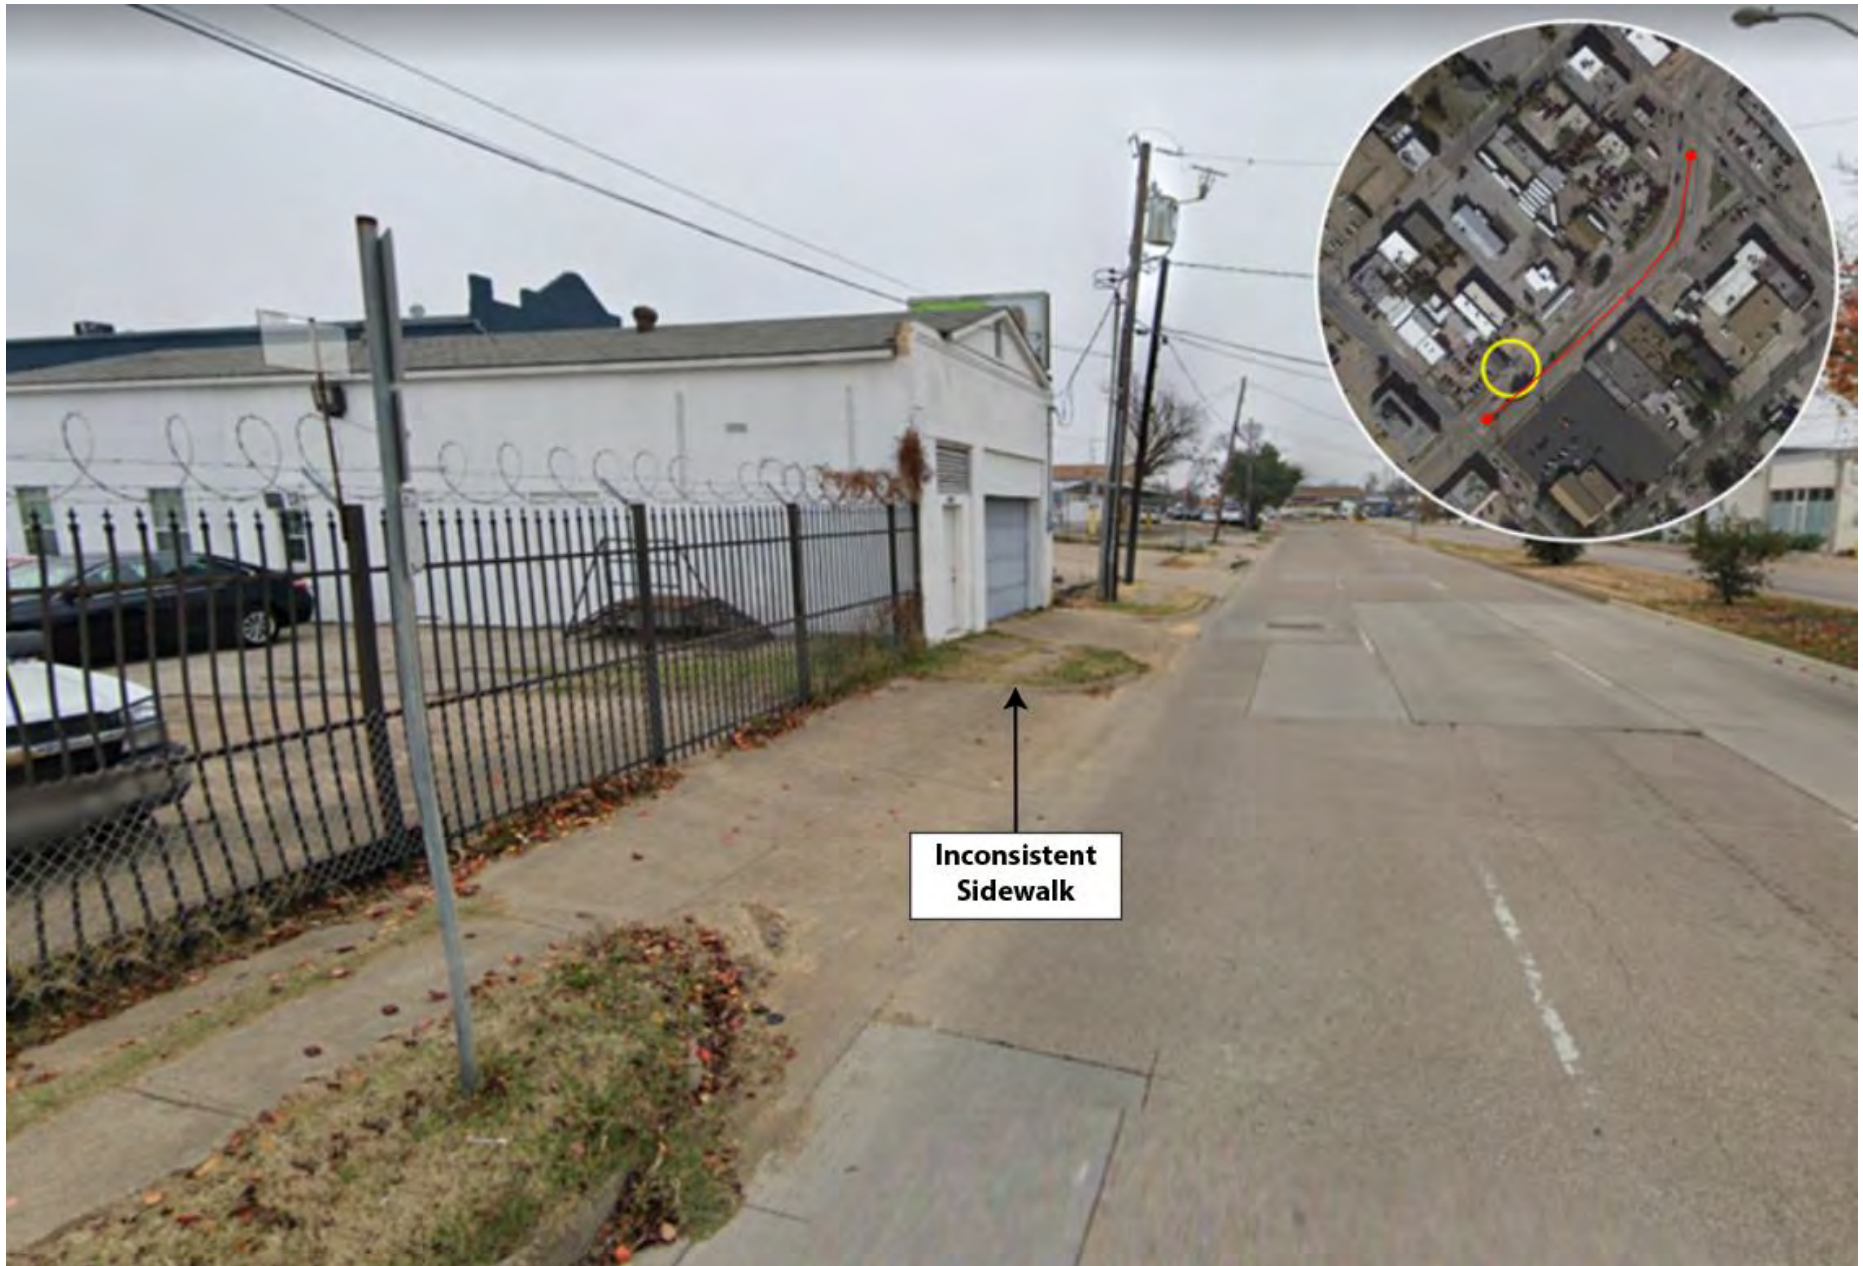
**Figure 6:** Pedestrian facilities near the intersection of Main and Peak: Sections of sidewalk lacking ADA compliance, that periodically disconnect and force pedestrians to walk closer to the road and oncoming traffic. Utilities and abutting properties possess part of the existing sidewalk.

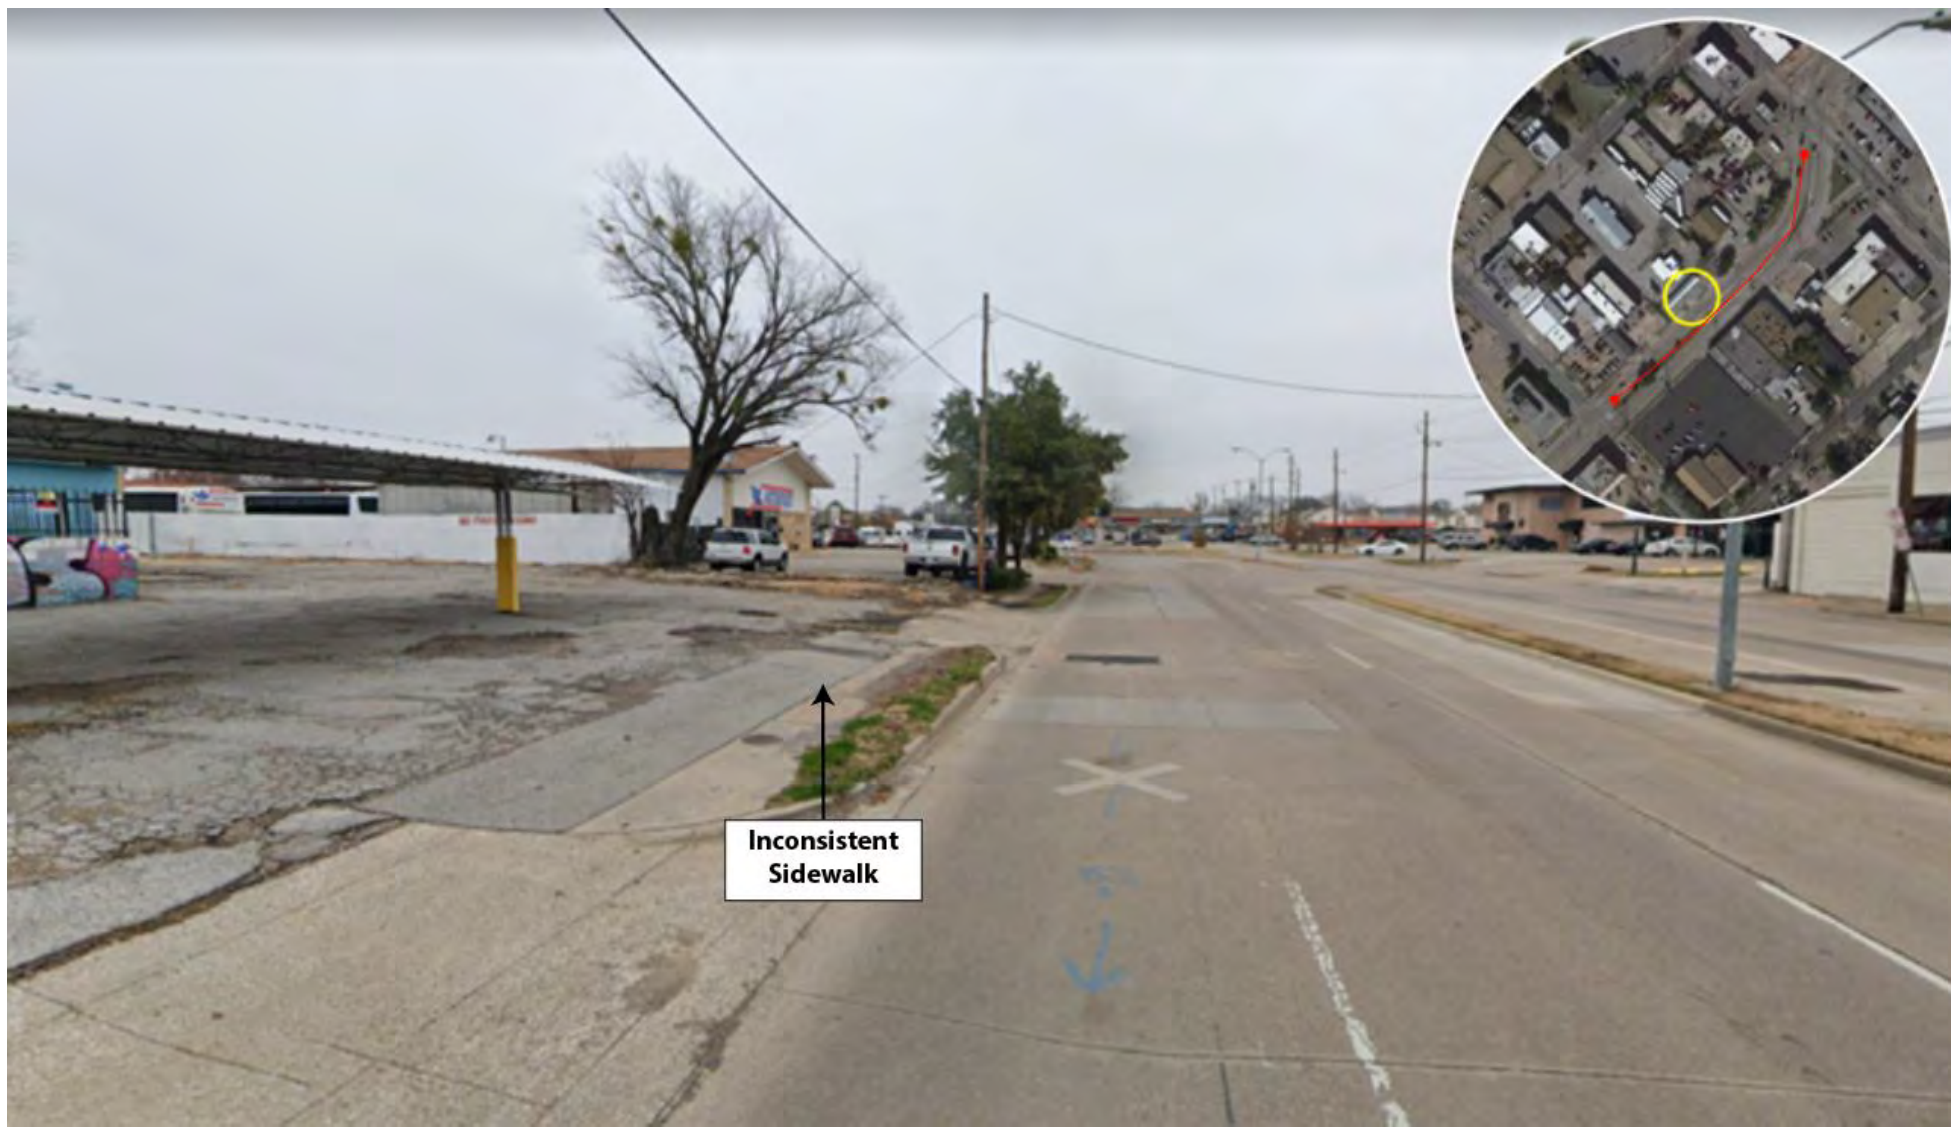
Figure 3: Pedestrian facilities halfway between Peak St and Carroll St have inconsistent and disconnected sidewalks that lack ADA compliance. Sidewalk and abutting property need repaving, ROW planting needs maintenance, and utilities encroach on sidewalk.

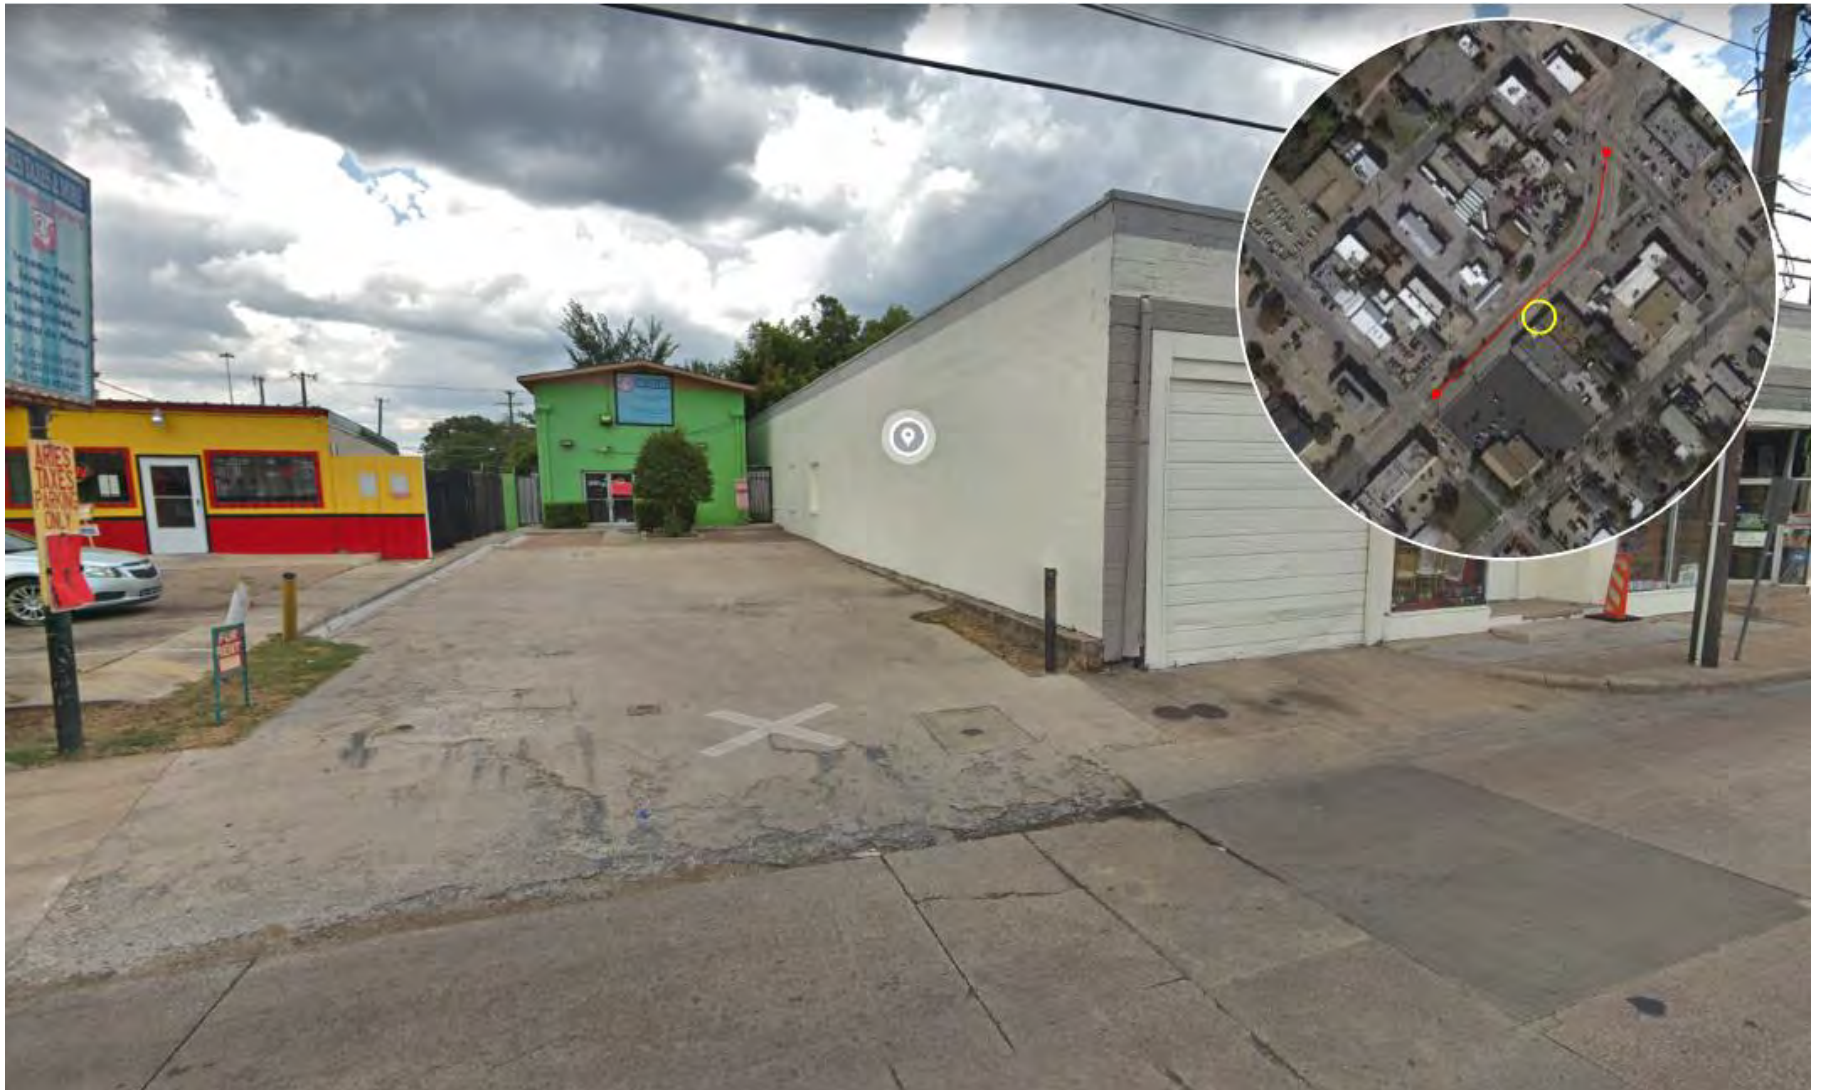
Figure 4: Access points and driveways with ADA compliance issues east side of Main St. Pedestrian facility is impeded upon by existing utilities and private driveways.

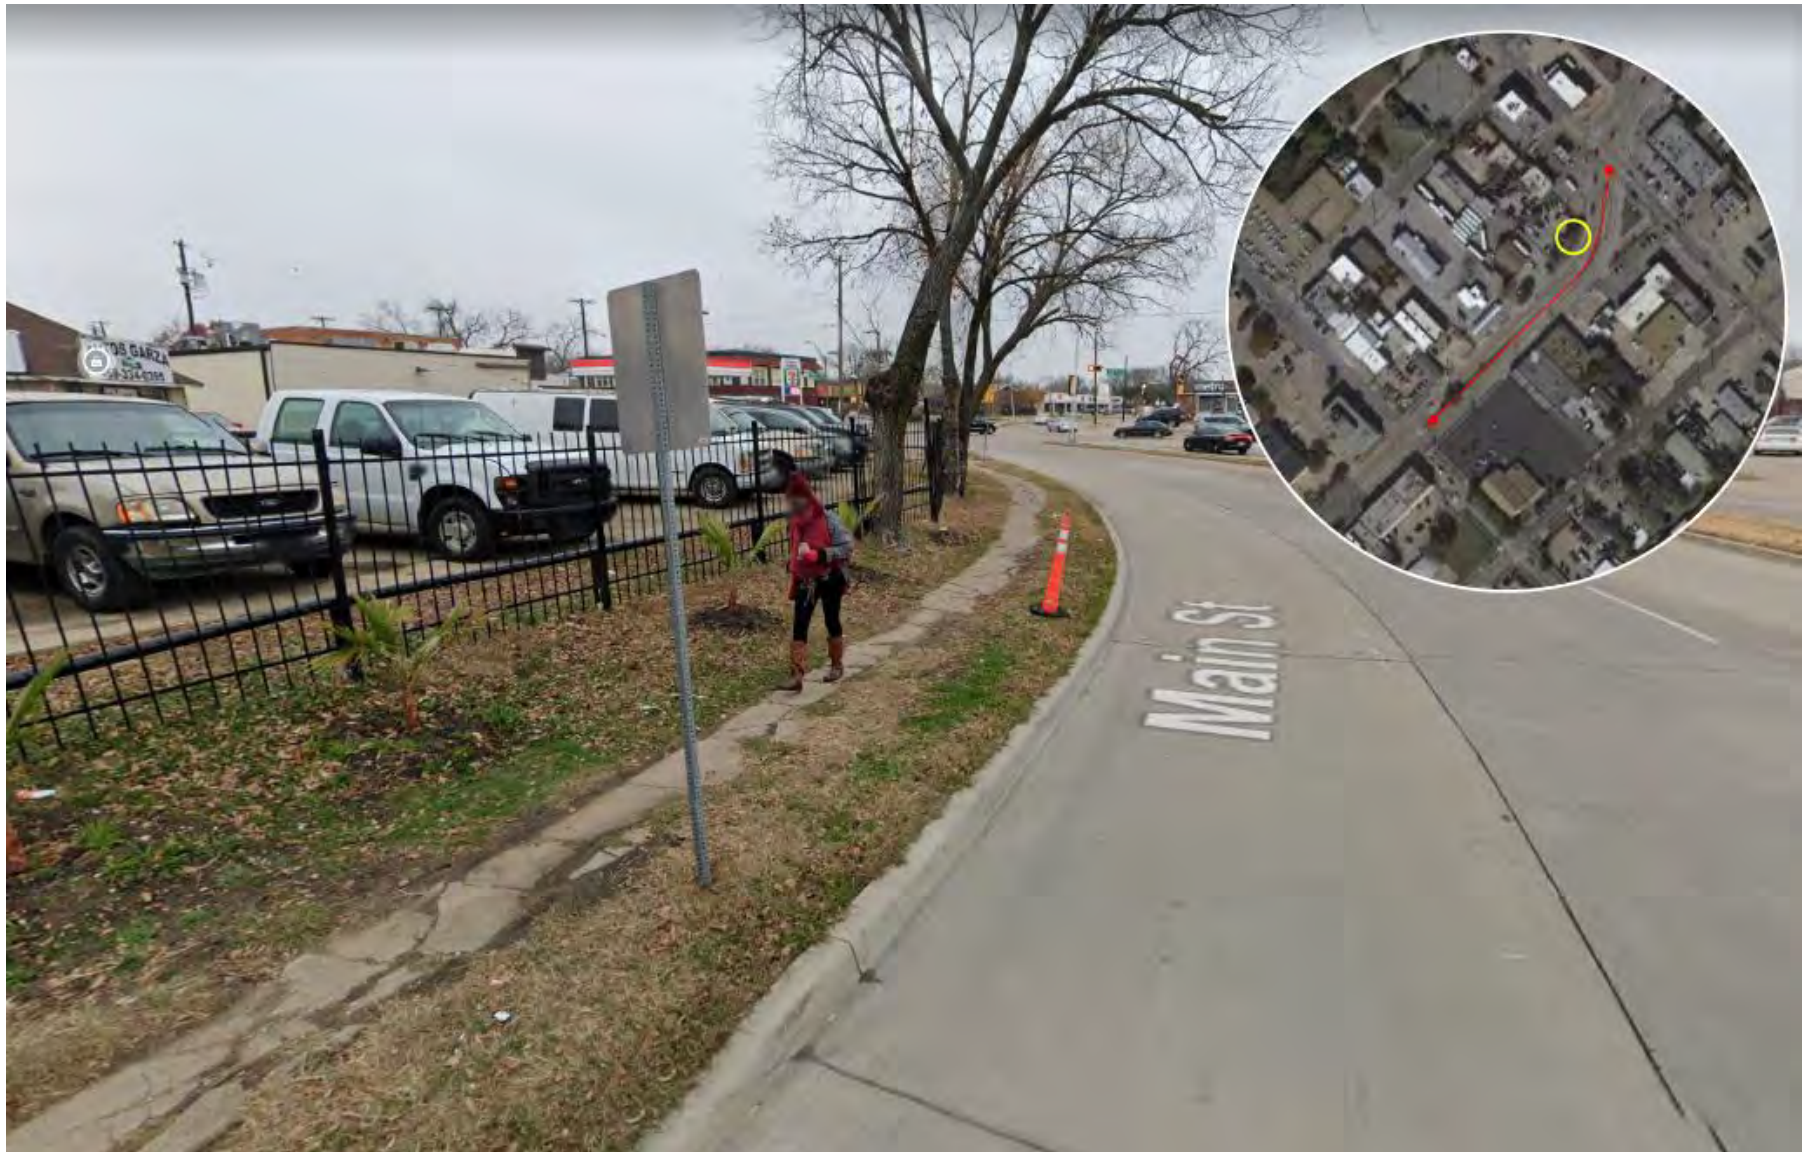
Figure 5: Pedestrian facilities approaching the intersection of Main St and Carroll lack ADA compliance. Sidewalk has been overrun by vegetation. Abutting property trees within the ROW.

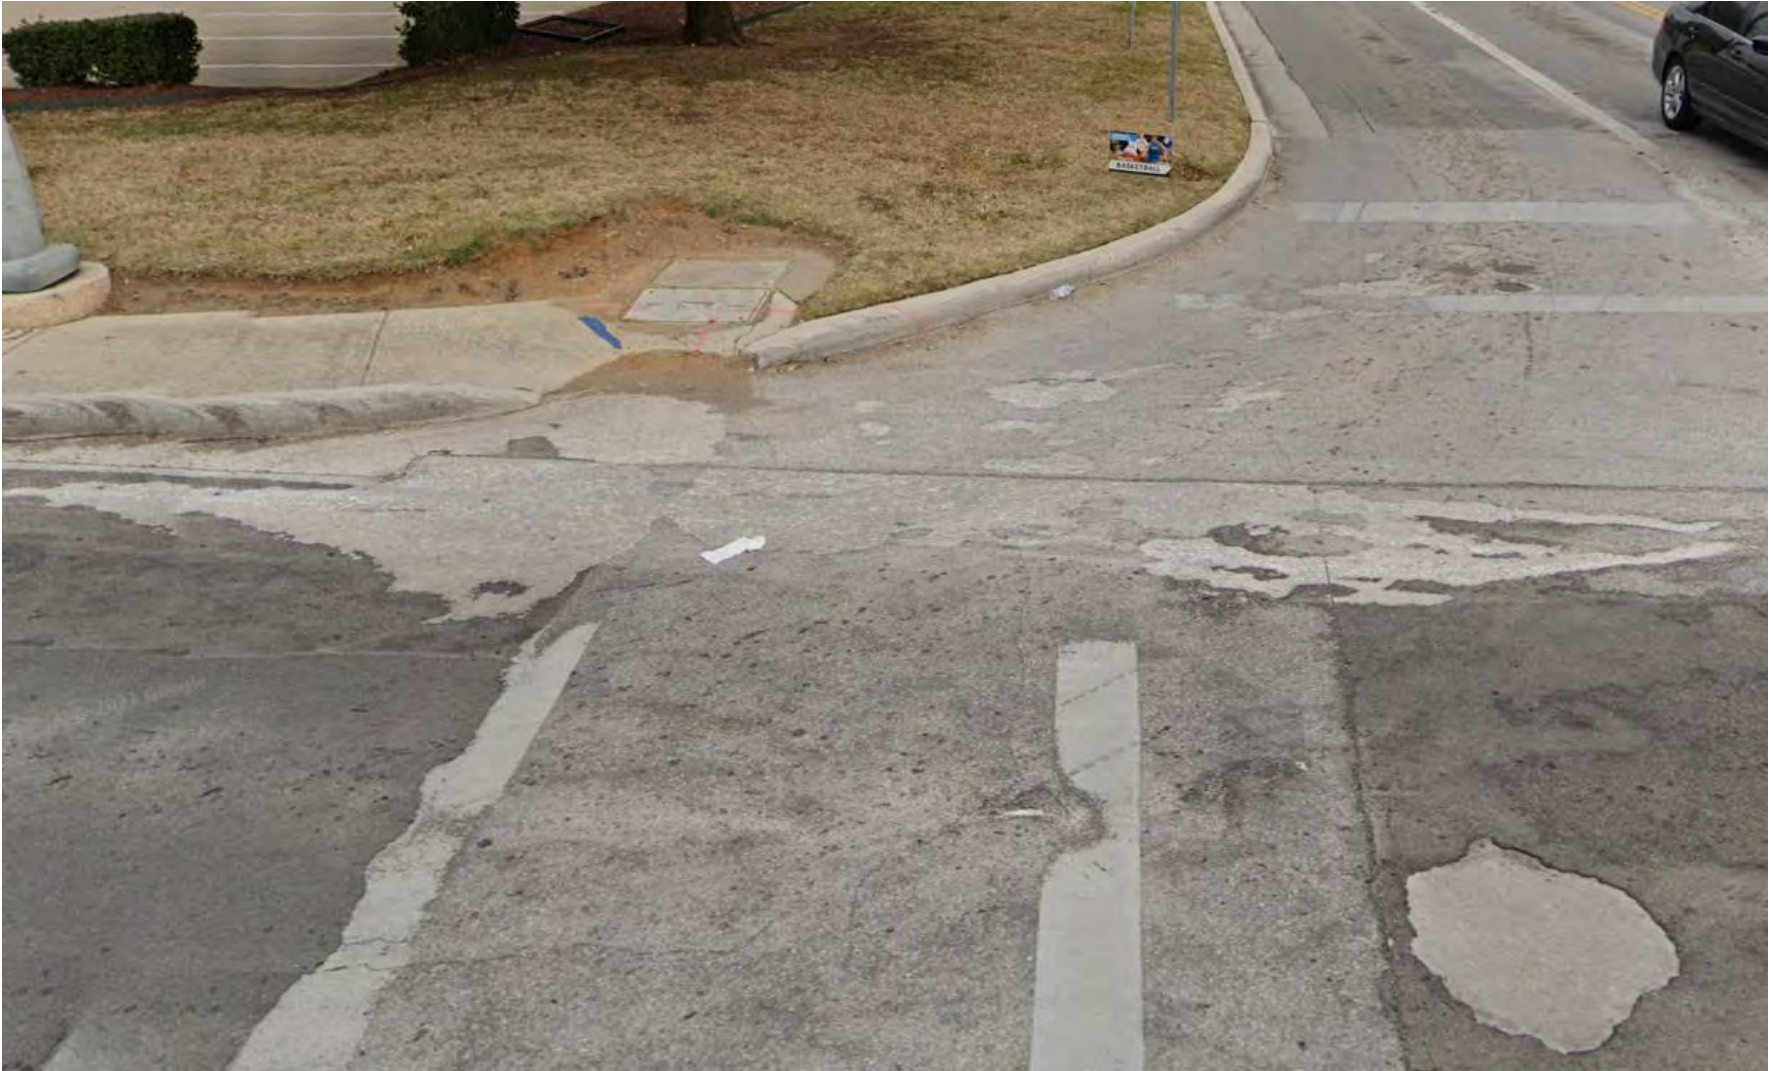
**Figure 1:** Pedestrian facilities at intersection of S Davis and Arkansas Ln: some sections lacking ADA compliance, no connected sidewalk facilities to Davis, utilities need to be relocated, narrow existing sidewalks, poor conditions, deficient crosswalk striping, etc.

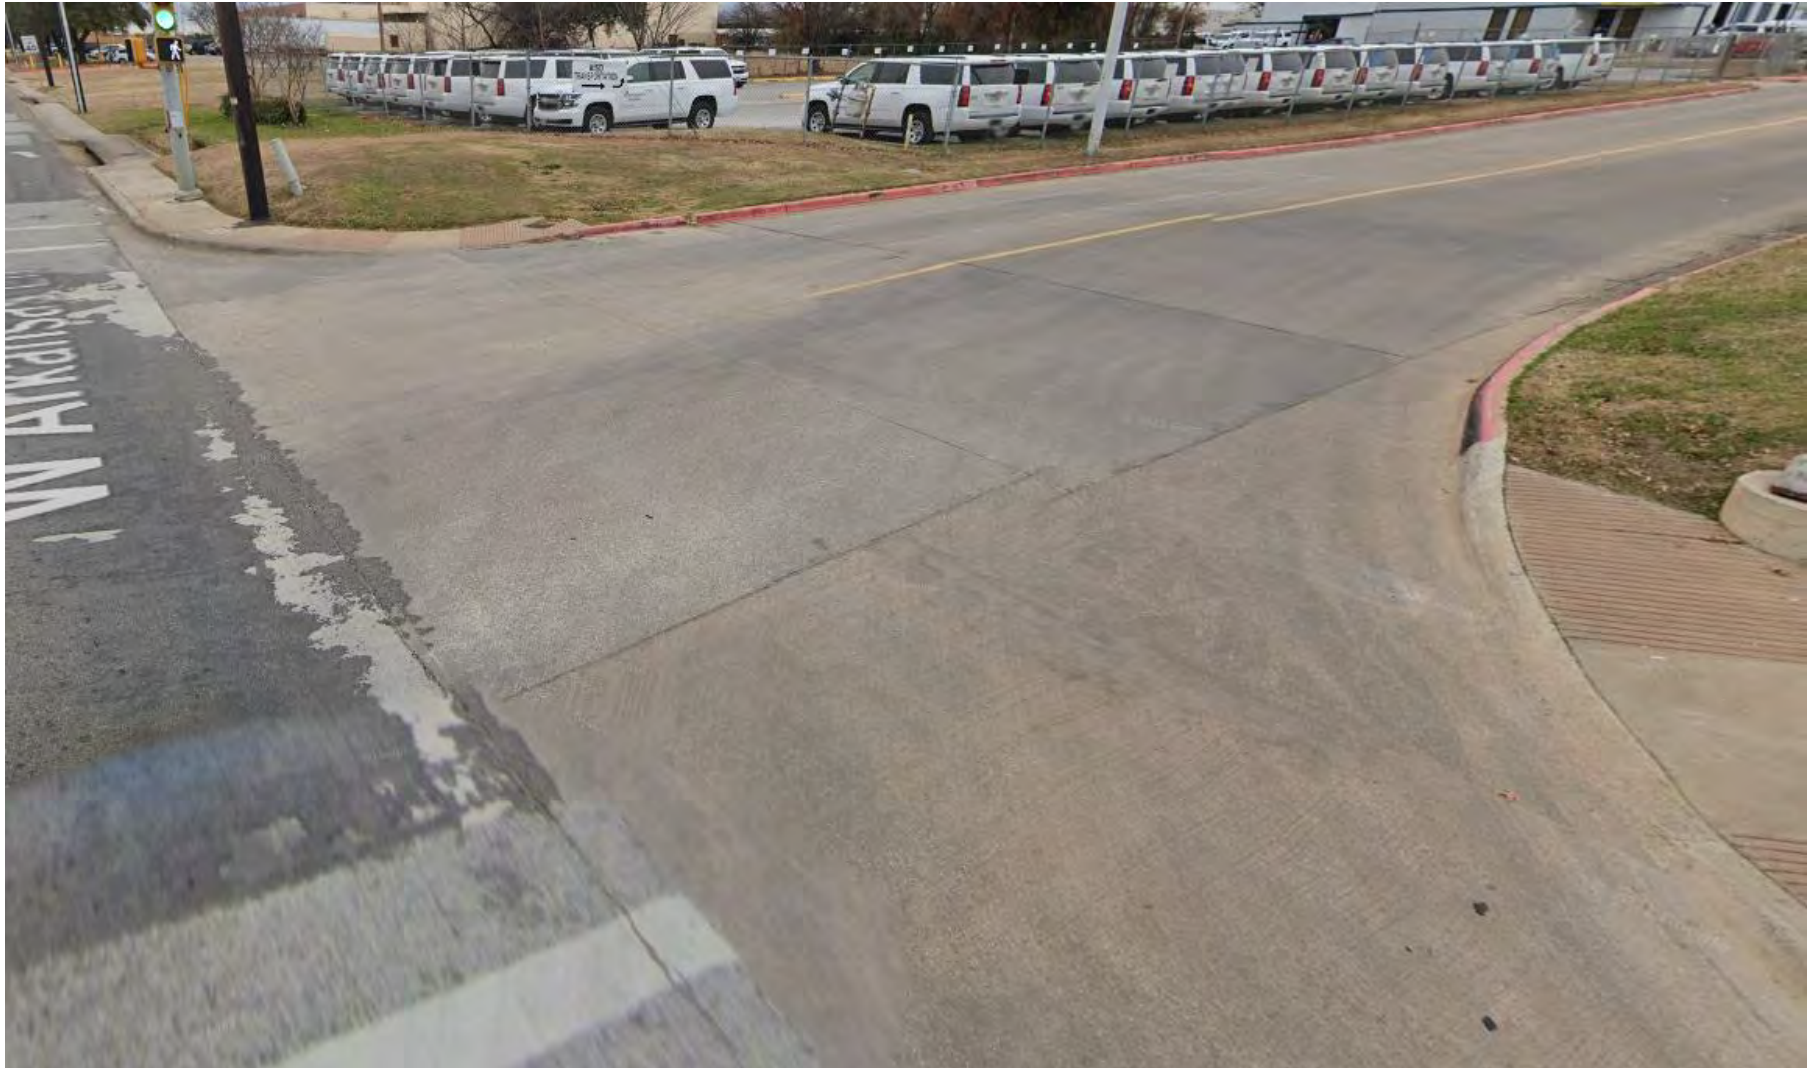
Figure 2: More pedestrian facilities at intersection of S Davis and Arkansas Ln: some sections lacking ADA compliance, no connected sidewalk facilities to Davis, utilities need to be relocated, narrow existing sidewalks, poor conditions, deficient crosswalk striping, etc.

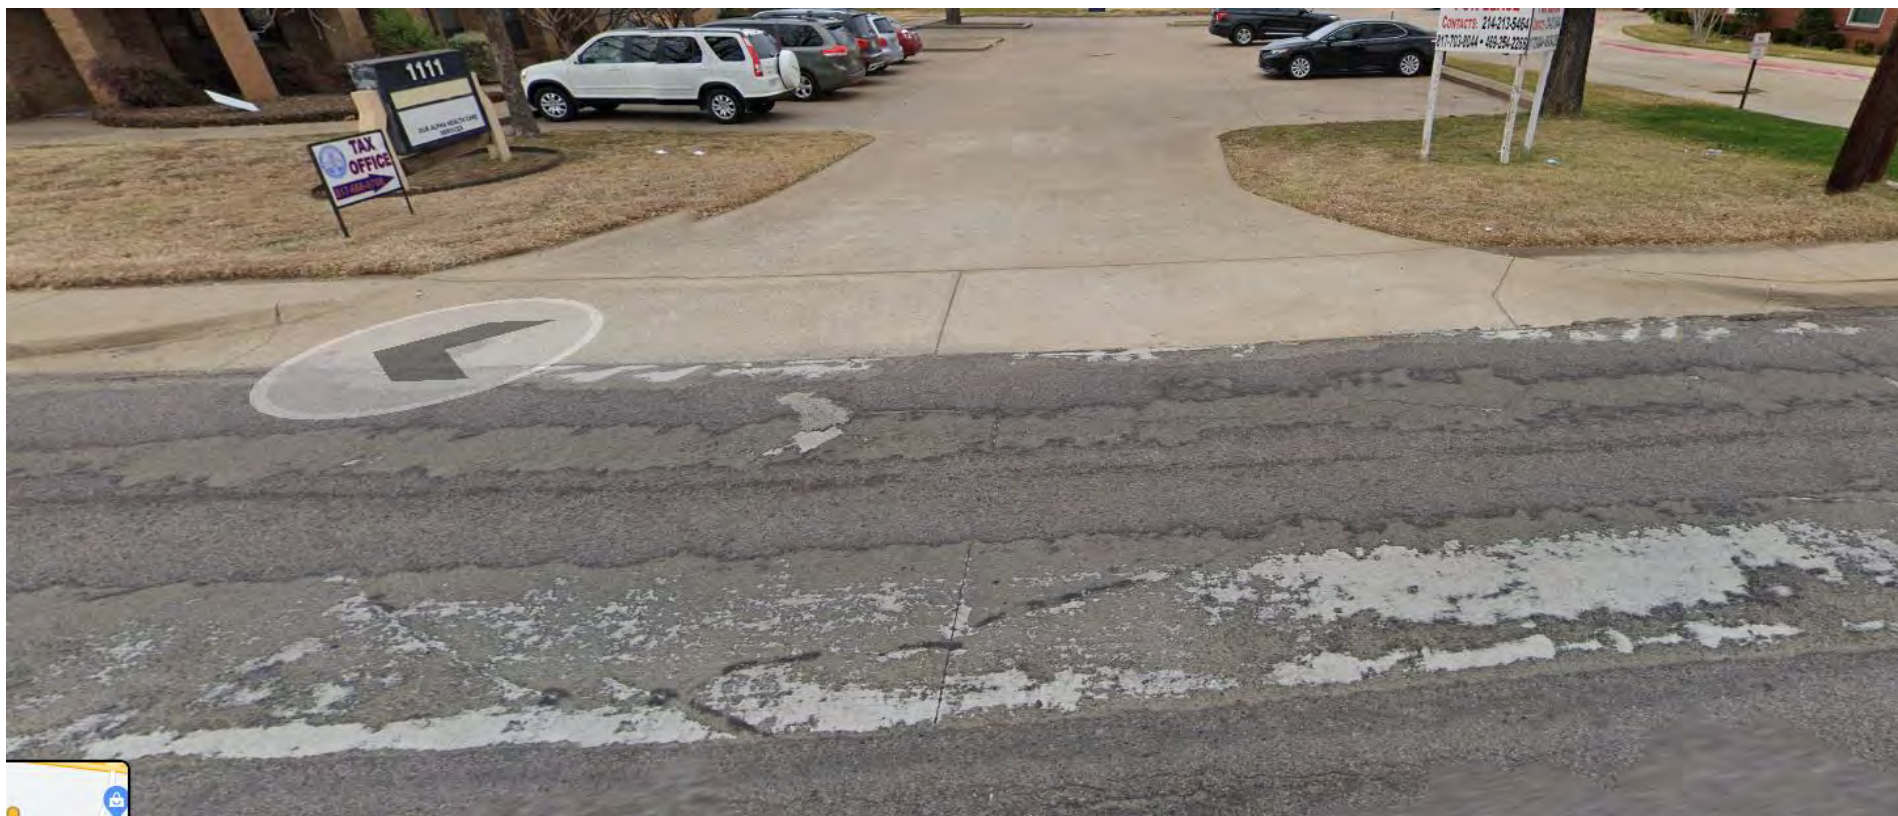
Figure 4: (Westbound along W Arkansas Ln) - Access points along the route with no ADA compliance, narrow sidewalks, poor pavement conditions, etc.
