## Virtual Field Exercise (VFE) A: Road Safety Audit Workshop: Bicycle and Pedestrian

Virtual Workshop: 4/27–4/29

This study area is along Main Street from Peak St. to Carroll St. in the city of Dallas, northeast of downtown. Travel direction is from SW to NE along the 6-lane, minor arterial, with 3-lanes in each direction, separated by a grass median.

## Virtual Field Exercise (VFE) B: Road Safety Audit Virtual Workshop: Bicycle and Pedestrian

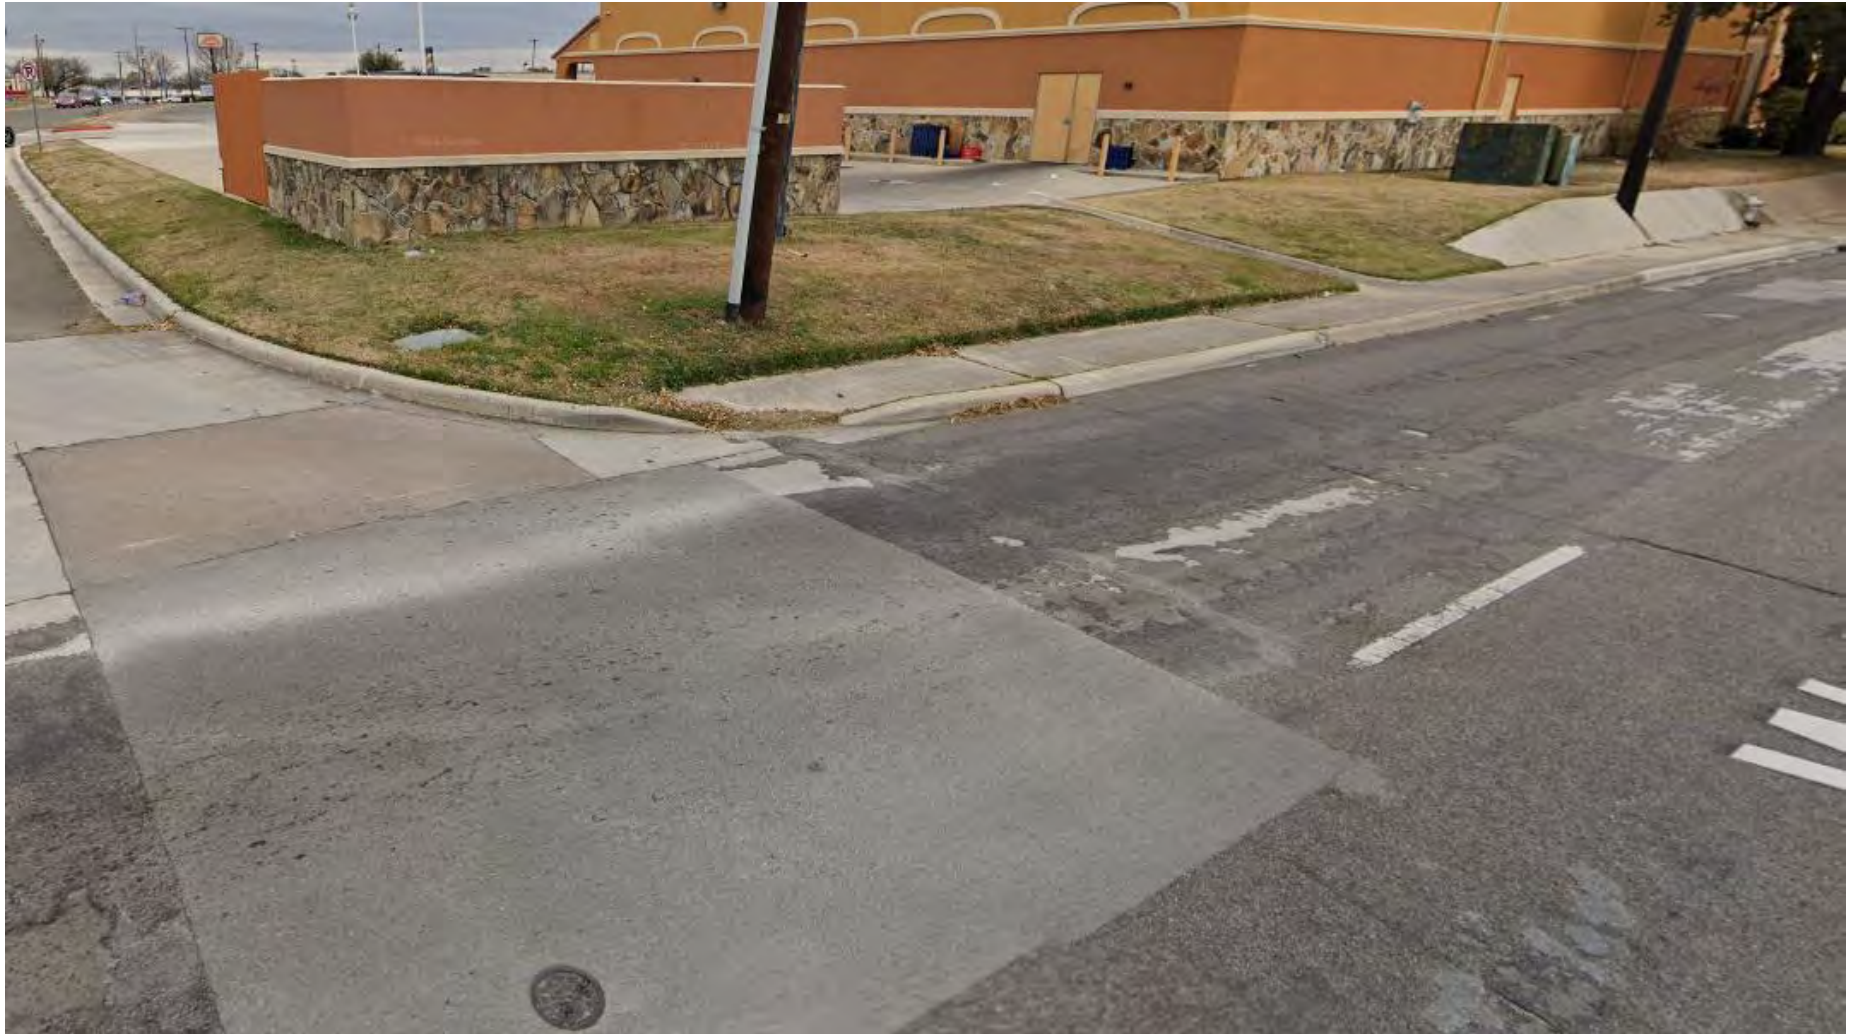
Figure 5: (Westbound along W Arkansas Ln) – More examples of access points with deficient conditions, lack of ADA compliance, limited right-of-way, and poor pavement conditions.

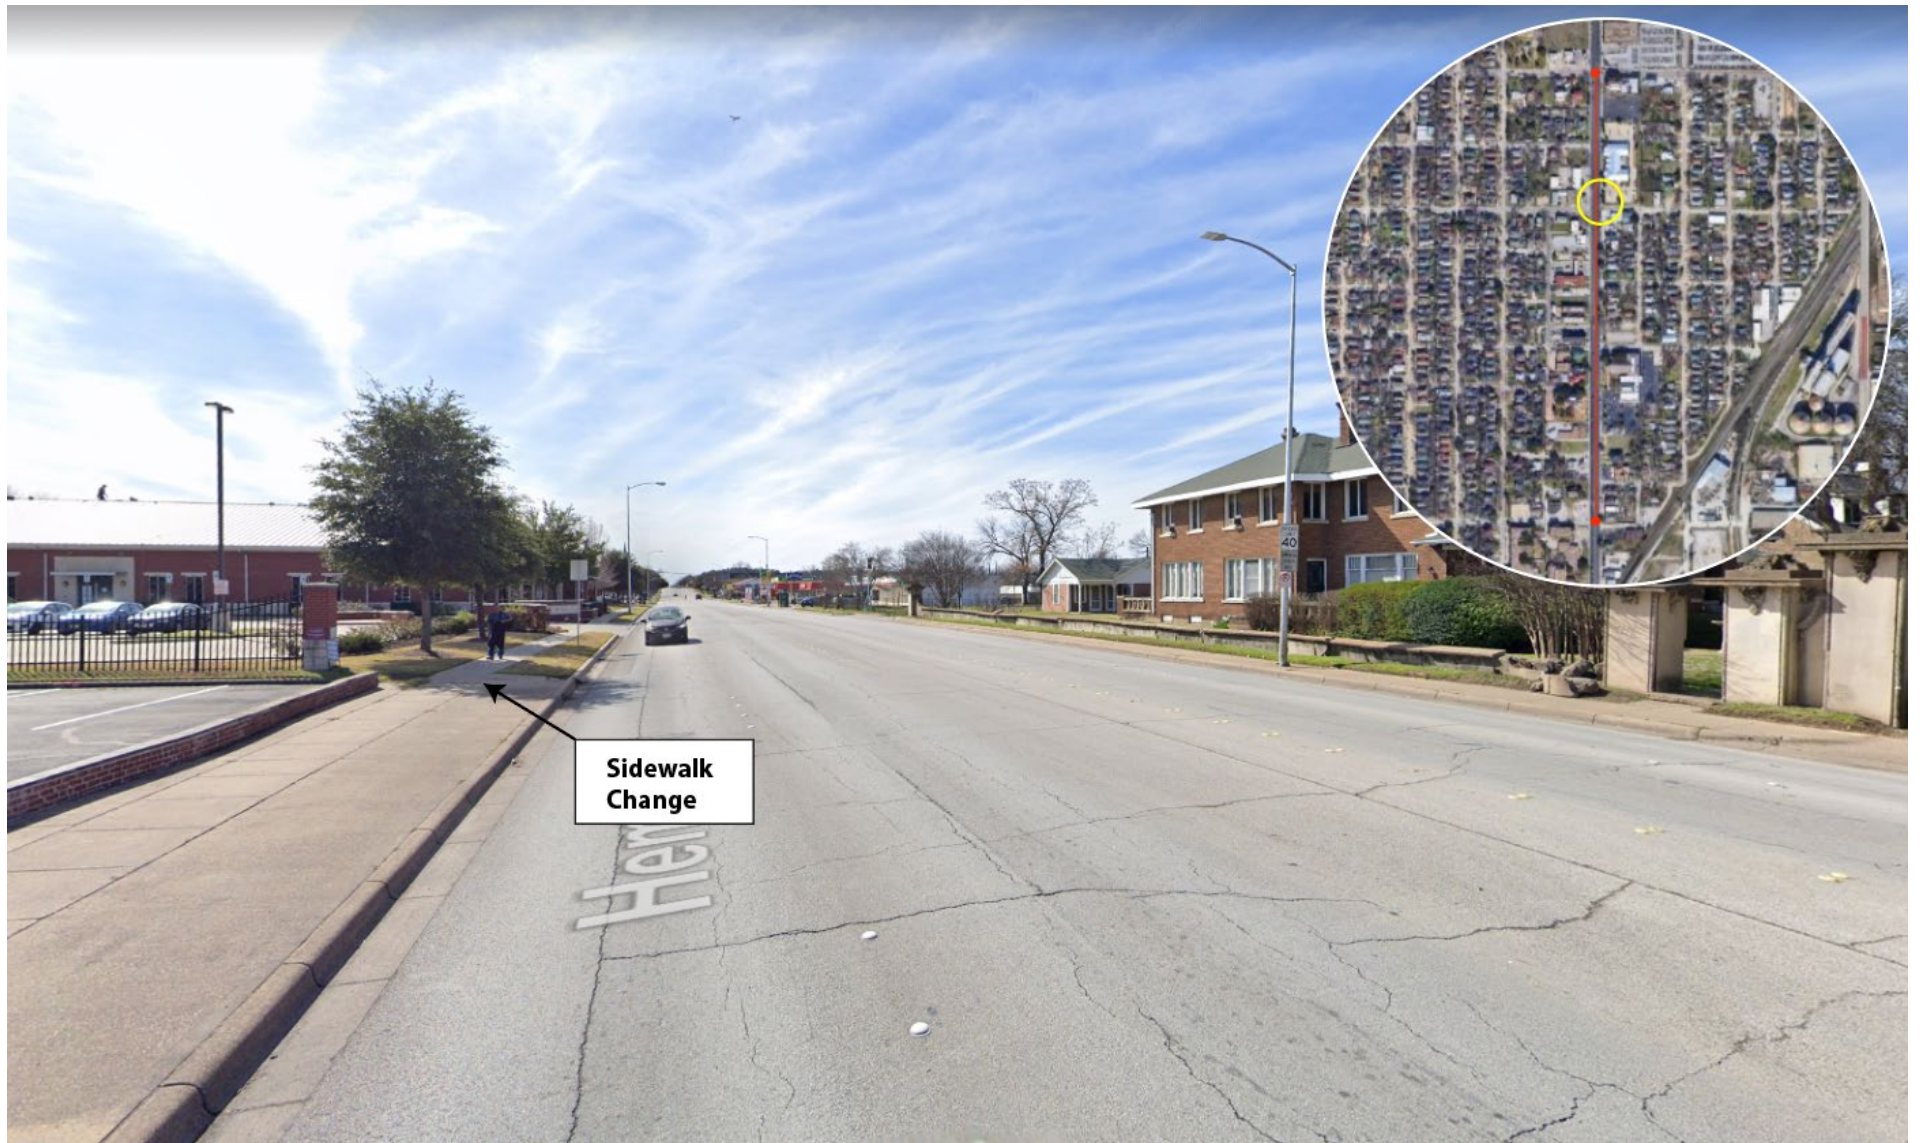
Figure 1: Pedestrian facilities are inconsistent and do not provide a buffer, however, sidewalks are wide enough for users to not be near the road.

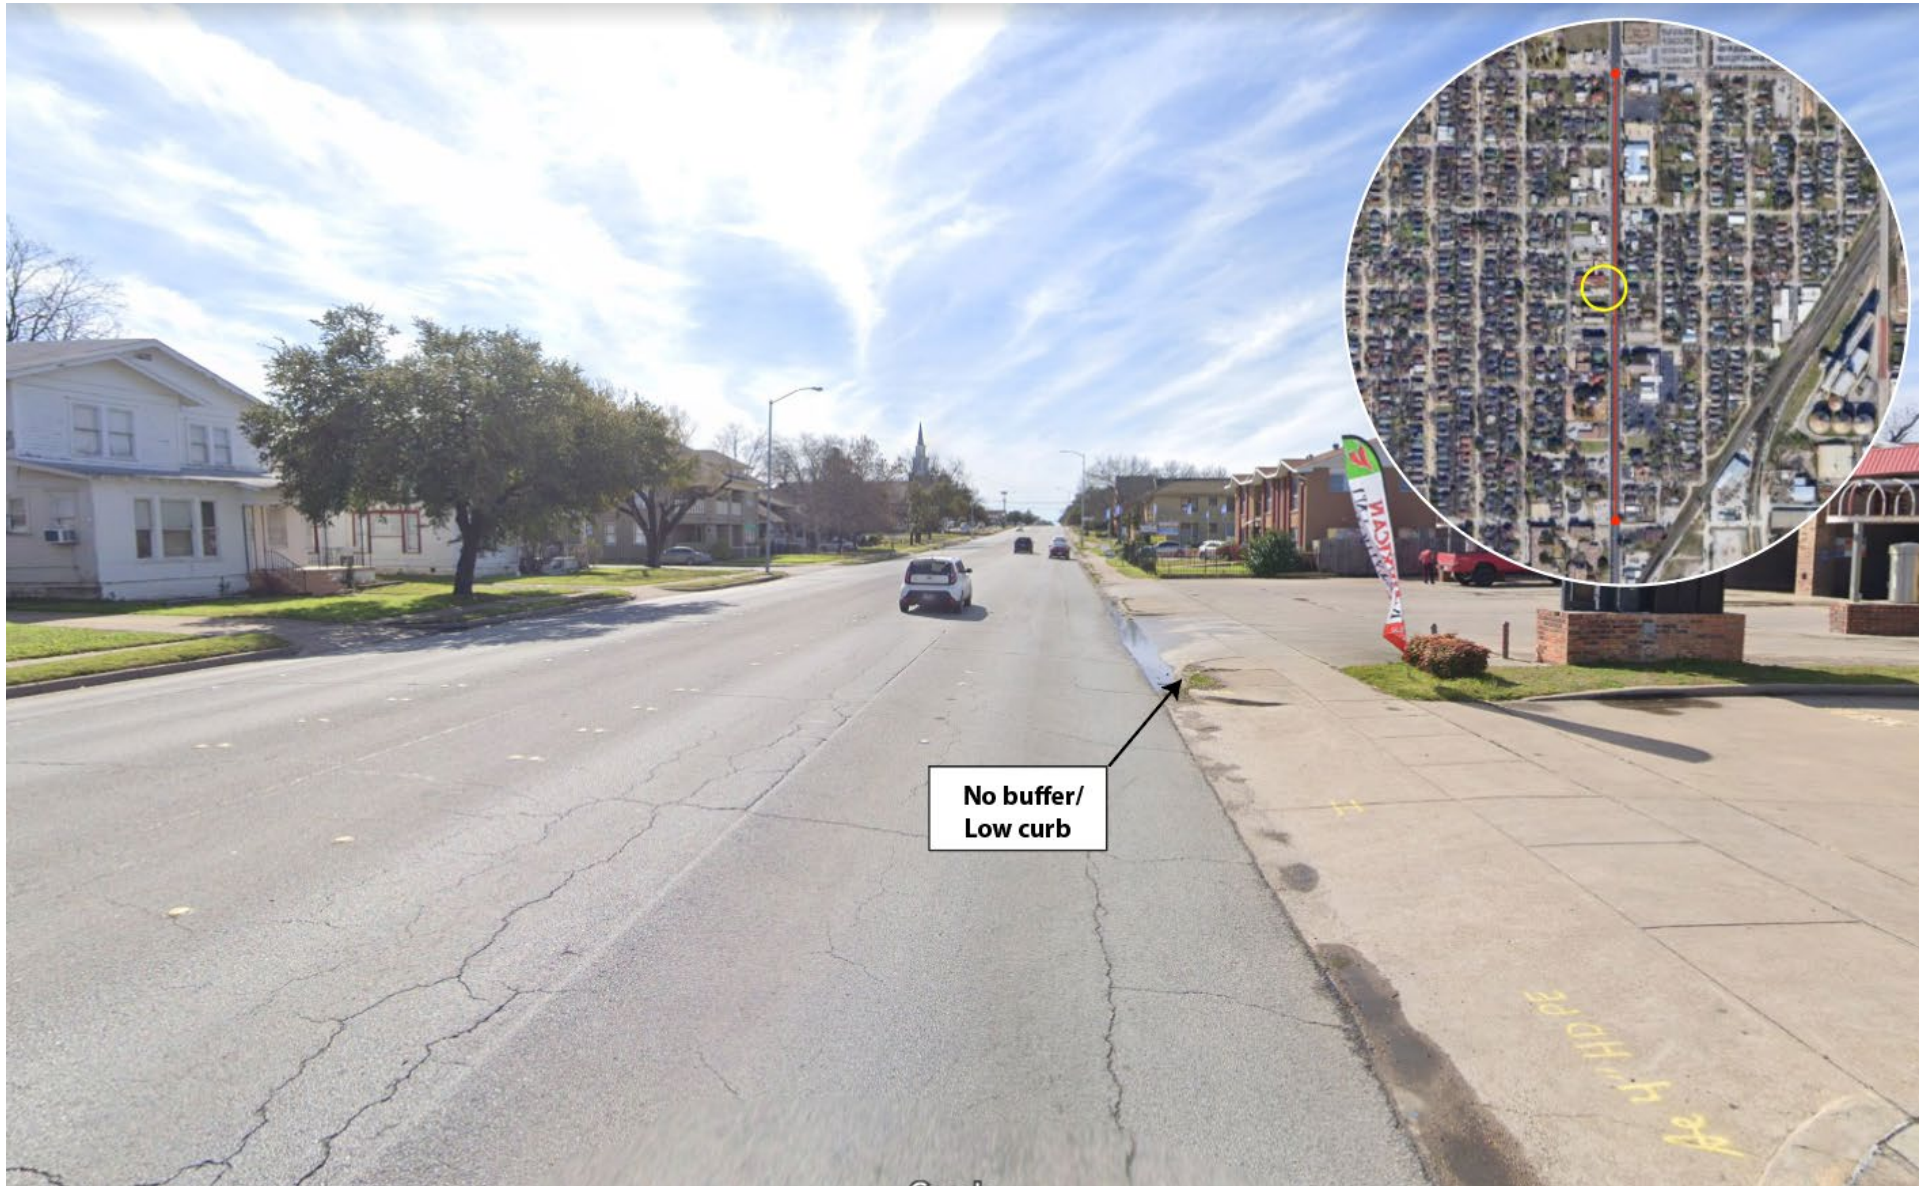
Figure 2: Existing pedestrian facilities lack ADA compliance and lack a buffer between road and sidewalk. Curbs are low and road striping is non-existent.

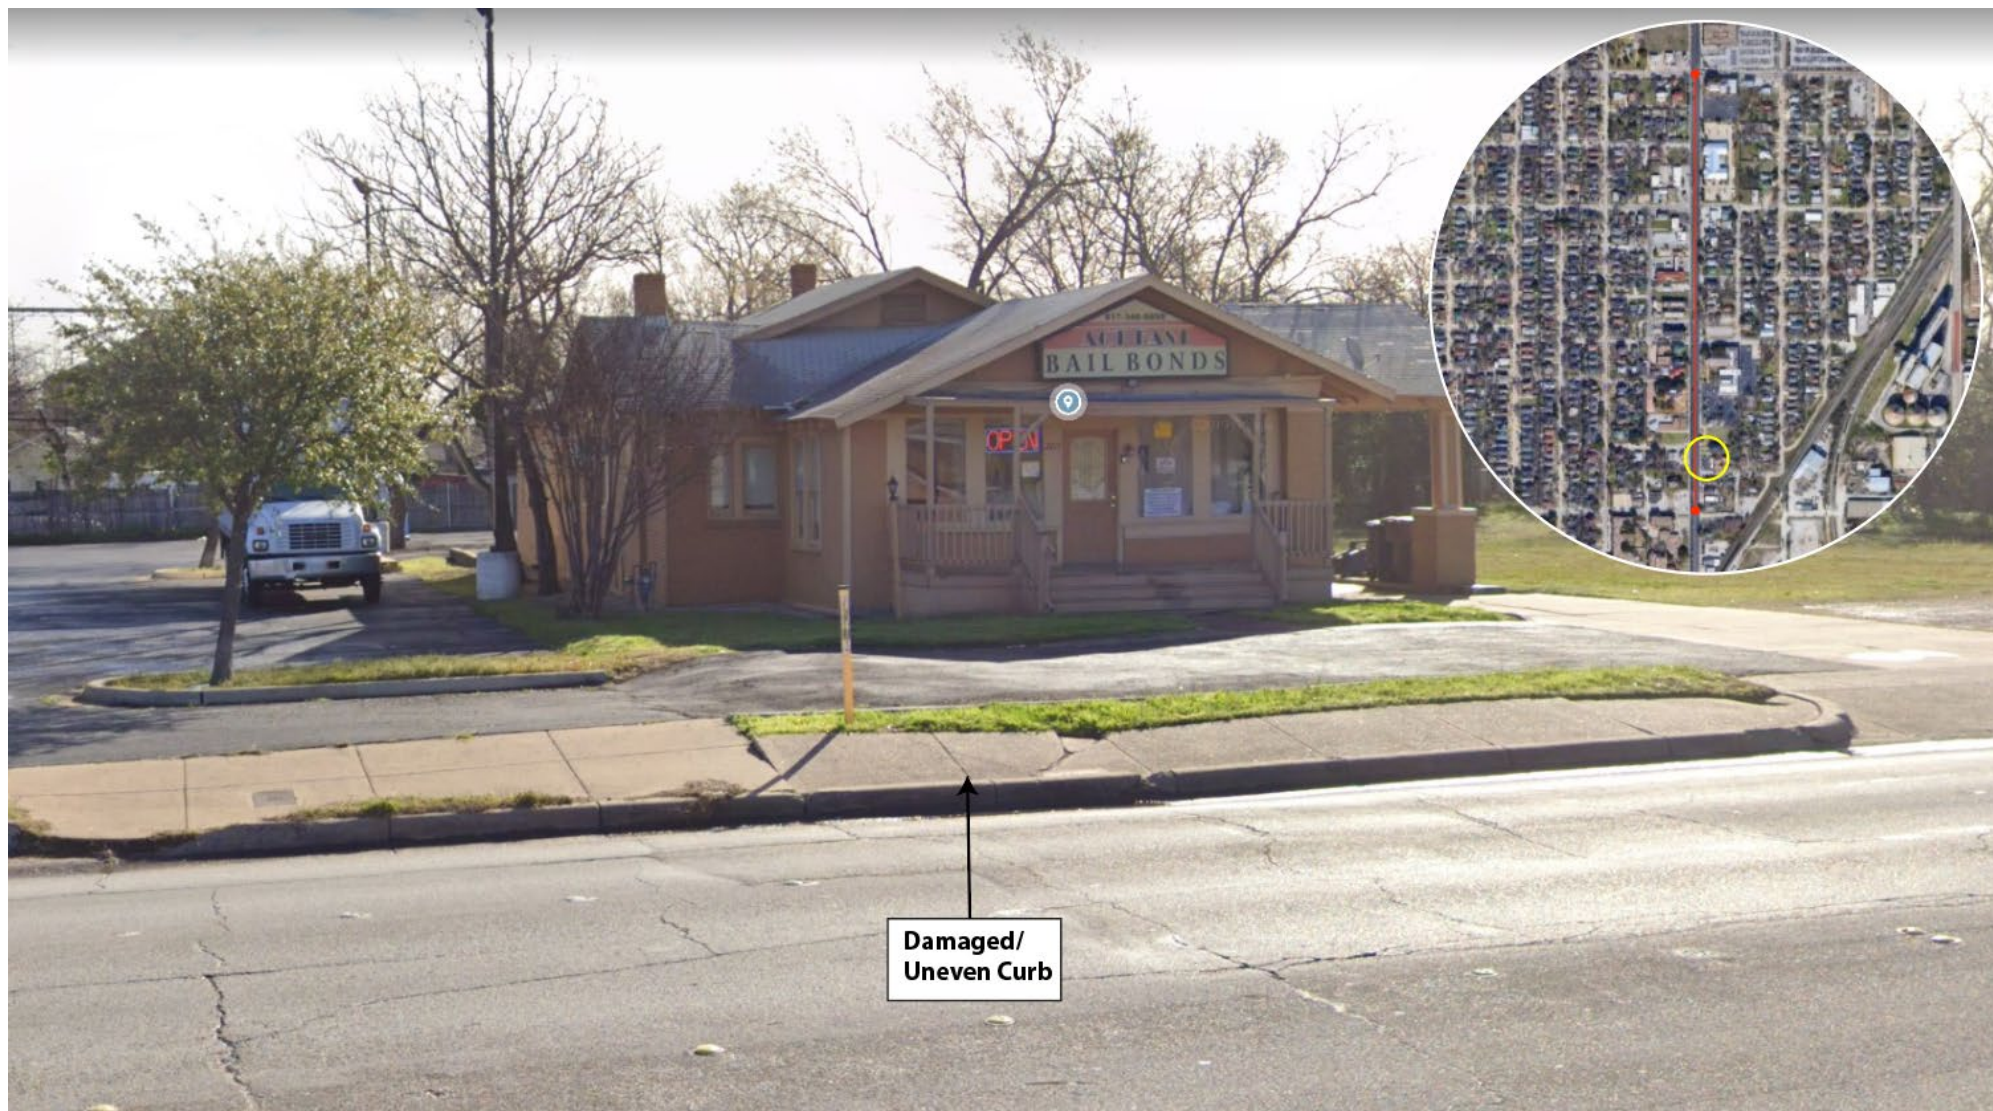
**Figure 3:** Pedestrian facility is not ADA compliant and damaged sidewalk poses a danger to users. Pedestrians are forced to walk closer to edge of sidewalk or onto private property to avoid this area. No buffer between road and road striping is non-existent.

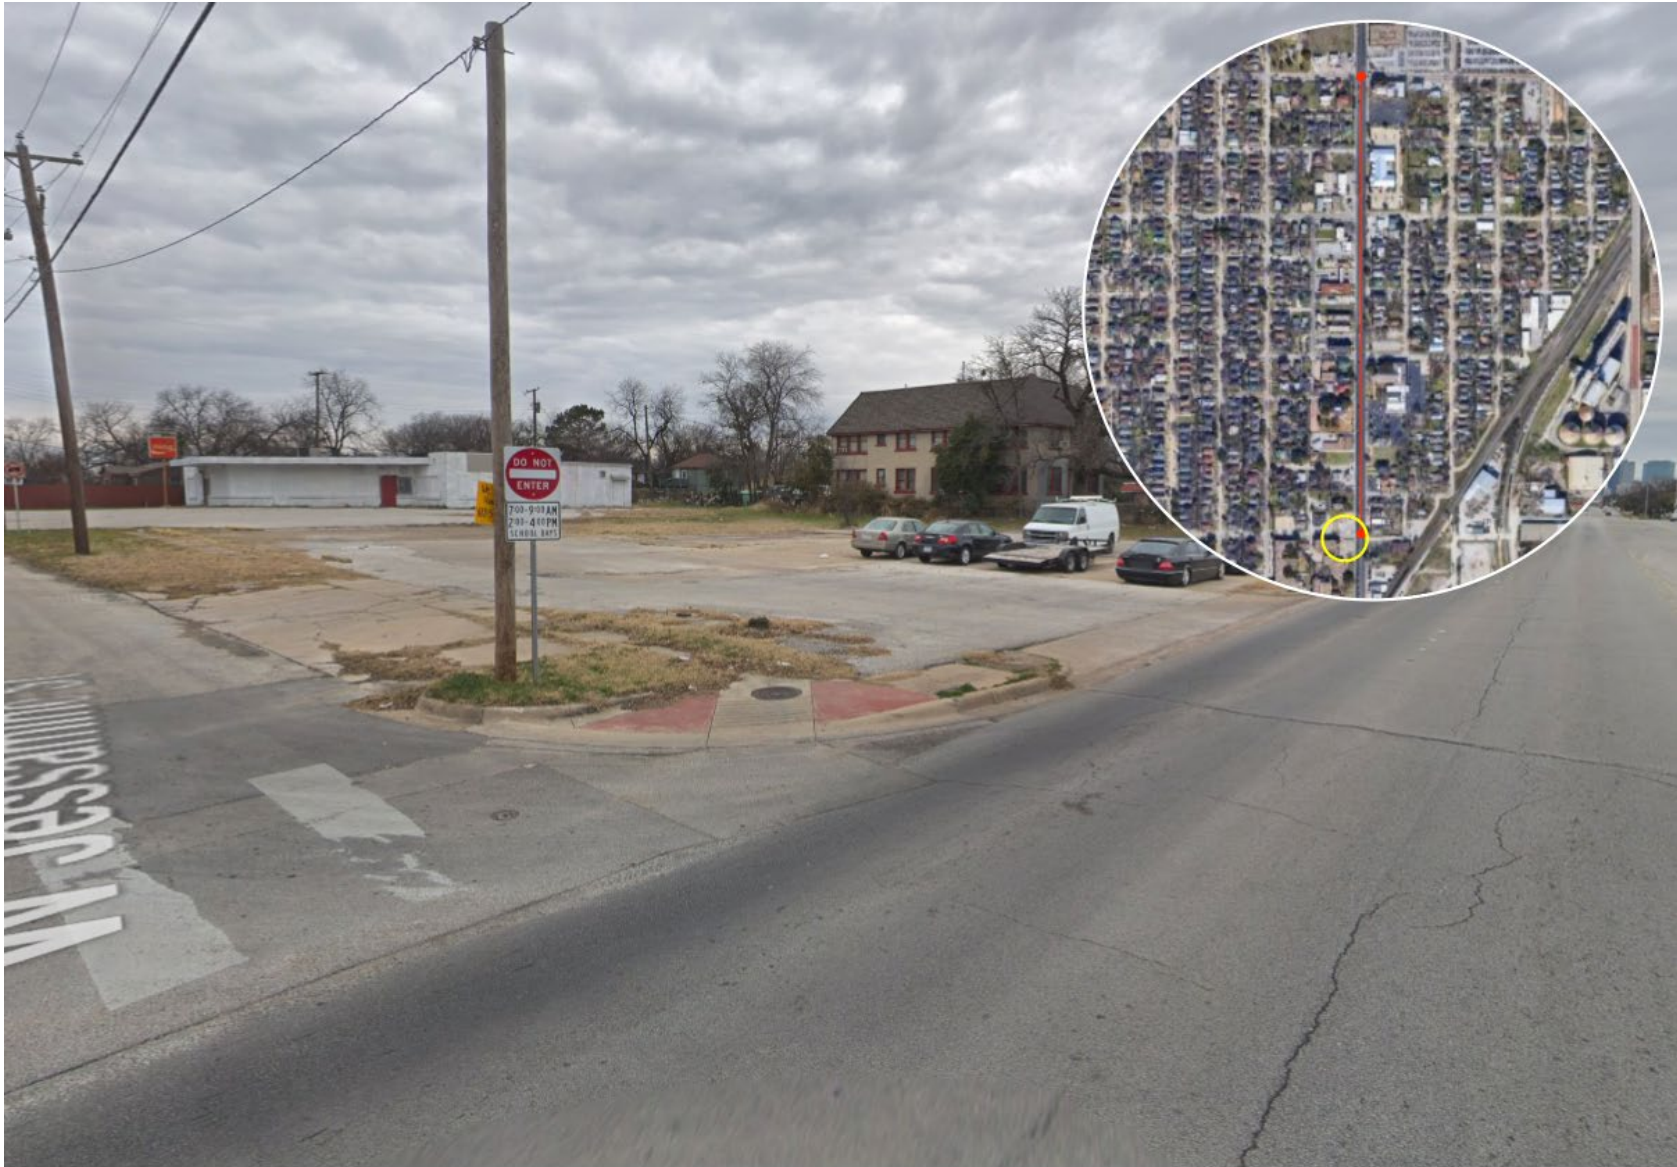
**Figure 4:** No connecting pedestrian facility on the corner of Jessamine and Hemphill, sidewalk is not ADA compliant. Vegetation has overrun much of the sidewalk. Road striping is deficient.
