CIRCLE K: LEAKING PETROLEUM STORAGE TANK

CITY OF PLANO ENVIRONMENTAL QUALITY

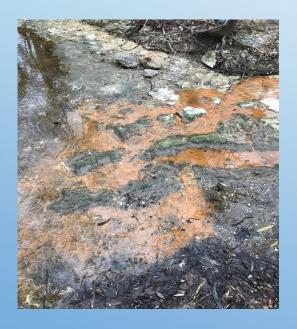
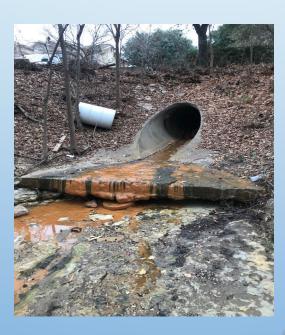
- On 1/2/2020, the Inspector observed a pungent-smelling discharge with an orange substance (possible iron reducing bacteria) settled on the concrete during a routine dry-weather inspection.
- Water color was clear, water sample was collected, and the following parameters were assessed:

рН	8
D.O.	8.4 mg/l
Conductivity	792 ∪S/cm
Temperature	16.2°C
Combined Chlorine	0.12 mg/l
Ammonia	0.70 mg/l
Iron	0.24 mg/l
Chelated Copper	0.06 mg/l
Nitrate	6 mg/l
Phosphate	0.21 mg/l

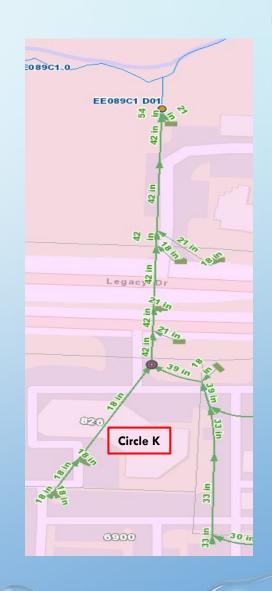
- A sample was taken to PACE Analytical to test for Total Petroleum Hydrocarbons (TPH) and Benzene, Toluene, Ethylbenzene, and Xylene (BTEX).
- Inspector observed that a Circle K gas station was nearby and drained to the same storm drain line. Circle K had recently replaced their pumps and were assessing for need to replace tanks.
- Manager was called and left a voicemail regarding recent work done at Circle K. We asked for recent tanks tests to be provided.

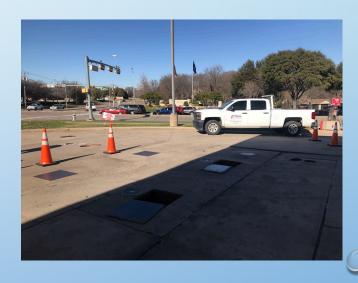
Sample results for TPH and BTEX at outfall:

ТРН	Non-detect (ND)
Benzene	0.019
Toluene	ND
Ethylbenzene	0.011
Xylene	0.012

^{* 0.005} mg/l is the surface water, default groundwater, and drinking water standard for Benzene.

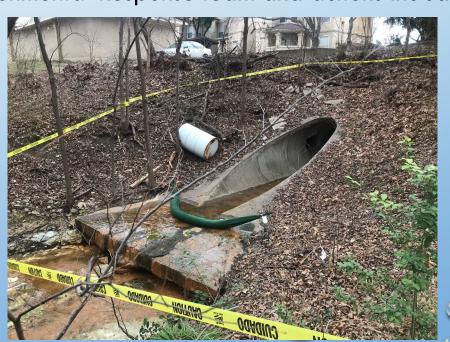
- After receiving BTEX results, Circle K was requested to provide immediate response to the discharge and report the release to TCEQ.
- 1/7/2020: Plano EQ spoke with Circle K Environmental Response team and actions included:
 - Addition of absorbent booms at the outfall
 - Petroleum line test and tank test scheduled
 - Drilling of monitoring wells for groundwater
 - TCEQ Petroleum Storage Team notified

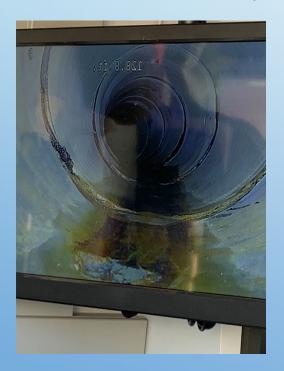
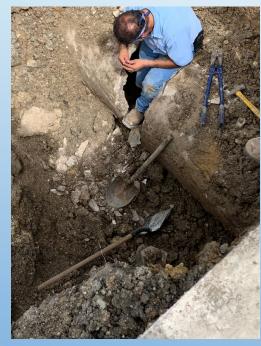
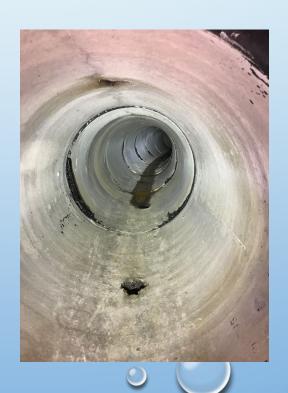
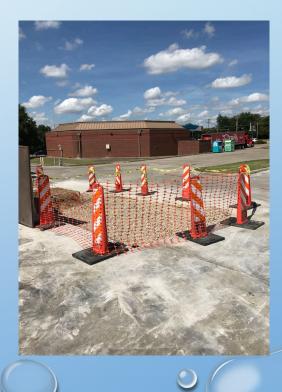
Both Plano Public Works and Pure Environmental have TV'd the storm drain line and found a break where repairs need to be made by the City to prevent contaminated groundwater intrusion.

- Plano Public Works worked on identifying exact line break location for simpler repair process.
- Line repaired on 7/21/2020

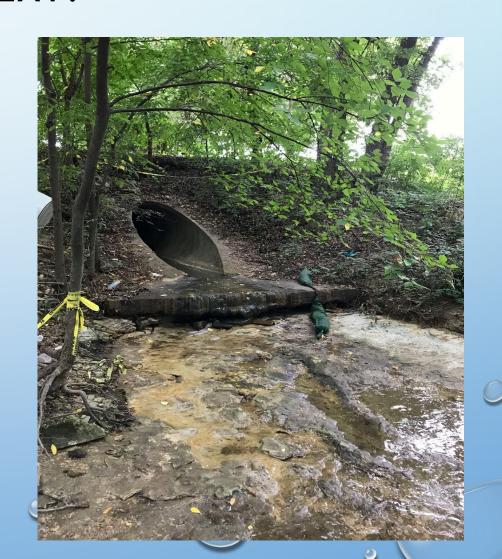
- Circle K to comply with TCEQ risk assessment order.
- We will continue to monitor the outfall and compliance.
- Outfall has cleared up regarding orange substance and odor.
