Dry Weather Screening to IDDE : A Gas Well Incident - Case study

Matthew Hendrix

City of Denton

Watershed Protection

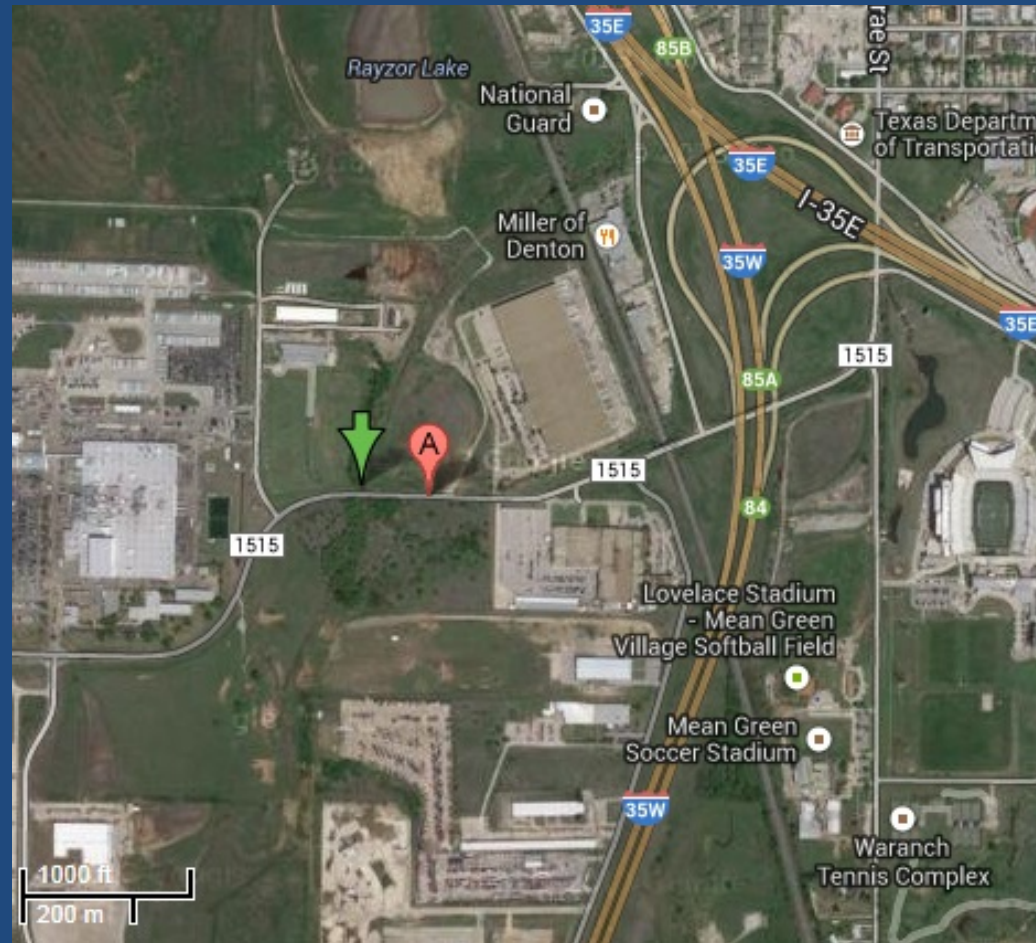
DWS January 2014

- Site 2: Airport Rd
 - Hickory Creek Tributary
 - Adjacent to Gas Well Pad Site
 - Small drainage area west of I-35
 - 4 businesses upstream, none of which have a stormwater permit
 - NECs

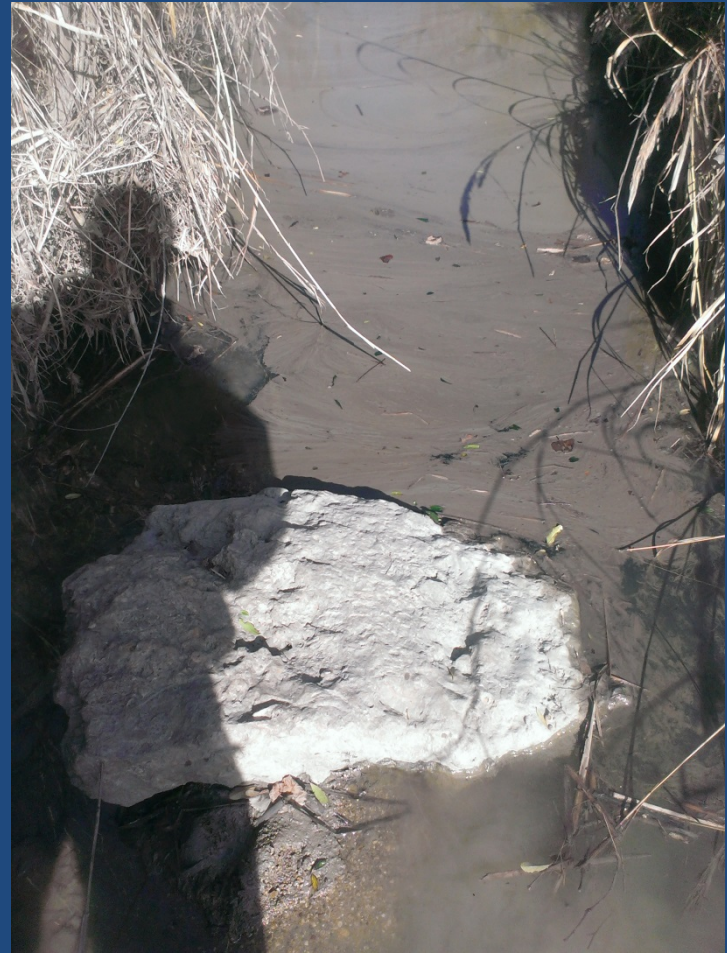
Further Upstream

- A small debris dam (rock and vegetation) holding back potential unknown IDDE material
- Grey and brown sludge backed up ~50 meters

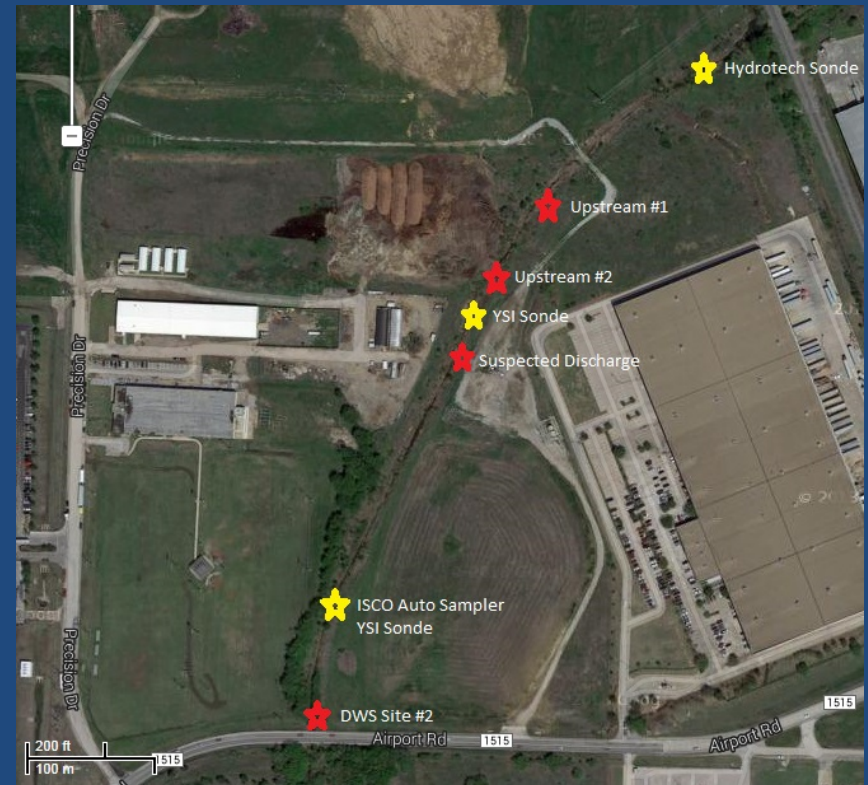
Building the Case

- Monitoring Information
 - ISCO auto sampler
 - Downstream of suspected discharge
 - Sonde Data (stars)
 - Upstream
 - Above Suspected Discharge
 - Pool Above Site 2 (ISCO)
- Grab Samples (stars)
