U.S. Department
of Transportation
**Federal Highway
Administration**

Road Safety Audit Akard and Ervay Streets Dallas, TX

MARCH 28, 2022

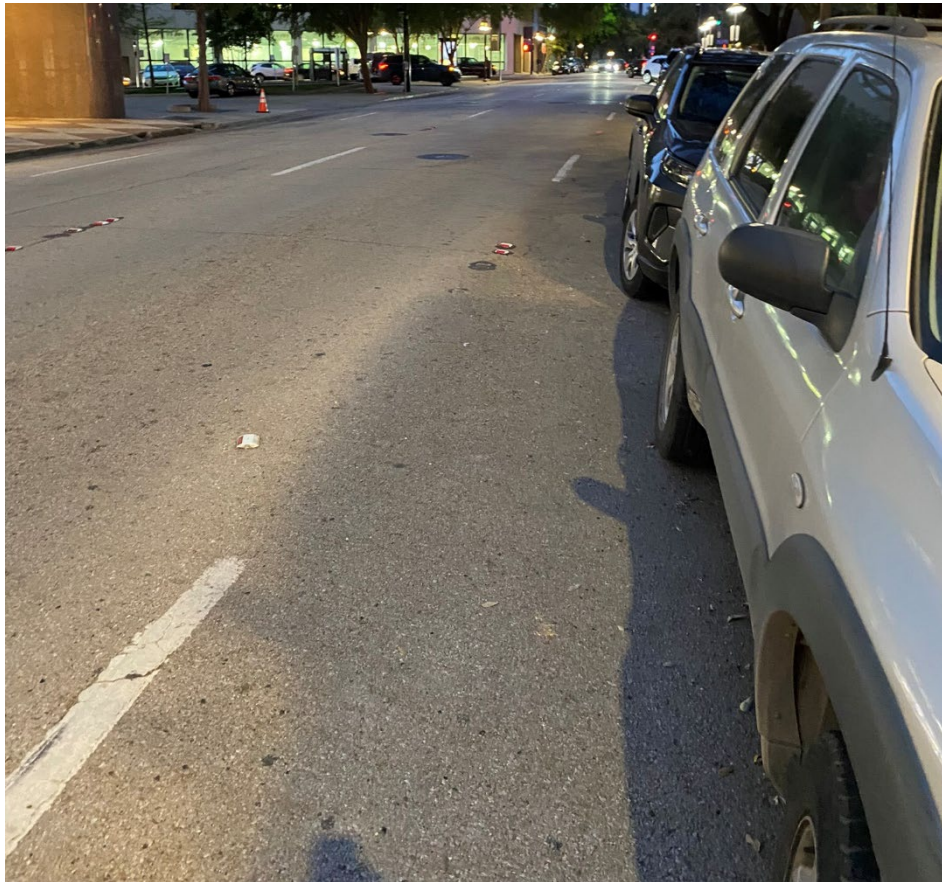
Figure 5: Pavement markings (lane skips)

- Refresh pavement markings, particularly at crosswalks. The City should ensure compliance with the new minimum levels of pavement marking retroreflectivity. Some of the intersections utilized brick pavers to delineate the crosswalks. While these treatments look pleasing and distinctive from overhead or while walking, they fail to provide adequate information to drivers about where to expect people walking, particularly at night. Additionally, at some locations the brick pavers of the crosswalk extended into the interior of the intersection and space used by vehicle traffic, which potentially creates an unnecessary conflict area between those walking and driving. Any striping that is placed should be clear of vehicle paths, even if it conflicts with the brick patterns. Timeline: Short-term.

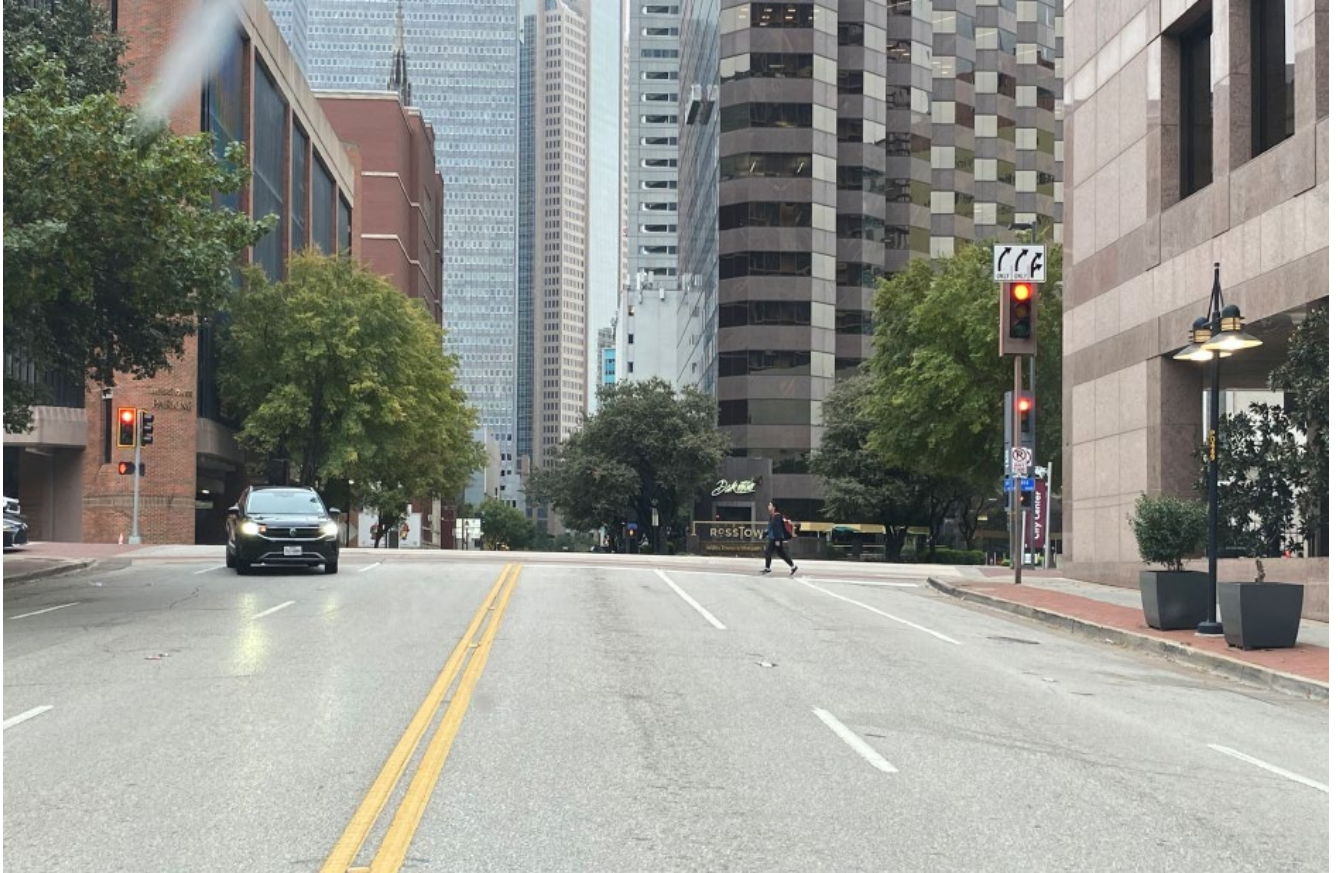
Figure 7: Akard/Erway/Ross

- **Observation:** The RSA Team observed many conflicts between drivers, often due to drivers deviating from their lane assignments as they traveled through the intersection. Drivers often conflicted in the right two lanes south of the intersection where the rightmost lane then allows for parking. The RSA Team also noted a history of right-angle crashes and sideswipe crashes: the last five years of crash data showed 43 crashes at this intersection, 23 of which were right-angle crashes and five of which were sideswipe crashes. The RSA Team observed that for drivers traveling southbound through the intersection, a variety of factors contributed to visibility issues.

Recommendation: Install and/or refresh signage and pavement markings, and consider signal upgrades. Upgrading to the City's current standard of mast arm signals would provide more conspicuous signal head placement and would better accommodate this larger intersection. Green arrow indications in lieu of circular green signal indications would provide more visual guidance to the driver about the upcoming horizontal curve, as would angled arrow pavement markings. Intersection lane control signs, possibly located on mast arms, would be more conspicuous and a supplemental sign on the near side that is located below the signal would reinforce the message. Pavement marking extensions through the intersection (“puppy tracks”) could be installed. South of the intersection, installing a raised curb median for the northbound Erway Street to southbound Akard Street U-turn movement would provide positive guidance and separation for southbound traffic. **Timeline:** Short-term for pavement marking and signage improvements that could be installed in an interim condition, otherwise medium- to long-term.

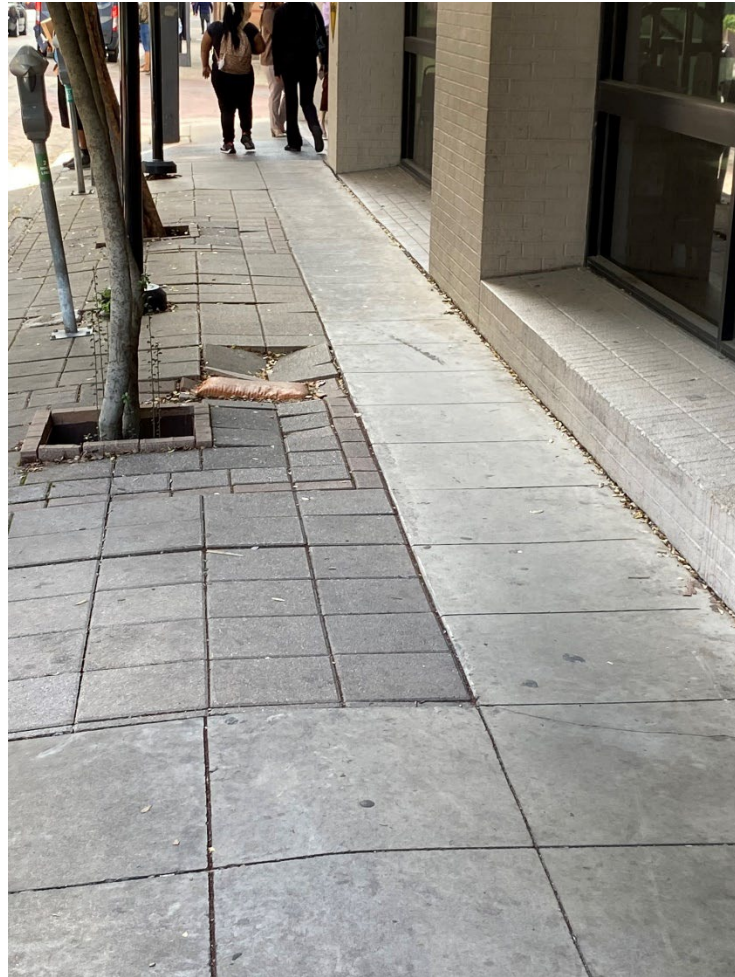
Figure 9: Obstructions on Akard Street north of San Jacinto Street

- Observation:** As noted in General Recommendations above, the sidewalks contained obstructions. The west side of Akard Street in this area, especially

north of San Jacinto Street, appeared to contain the narrowest sidewalks in the corridor. Obstructions further reduced its effective width.

Recommendation: Sidewalks should be a minimum of six feet wide, free of obstructions, with wider areas when needed. The City should ensure basic maintenance of the pedestrian path. **Timeline:** Long-term.

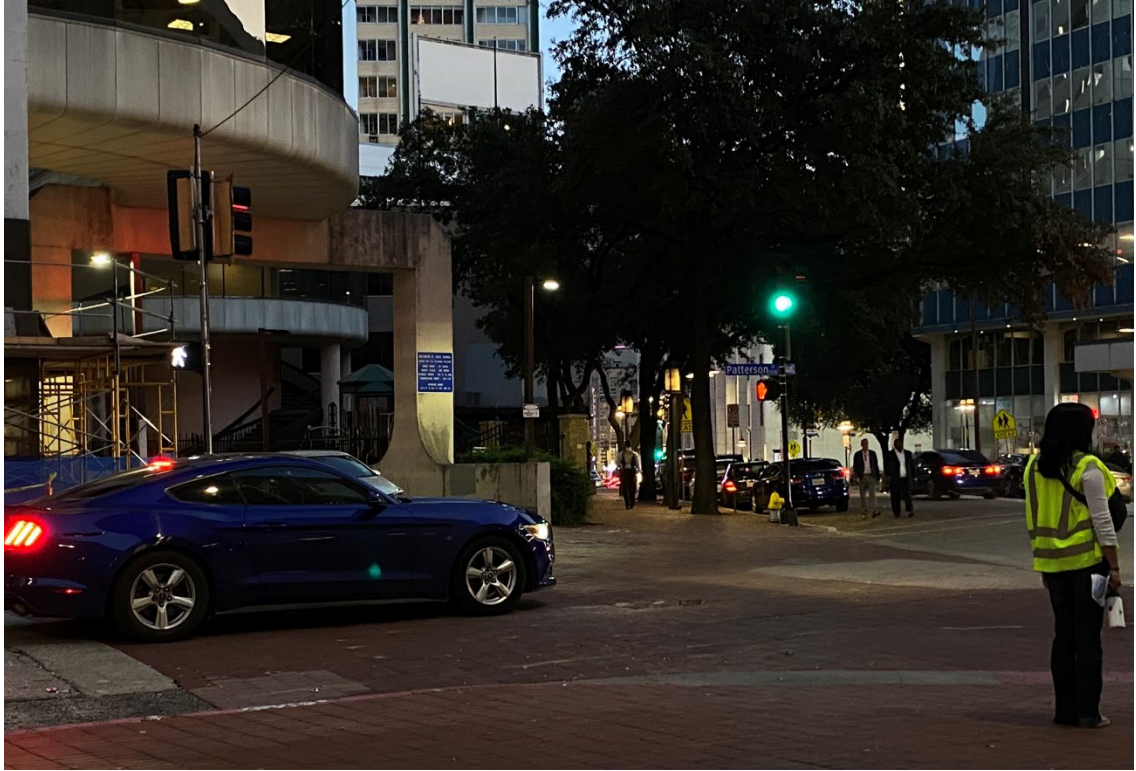
Figure 10: Misleading pedestrian signal head

- **Observation:** On the east side of the intersection, the unusual configuration is leading to safety concerns. On Patterson Street, the Bullington Street Truck Terminal entrance/exit driveway is east of the Akard intersection, and has its own pedestal signals (vehicular heads and pedestrian heads) on the east and north sides. It appears that pedestrians walking northbound or southbound on the east side of Akard Street are intended to make two crossing maneuvers: one across the Truck Terminal driveway and the other across Patterson Street. The same brick patterned aesthetic treatment used in the corridors for crosswalks also spans the surface of the Truck Terminal entrance/exit intersection. The observed pedestrian behavior and crossing paths conflicted with both the pedestrian signalization and messaging conveyed by the aesthetic treatment. The RSA Team observed several conflicts with drivers and pedestrians on the east side of the intersection. When walking southbound on Akard Street, pedestrians often followed the pedestrian signal head southeast quadrant of Akard/Patterson, which is intended to serve pedestrian traffic crossing the Truck Terminal driveway.

Recommendation: The City should rotate the misleading Truck Terminal driveway pedestrian signal to make it less visible to pedestrians crossing Akard Street. The City could consider striping the larger expanse of pavement near the Truck Terminal to allow for a single pedestrian crossing movement on Akard Street since it provides a more direct pedestrian path. The City could also consider making the truck terminal exit a right-turn only to reduce some of the conflicts. **Timeline:** Short-term for adjusting the pedestrian signal head, medium-term for others.

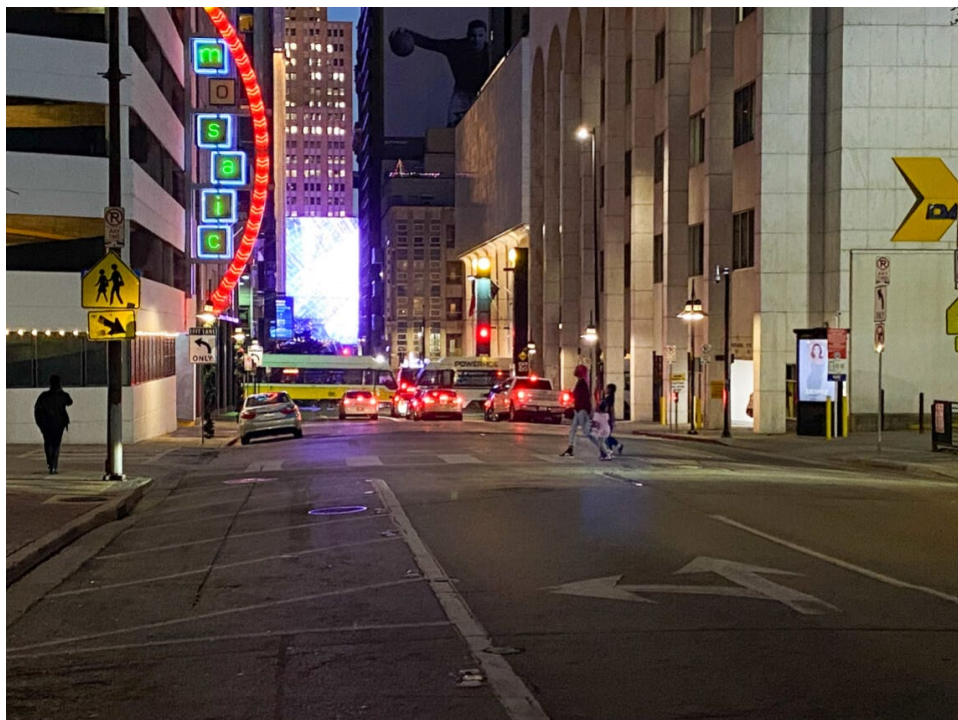
Figure 11: Pedestrians crossing Akard Street at Federal Street

- **Observation:** The RSA Team observed many conflicts between pedestrians crossing Akard Street (using the marked crosswalk or otherwise) and drivers making the eastbound through movement continuing on Federal Street. Due to the skewed configuration, drivers continuing eastbound on Federal Street tended to focus on looking for oncoming vehicular traffic on Akard. This often led to drivers not looking for pedestrians using the marked crosswalk. The RSA Team observed some pedestrians preferring to cross Akard Street north of the existing crosswalk, likely desiring to avoid the conflict with eastbound Federal Street drivers.

Recommendation: The crosswalk could be relocated with enhanced pedestrian improvements, which would remove the conflict with pedestrians crossing Akard Street and drivers making the through eastbound Federal movement. Enhanced pedestrian improvements to the crosswalk could be the addition of a [Pedestrian Hybrid Beacon](#), [Rectangular Rapid Flashing Beacon](#), or [Crosswalk Visibility](#)

Enhancements. **Timeline:** Short-term for pavement markings; medium-term for other enhancements.

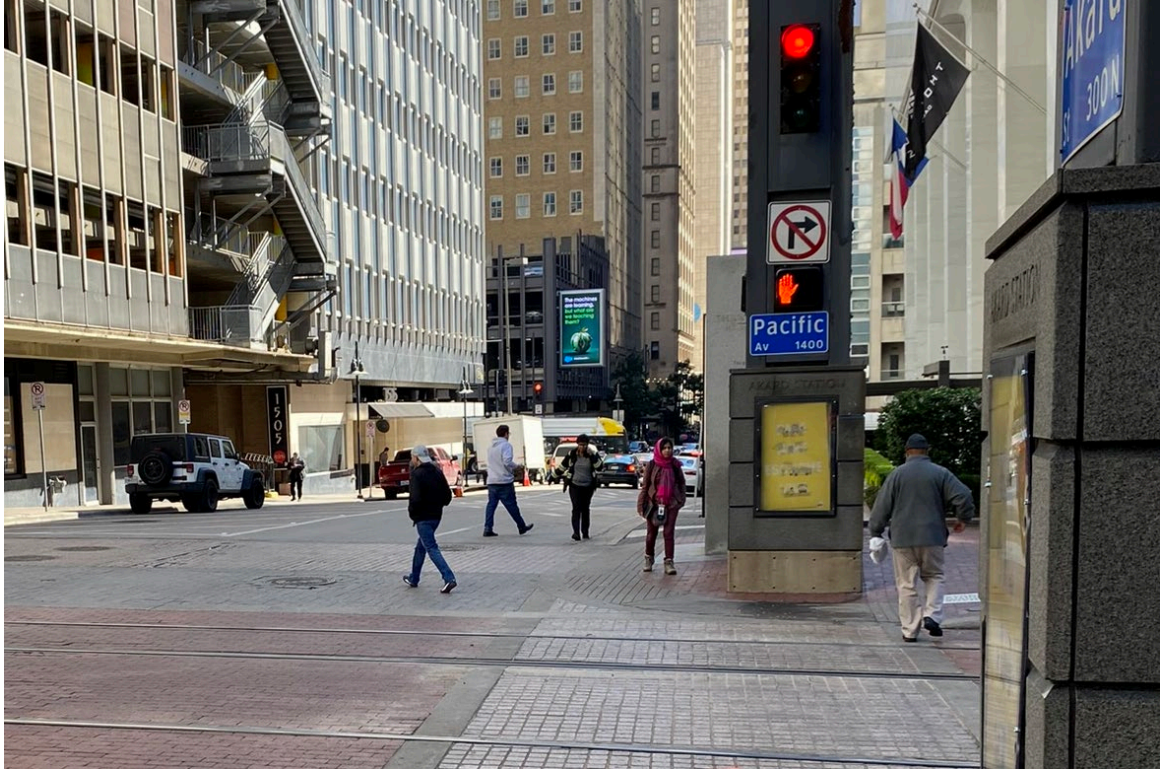
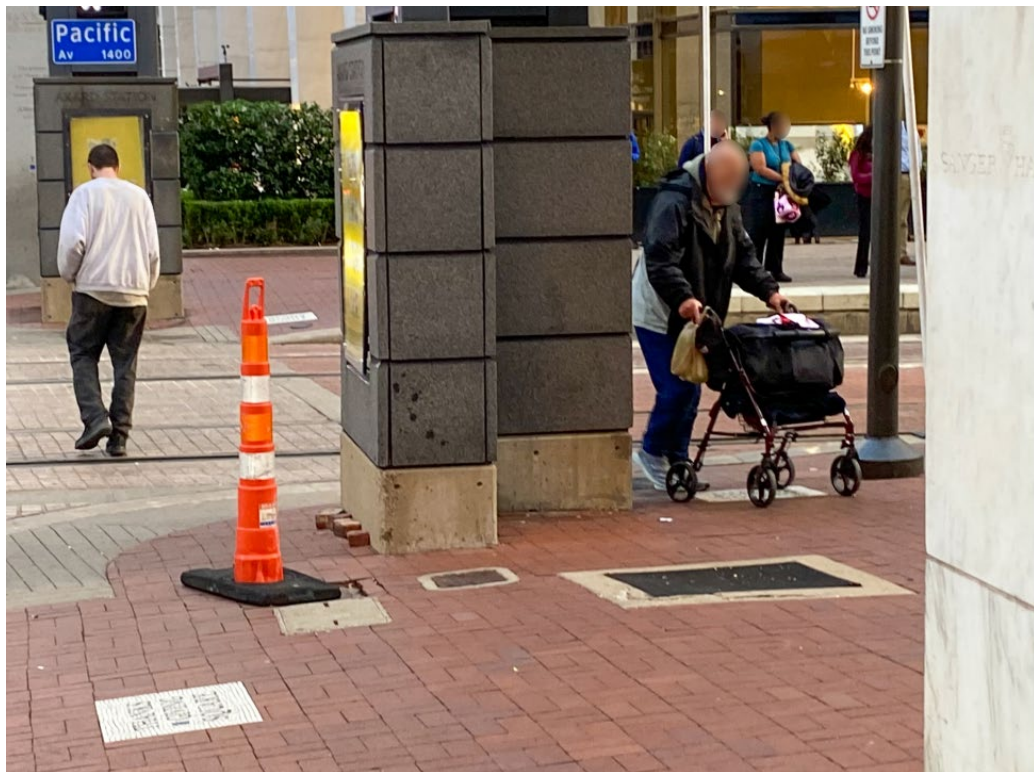
Figure 13: Pedestrian activity on the west side of Akard/Pacific

- **Observation:** This is an area of very high pedestrian activity. The width of the sidewalks are inadequate, especially on the west side of the intersection adjacent to Akard Station. The RSA Team observed conflicts between drivers and pedestrians crossing Pacific Avenue, especially on the west side of the intersection after passengers arrived via light rail. In peak periods, the RSA Team observed pedestrians challenged by the lack of space in certain locations (e.g. maneuvering around planter boxes, safety railing, vertical drop-offs, pedestal signals with large footprints, placemaking/art, etc.). On the west side of the intersection, within the crosswalk, there was a large gap between the rails and the pavement surface that exceeded the typical flange way gap in this and other locations. The RSA Team observed more than one pedestrian struggle to traverse this area. There were several other locations where basic maintenance is needed.

Recommendation: Due to high pedestrian volumes, the City should consider enhancing the pedestrian use and accessibility. Bulbouts similar to those at St Paul Station would provide more space for pedestrians and shorten the crossing distances. The City should install detectable warnings in compliance with current standards. The City should ensure that the sidewalk is free of obstructions and ensure basic maintenance of the pedestrian path. **Timeline:** Short-term for basic maintenance needs, medium- to long-term otherwise.

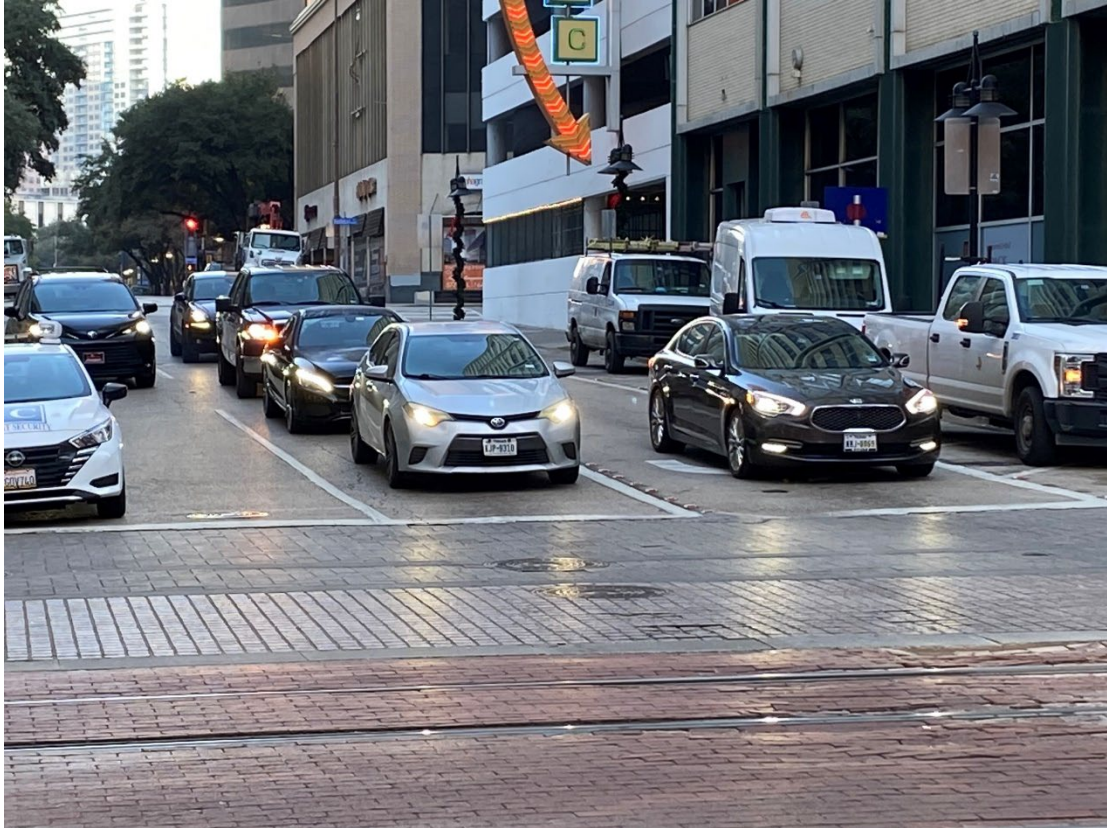
Figure 15: Parking activity on the north side of Akard/Pacific

On the northwest side, rush hour parking restrictions were in place but were often ineffective, and no enforcement was observed during the field visits. This resulted in an effective cross-section of one through lane and one left-turn lane.

On the northeast side of the intersection, the crosshatched pavement markings and No Parking signage were often ineffective, and no enforcement was observed during the field visits. Parked vehicles on both northeast and northwest sides of the street were often DART vehicles, especially on the northwest side adjacent to their headquarters building and Akard station.

Recommendation: As noted in General Recommendations above, the City could consider changing the Akard cross-section to two through lanes and two dedicated parking lanes, including bulbouts. Bulbouts and extended sidewalk would be particularly helpful to improve the narrow pedestrian path. To allow for the observed parking needs, the City could consider the northeast parking lane to be loading/unloading or freight vehicles, and northwest parking lane for DART vehicles (security, DART Police, maintenance vehicles servicing Akard Station, etc.). **Timeline:** Medium-term.

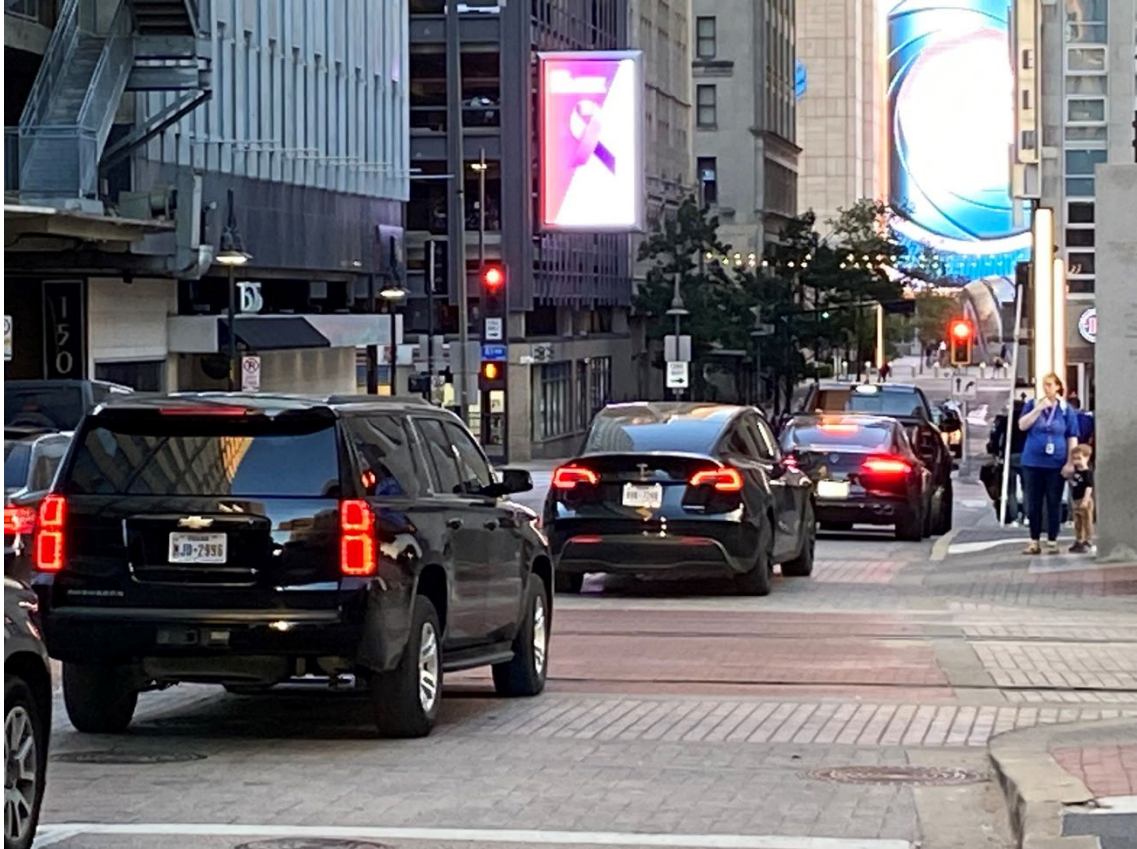
Figure 16: Congestion north of Akard/Elm extending to Akard/Pacific

- **Observation:** North of the intersection, between Pacific Avenue and Elm Street, curb management was impacting safety and operations. Valet parking on the west side was operating on a mountable sidewalk which spanned approximately one-third of the sidewalk on this block. The RSA Team observed several peak periods throughout the day where the valet queuing impacted the westernmost lane as newly arriving drivers blocked the travel lane adjacent to the sidewalk/valet. This resulted in an effective cross-section of one through lane instead of a through and right-turn only lane.

As noted in Akard Street at Pacific Avenue location above, this is an area of very high pedestrian activity. The width of the sidewalk was inadequate even without the presence of the valet operation, especially on the west side of the intersection adjacent to Akard Station. The RSA Team observed conflicts between drivers and pedestrians, especially on the west side of the intersection after passengers arrived via light rail. As noted in Akard Street at Pacific Avenue above, in peak periods, the RSA Team observed pedestrians challenged by the lack of space in certain locations (e.g. maneuvering around planter boxes, landscaping, aesthetic light fixtures, between vehicles in the sidewalk-turned-valet, etc.).

For pedestrians walking on the sidewalk traveling northbound, two planters served as a physical barrier between the expected pedestrian path and the valet portion of the sidewalk. For those pedestrians traveling southbound, no barrier or other visual indication to expect vehicles on the sidewalk was provided. Longitudinally on the sidewalk, a series of bollards were present.

Recommendation: The two travel lanes could be shifted to the east for the majority of the block and tapered back to the west approaching Elm Street, and one crosshatched lane could be installed on both the east and the west sides. This would allow for vehicles to stay in the street, and valet operations could occur in the crosshatched area with one lane for each of the 1505 Elm Street residences and The National building. **Timeline:** Medium- to long-term.
