U.S. Department
of Transportation
**Federal Highway
Administration**

Vickery Meadow Pedestrian Road Safety Assessment (PRSA)

**Conducted:
February 24-26, 2015**

**At the Request of:
City of Dallas**

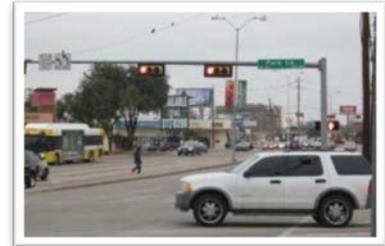
Figure 5: Pedestrian crossing outside of intersection

There were four intersections that the PRSA team focused on. Each of the intersections had either one or more concerns that could be improved. Some pedestrian signals and buttons were not operating properly. Equipment that does not work properly and is not repaired in a timely manner might lead to road users ignoring not only the broken equipment, but avoiding the intersections all together. The 2009 national Manual of Uniform Traffic Control Devices (MUTCD) lowered the walking speed rate for the clearance interval from 4 feet per second (ft/sec) to 3.5 ft/sec to provide pedestrians a little more minimum time to clear the intersection. However 3.5 ft/sec is a minimum walking rate and agencies should provide enough time for pedestrians to safely cross. The Americans with Disabilities Act (ADA) Title II are regulations set by the U.S. Department of Justice. All city governments were required to complete a self-evaluation of their facilities, programs, policies, and practices by January 26, 1993. The self-evaluation identifies and corrects those policies and practices that are inconsistent with Title II's requirements. Both the self-evaluation and transition plans must be available to the public per 28 C.F.R. §§ 35.105, 35.150(d). Capital improvement projects by Texas cities must also generally comply with the Texas Accessibility Standards (TAS) defined by the Texas Department of Licensing and Regulation (TDLR).

- Suggestion: Check all pedestrian signals and push buttons to ensure they are working properly
- Suggestion: All signal timings should be checked to ensure adequate crossing times.
- Suggestion: Each intersection should be evaluated for proper ADA/TAS curbside ramps and pedestrian signals. Non ADA/TAS compliant features should be documented in the City of Dallas' ADA transition plan.

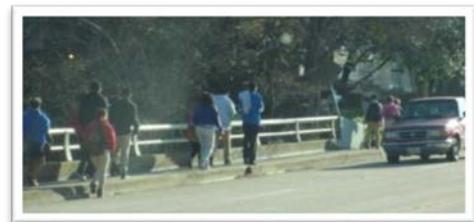
Figure 6: Students walking on sidewalk and in the roadway

Although it was great to observe sidewalks in many parts of the VM Neighborhood, there were places where the condition of the sidewalks was in need of repair. In addition wider sidewalks could benefit the very high volume of people walking. In some locations people were walking in the street because the sidewalks could not handle the pedestrian demand (Figure 6), especially along Fair Oaks Avenue near Emmett J. Conrad High School. Sidewalk connectivity and obstructions are two other considerations when developing plans for improvement.

- Suggestion: Upgrade and repair sidewalks
- Suggestion: Widen sidewalks
- Suggestion: Fill in sidewalk gaps for continuity and to create a sidewalk network

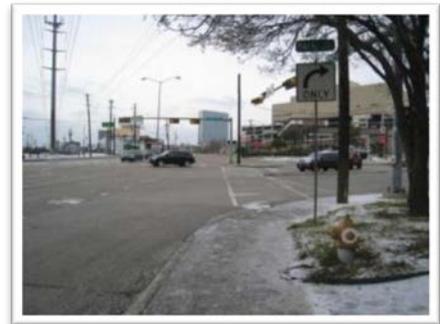
Figure 14: Large corner radius

How an intersection is designed can influence both driver and pedestrian behavior, but can also impact signal operations. A large corner radius of an intersection tends to encourage higher speeding turns (Figure 14).

- Suggestion: Evaluate the geometry at intersections and consider designs that accommodate trucks but also discourage high speed turns.

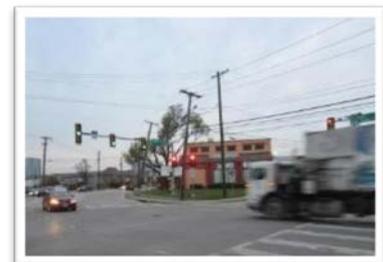
Figure 15: Large trucks heading to transfer station

It was discovered that there is a refuse transfer station across from the high school near Fair Oaks Ave and Walnut Hill Ln. The route currently used by the refuse semi-trucks travels through the 5-Points intersection and along Fair Oaks Avenue and Park Lane (Figure 15). The trucks were observed traveling through during school dismissal hours. This truck traffic is not compatible in a neighborhood environment with schools and high pedestrian activity.

- Suggestion: Look into other travel routes for trucks that do not travel along Park Lane, 5-Points Intersection, and Fair Oaks.
- Suggestion: If rerouting is not possible, do not allow trucks during peak school dismissal periods.

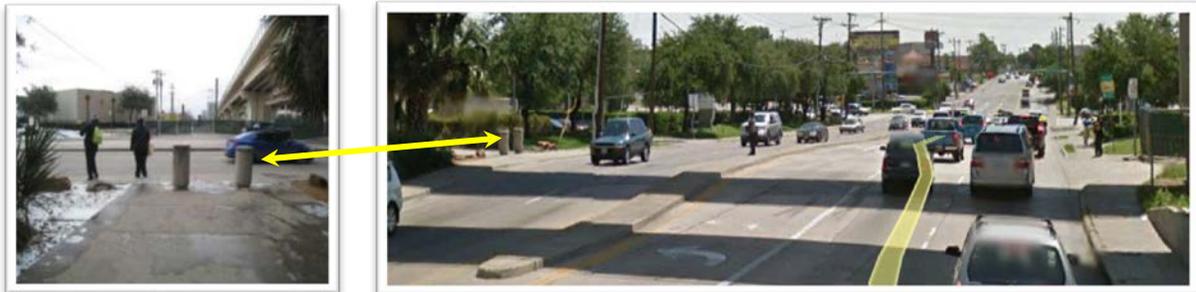
Figure 16: DART Station Exit

1. A high percentage of pedestrians coming and going from the south side of the DART station towards the 7-11 convenient store at the southwest corner of Park Lane and Greenville Avenue were crossing midblock where there is not a marked crosswalk (Figure 16). The distance to cross the roadway from the stations walkway via signalized intersection is approximately 435 feet compared to 80 feet crossing midblock generally near the elevated DART rail line. This does not include the distance to walk to the entrance of the 7-11. The extra walking distance explains why so many are willing to risk crossing midblock. In addition there is a 5 foot wide raised median on Park

Lane where pedestrians wait to finish the crossing.

- Suggestion 1: Extend the pedestrian bridge across Park Lane from the elevated train platform. This would be the most direct path, therefore a higher probability it will be used. A similar design was constructed at the Downtown Carrollton DART Station (Figure 17).
- Suggestion 2: Evaluate installing a marked crosswalk with a Rectangular Rapid Flashing Beacon (RRFB) or Pedestrian Hybrid Beacon (PHB) enhancement where pedestrians are currently crossing.

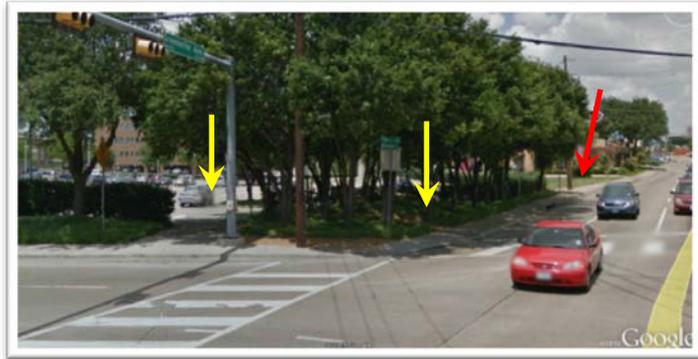
Figure 20: DART Parking Lot at the northeast corner of Park Lane and Greenville Avenue

2. There are multiple locations on the east side of the DART station parking lot where pedestrians are exiting (Figure 20 & 21 red arrows) and crossing midblock instead of walking 110 to 130 feet to the signalized intersection (Figure 20 yellow arrows). At one location stepping stones were constructed to assist people making their way up the slope of the parking lot but did not direct pedestrians to an appropriate street crossing location.

- Suggestion: Remove the stone steps (Figure 21), add fencing along the edge of the parking lot along Greenville Avenue, and add pedestrian wayward signing and markings through the parking lot so pedestrians will be guided and encouraged to cross adjacent streets at the proper crossing points. Consider re-orienting the parking lot stalls and aisles to direct pedestrians more directly to the corner of Greenville Ave and Park Ln.
- Timeframe: Short to Intermediate
- Cost: Low to Medium

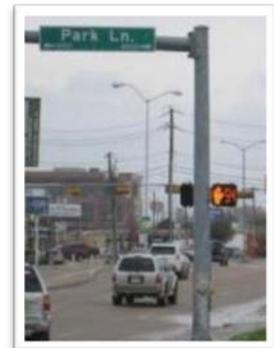
Figure 22: Countdown signal

1. Some pedestrians did not finish crossing Greenville Avenue before the countdown signals went to zero.

- Suggestion: Check signal timings for all legs of the intersection. Use at a minimum the 3.5 ft/sec per the national MUTCD. For the higher volume crossings across Greenville Avenue enough time should be provided per the characteristics of the pedestrians using the crossings. For example older and disabled population will need more crossing time than the 3.5 ft/sec.
- Timeframe: Short
- Cost: Low

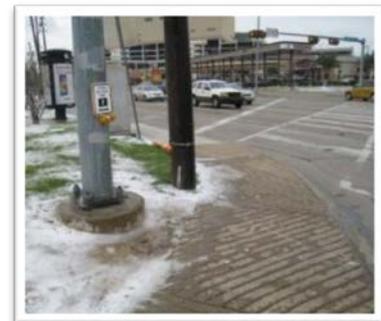
Figure 23: Pedestrian Push Buttons and curb ramp

2. Some of the pedestrian signals and push buttons were not working or not working properly. This might influence pedestrians to not use any of the pedestrian push buttons nor the crosswalks. Accessibility for someone in a wheelchair to use the push buttons would be challenging on some of the corners (Figure 23).

- Suggestions: Check and repair all the push buttons and pedestrian signals heads that are not working properly. Place a sticker on poles to who can be contacted if buttons and signals do not seem to be working
- Evaluate accessibility design standards for push buttons and curb ramps. If locations cannot be fixed right away be sure to add the locations in the city’s ADA transition plan.
- Timeframe: Short to Long
- Cost: Medium to High

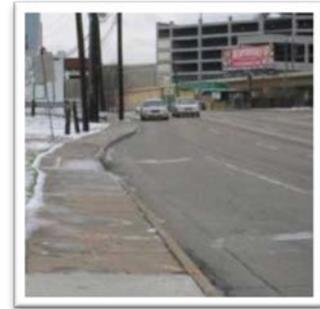
Figure 24: Right Turn Lane

3. There may be more lanes, both travel and turning lanes, than necessary. The team learned historically Greenville Avenue may have carried and/or was projected to have higher traffic volumes than are using the roadway today. The intersection is also at a skew therefore some of the corners of the intersection have a large turning radius, which encourages faster turns.

- Suggestion: Evaluate the intersection to determine if any through or turning lanes can be eliminated. If lanes can be eliminated consider widening the narrow medians that are currently there and consider adding medians where they do not currently exist. Evaluate the corners to determine if the radius can be designed to discourage fast turning movements.
- Timeframe: Short to Intermediate
- Cost: Low to Intermediate

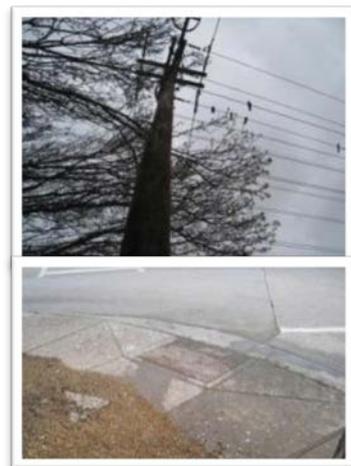
Figure 26: Birds in trees and bird droppings on waiting area of pedestrians

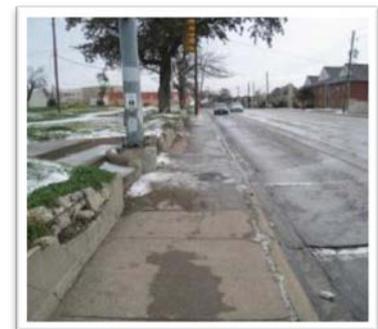
Figure 28: T-Intersection of Park Lane & Shady Brook

2. There were crosswalks at the T-Intersection; however there were no curb ramps on the north side of Park Lane at the ends of two of the three crosswalks. (Figure 28) This makes it very difficult for people with disabilities to cross at these signalized locations. The curb ramp on the southwest corner had a large hole (Figure 29), therefore making it unusable for a person in a wheelchair, but also tripping hazards for both sight able and disabled pedestrians. The pedestrian push buttons were also placed at locations and heights that made it difficult or impossible for a person in a wheelchair to access. Truncated domes or detectable warnings are required to indicate to the blind where the edge of the sidewalk is located and that a curb ramp exists.

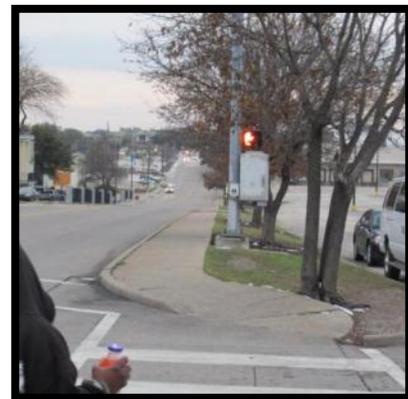
Figure 31: Pedestrian Signal far distance from Crosswalk

1. A couple of the pedestrian push button and signals were located a fair distance away from the curb ramp and do not conform to ADA standards (Figure 31). This causes two issues, one is the signal timing and the other is visibility of the pedestrian signal. The signal timing should include the time a person in a wheelchair would push the button, get to the curb ramp and cross the roadway. The visibility of the signal head was difficult to see due to the angle and expected location of the pedestrian signal head (Figure 32 yellow circle).

- Suggestion in three parts:
 - i. Check the pedestrian walk and clearance times for all the crossings.
 - ii. Align the pedestrian signal heads so it is visible from the location a pedestrian would be standing on the corner waiting to cross.
 - iii. Install / move the pedestrian signals and push buttons closer to the corner/curb ramps. Reference the MUTCD standards and guidance.
- Timeframe: i. Short ii. Short iii. Intermediate to Long
- Cost: Low to High

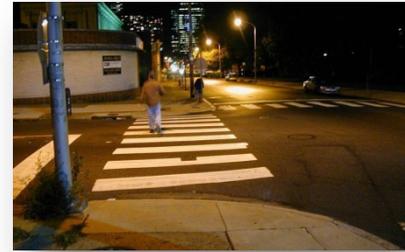
Figure 33: Lighting

2. Some street lighting was observed but could be improved for pedestrians.

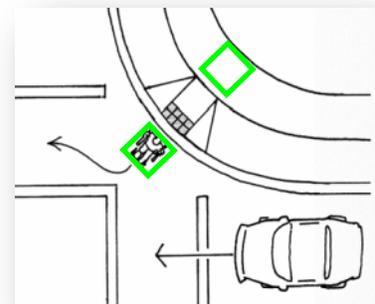
Figure 35: Single Ramp needing top and bottom 4'x4' level landing

- Suggestion: Check the City's ADA Transition Plan for when these locations will be brought up to current ADA standards.
- Timeframe: Intermediate to Long
- Cost: Low to High

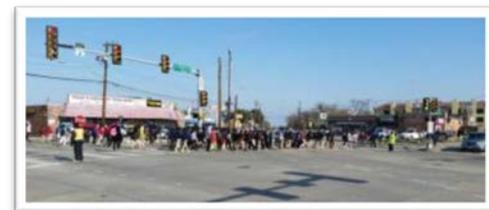
Figure 36: 5-Points during school dismissal

1. The 5-Point's intersection is challenging because it was designed with 5 different approaches, the elementary and middle schools location of buildings and entrance/exits doors are very close to the street and intersection, and the majority of students walk to and from school. The configuration of the intersection is also confusing for drivers. Due to the nature of where people are coming and going, two legs of the intersection need to be crossed, which makes for longer crossings and additional delay to the pedestrians while waiting for two walk signal indications. This may be part of the reason so many pedestrians were observed crossing away from the intersection at uncontrolled midblock locations.

- Suggestion: Evaluate different intersection designs that would improve pedestrian flow, such as a modern roundabout. Roundabouts have fewer conflict points, and also can be more efficient than a signalized intersection in many situations.
- Timeframe: Intermediate to Long
- Cost: Intermediate

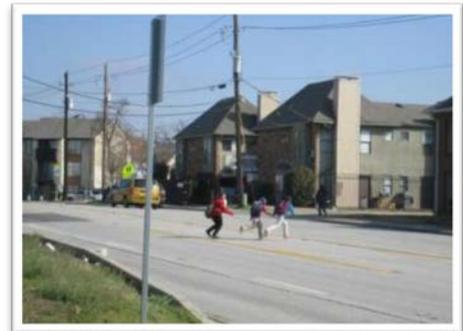
4. Prior to the 5-Points intersection along Park Lane there is a school advance sign; however students and adults taking their children to school were crossing midblock on Park Lane in advance of the school zone signs. (Figure 41)

Figure 41: Children crossing at uncontrolled midblock location prior to 5-Points

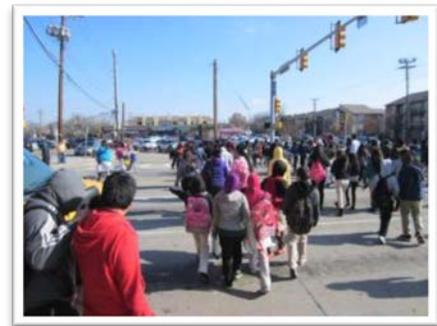
Figure 42: 5-Points Intersection school dismissal

1. The site design for the elementary and middle school is causing several challenges during school dismissal. One challenge is getting students to wait for the pedestrian walk phases at the 5-Points intersection because there are so many students exiting at the same time and all the students cannot cross during one pedestrian cycle. This creates the second challenge where students do not have adequate space to wait between the middle schools main entrance doors and the 5-Points intersection corner. An additional challenge is keeping students from crossing Fair Oaks midblock directly outside of the main doors of the middle school where there is no traffic control.

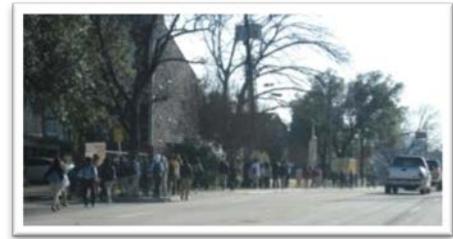
Figure 43: School Students at dismissal

2. The width of the sidewalks is not adequate for the number of school students walking along the road after school dismissal. (Figure 43) This applies to all the schools from elementary to high school.
