Road Safety Audit

Martin Luther King Jr. Blvd

Dallas, TX

Facilitated by: Stephen Ratke, PE (NV), RSP2I
FHWA Texas Division

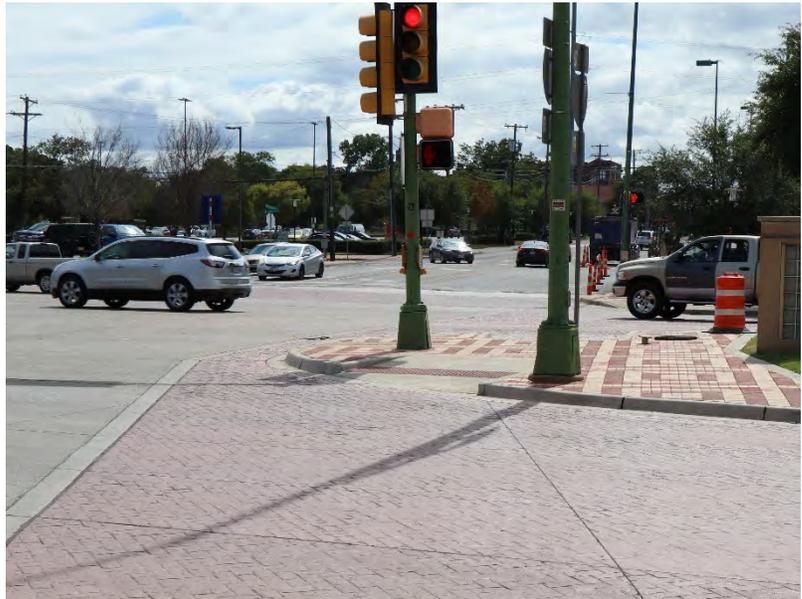
- **Observation:** The brick crosswalks at the intersection are not well aligned with desired walking paths, including a change in direction on one leg while crossing the median. The crossings are long and require large amounts of clearance time, and the south corner has a large amount of ambiguous space

Figure 5: Misalignment of the accessible ramps and the crosswalk.

where the crosswalk exists well away from the curb and desired walking path. On the south median, the median nose projects part way into the crosswalk, while on the north median the crosswalk is more fully protected by the median nose. The dual left and right turn lanes also generated more conflicts between drivers and those walking, particularly for the more heavily used left turn to proceed north on Robert B Cullum. **Recommendation:** Dual ramp curb ramp designs and pulling the crosswalks back from the intersection would allow for shorter, more direct crossings. The space in the crosswalk that is used by turning vehicles would be reduced as well. The median noses could be extended to fully protect the crosswalk, providing a better refuge for someone who is unable to cross the street in one cycle, and potentially slowing cars. An LPI at this location should be explored, as there are dual turning lanes in both directions from MLK contributes to lower yielding rates by drivers to people walking with a walk sign in the crosswalk. The City should determine if the dual right is necessary, as observed usage by the RSA team was quite low.

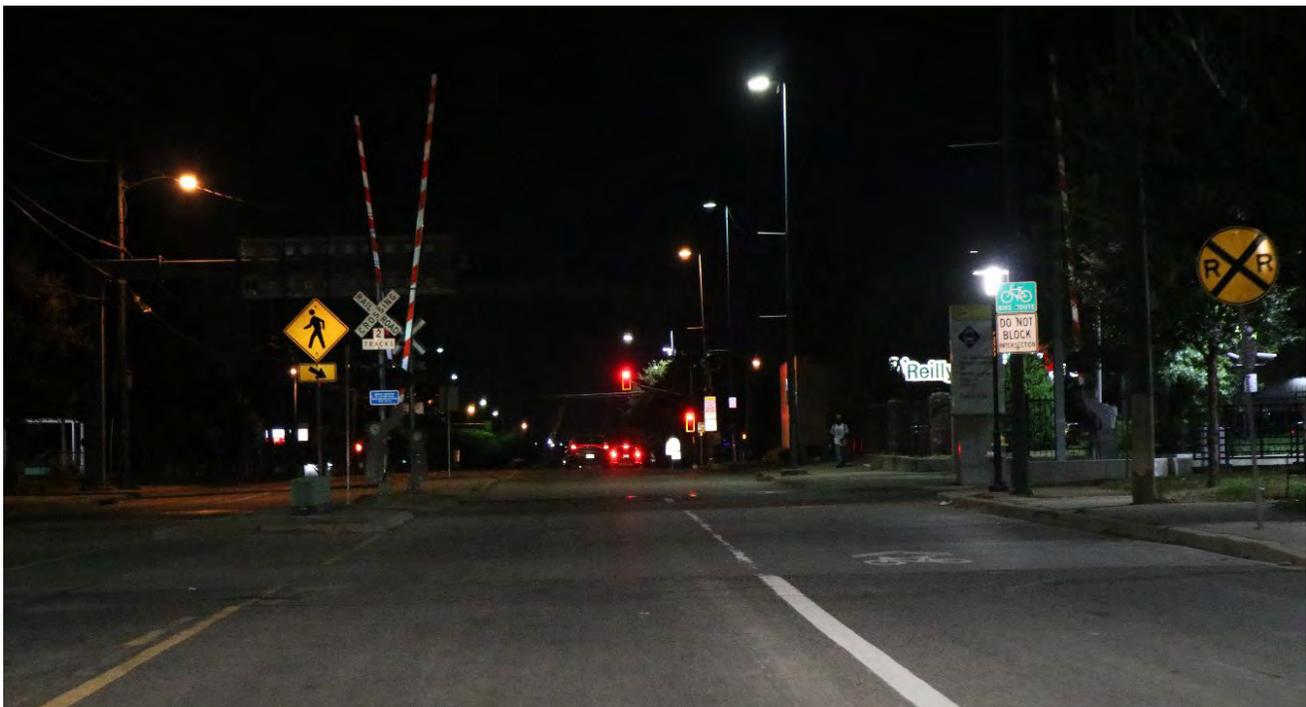
Figure 6: Crosswalk near the DART station. The addition of pavement markings and a right-side warning sign would increase conspicuity for drivers, particularly at night.

-
- **Observation:** Similar to other crosswalks, any pavement markings that had been placed were worn away or were now missing entirely. Particularly at night drivers have little awareness of the location of the crosswalk as only a left-side sign indicates the crosswalk. **Recommendation:** Consider installing a high visibility (continental or ladder style) crosswalk pavement markings. Investigate the possible use of a [Rectangular Rapid-Flashing Beacons](#) (RRFB) or [Pedestrian Hybrid Beacons](#) (PHB) enhanced crossing, recognizing the interaction with the DART rail crossing may complicate the use of such a device.

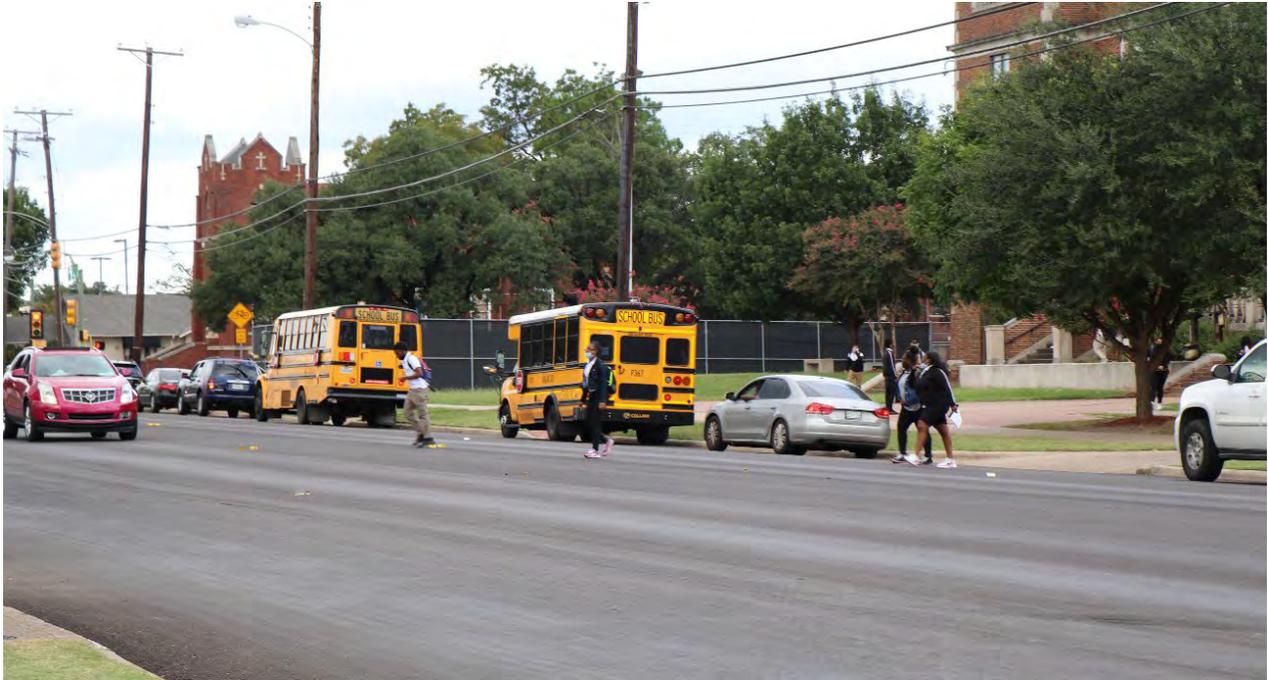
Figure 7: Students cross between stopped and moving cars and buses during the afternoon dismissal of James Madison High School.

- **Observation:** The school dismissal period is particularly busy with a large number of observed conflicts between users. Students are crossing MLK in both directions, buses depart from both MLK and Meyers St, and car picks up happen in a combination of in a small lot, on Meyers St, on MLK, and in the community center/library parking lot, along with students walking in all directions. Students crossing MLK routinely walked between cars and forced some drivers to slow or stop for them, even outside of crosswalks. Mitigating this concern is that the school zone signing and driver behavior seemed to expect these actions and vehicles generally were traveling slowly enough to stop for the students crossing on foot. The draft school traffic management plan called for a possible crosswalk with RRFB mid-block in an area where most students crossed, but the City informed the RSA team after the review that the school is no longer pursuing this option (a number of driveway access points across the street made this option difficult to implement). The school will be working on installing fencing to better control walking paths and access. **Recommendation:** While the mid-block crosswalk was deemed to be infeasible going forward, reducing the number of possible conflict points would benefit safety and operations in the area during the school dismissal period. This could include preventing waiting vehicles on MLK and reserving the area for buses only or modifying curbs or shoulders to

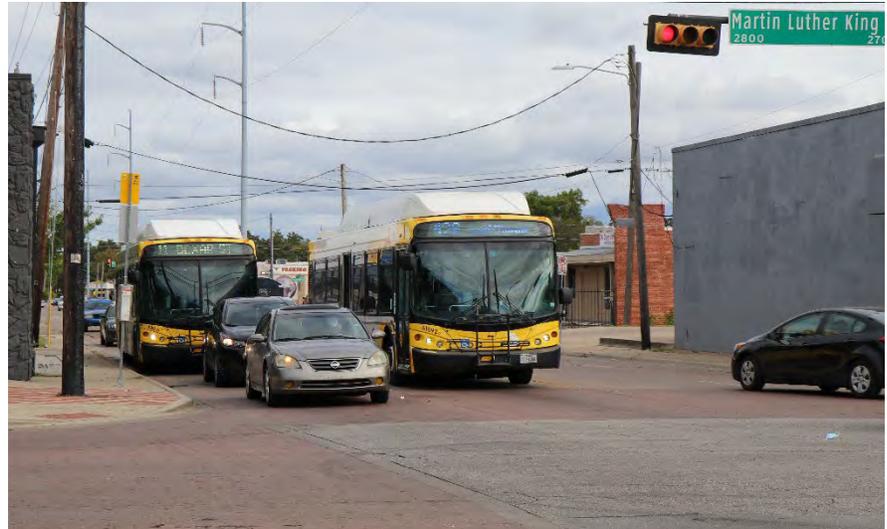
- **Observation:** There are a fairly large number of left turns from Malcolm X onto MLK in both directions, including at least one bus route with a left turn through the intersection.

Figure 8: Two busses on Malcolm X, with one at the bus stop and another waiting to complete a left turn.

Consider the applicability of a 4 to 3 lane road diet with a permanent left turn lane at the intersection, as during most cycles observed there was rarely any through traffic using the left lane while vehicles waited for a gap. The reallocation of space would also make it easier for bus and other heavy vehicles to complete the turns.

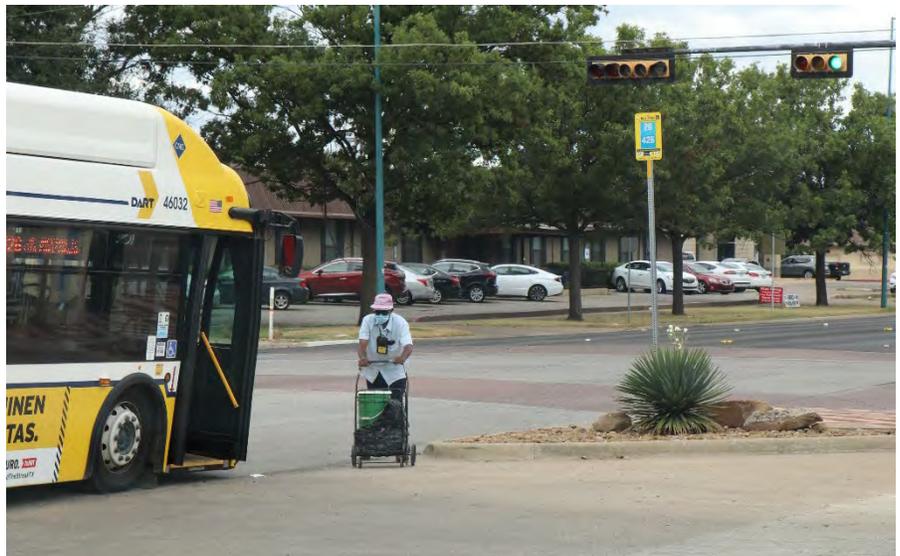
- **Observation:** Pull-in angle parking provides additional parking storage per length of curb along the street but has the disadvantage of requiring drivers to back into the flow of traffic. At this intersection, it also results in the bus stop not having

Figure 9: A person entering a bus after having to step into the street near the bus stop at the Malcolm X intersection.

enough space to serve both doors at curb height and with adequate boarding areas. The team observed a person with a walker who had to step into the street and then up onto the bus because of this configuration. **Recommendation:**

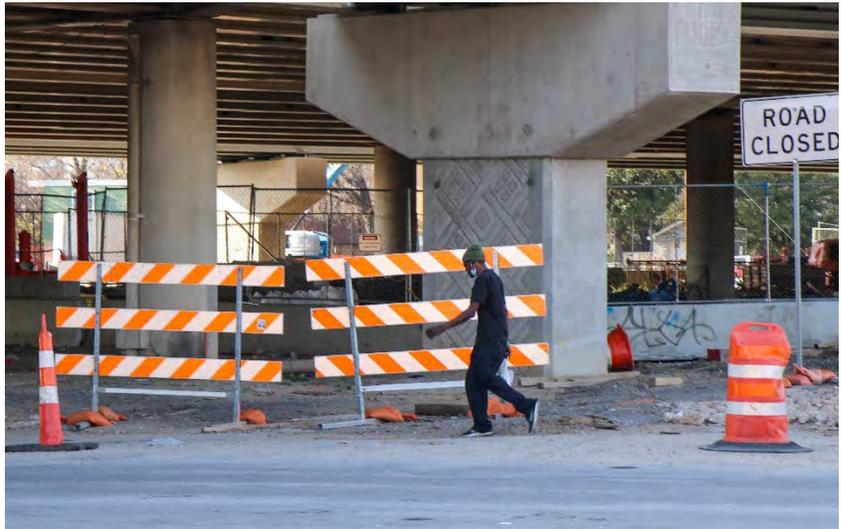
- **Observation:** There were many pedestrians observed throughout the area, particularly at the SM Wright frontage road intersections and along MLK under IH-45. The area currently under construction does not have a continuous walking path on either side of

Figure 11: A person walks through the construction area along MLK and underneath IH-45, where there is no accessible path.

MLK and results in the public walking through dirt and is inaccessible to someone in a wheelchair. **Recommendation:** A temporary path that is at least as accessible as the prior condition needs to be maintained on at least one side of MLK at all times. Gaps needs to be filled with asphalt or other accessible materials, and traffic control devices should not block the walking paths. This needs to be planned in advance for the upcoming construction of the SM Wright and MLK intersection.

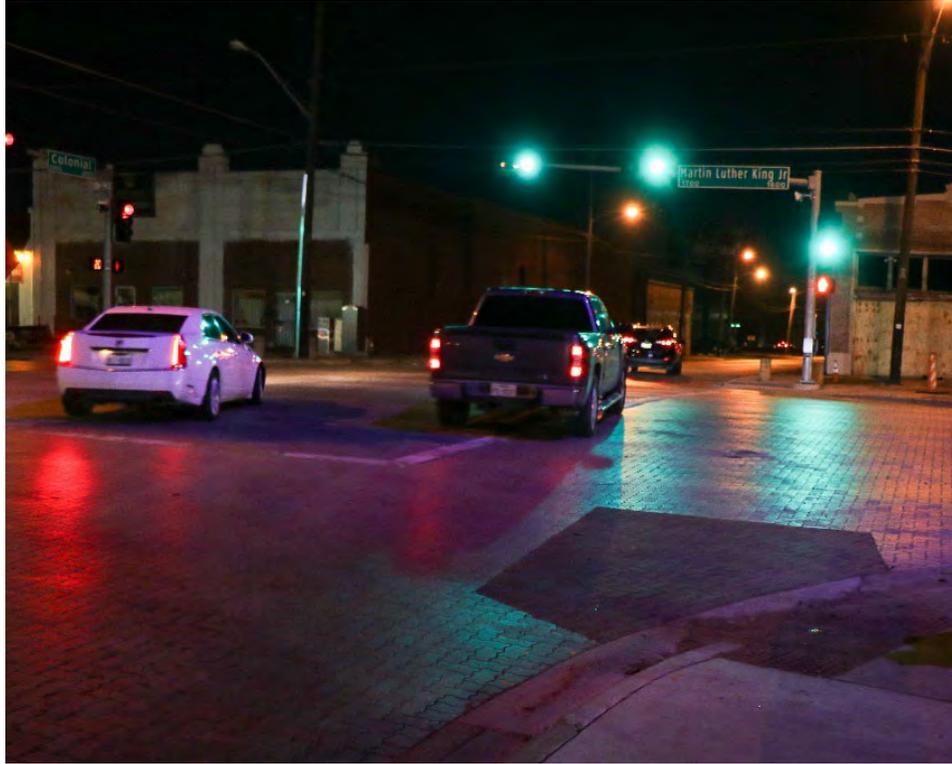
- **Observation:** The high level of left turning traffic from Colonial made the left lane effectively a permanent left turn lane, with through and right turning traffic using the outside lane. **Recommendation:** Colonial may be a good candidate for a 4-to-3 lane road diet with little effect on operations. The additional space could be used as a shoulder, a parking area, or a bicycle lane. Moving the through traffic away from the outside curb would result in less tracking through the brick crosswalk area and fewer conflicts between those walking and those driving.

Figure 13: Traffic in the outside southbound through lane overlaps with the textured crosswalk area of Colonial intersection

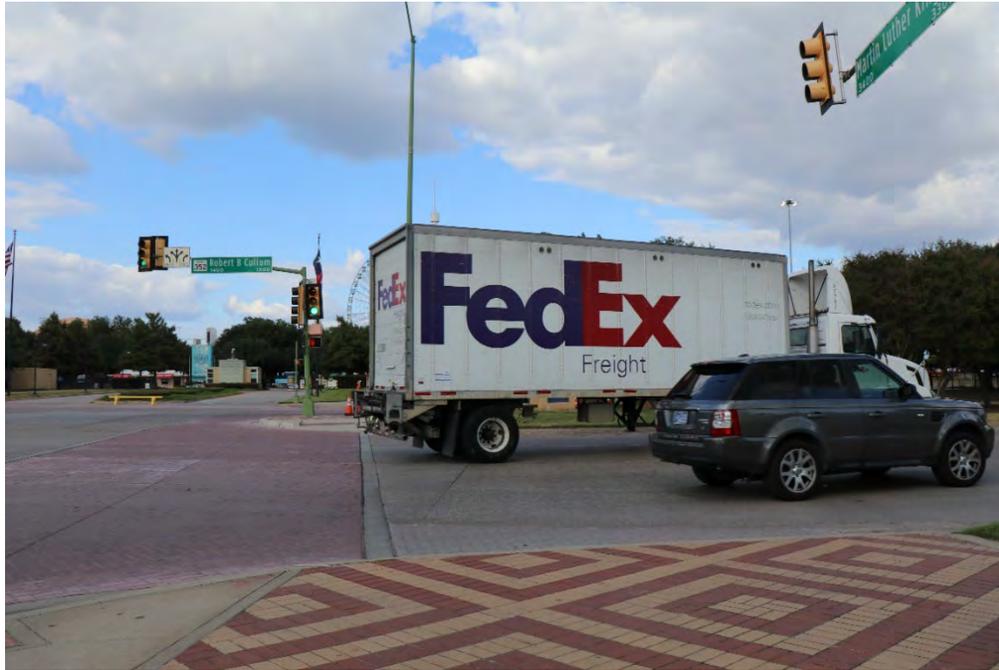
Location: TX 352 / Robert B Cullum Blvd

Figure 1: Dual right turns from MLK to SH 352

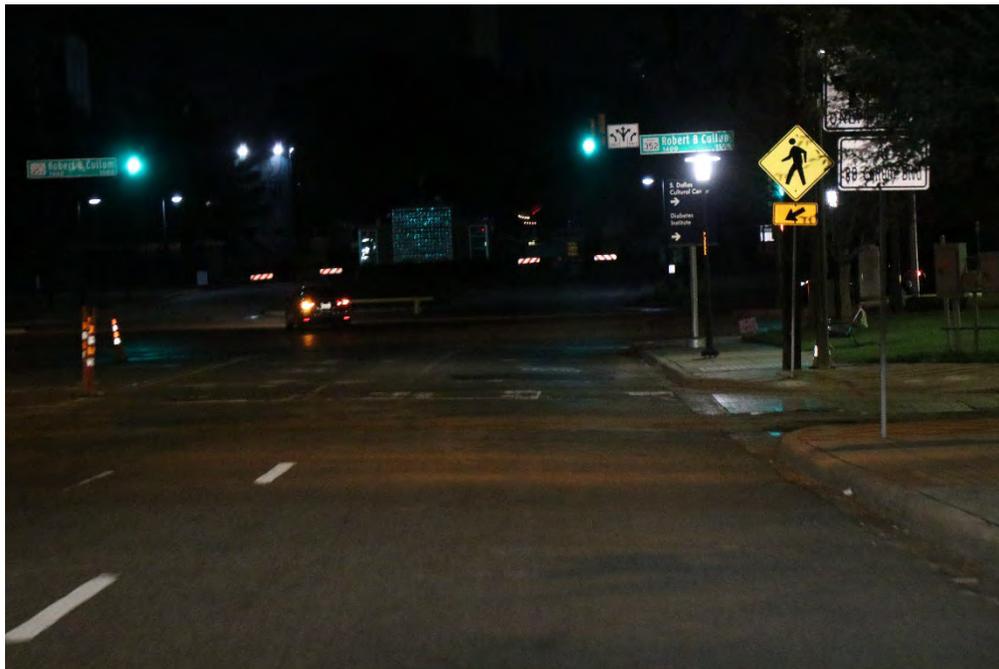
- **Observation:** On MLK just west of the intersection, the pavement condition was quite poor and through the asphalt what appeared to be an old brick crosswalk could be seen. This area was broken up enough that it was altering some drivers' behaviors, while it was also observed that many cars appeared to be bottoming out their suspension travel while traversing. It also made the pavement markings harder to see in the area. **Recommendation:** Reconstruct this approach and refresh the pavement markings.

Figure 2: Conflicting and faded markings on the MLK westbound approach to TX 352

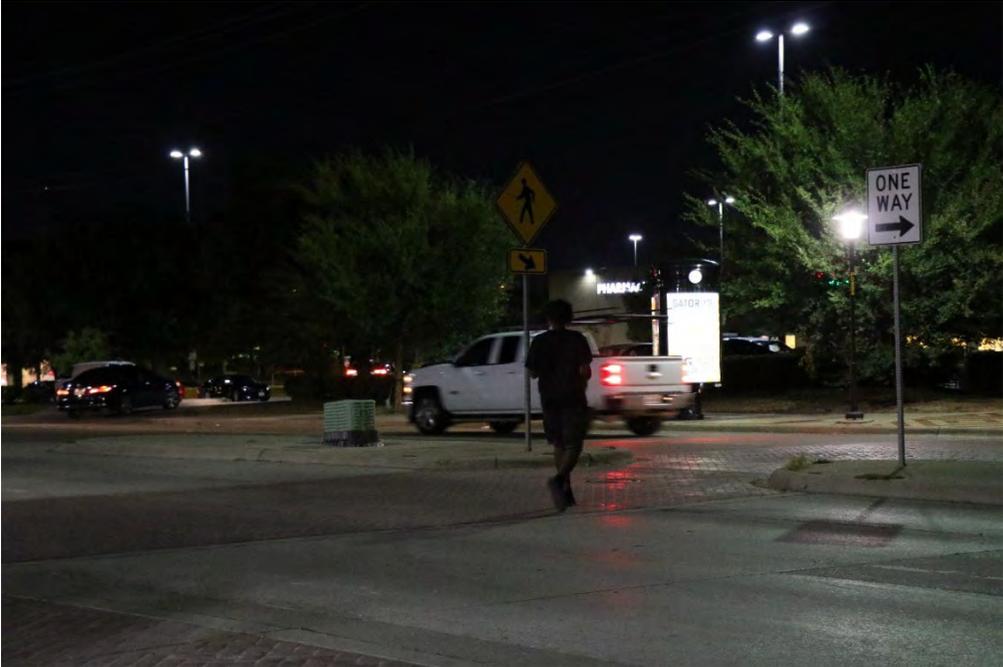
Location: MLK DART Station

Figure 3: A person crossing on foot at the MLK crosswalk south of the DART station.

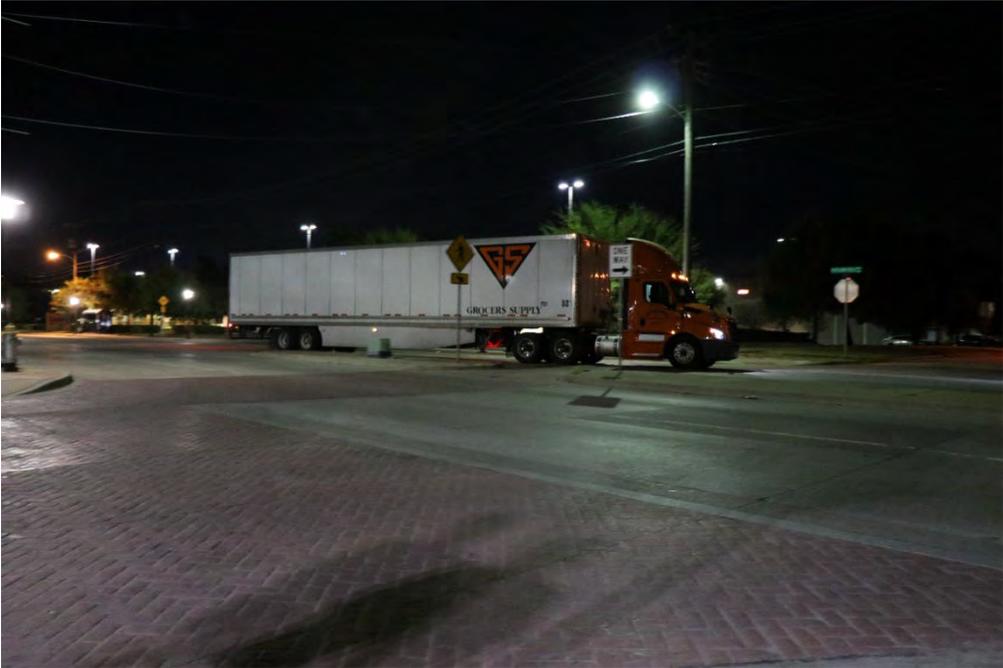
Figure 4: A Commercial vehicle drives on the wrong side of MLK to access a loading area south of MLK near the DART station.

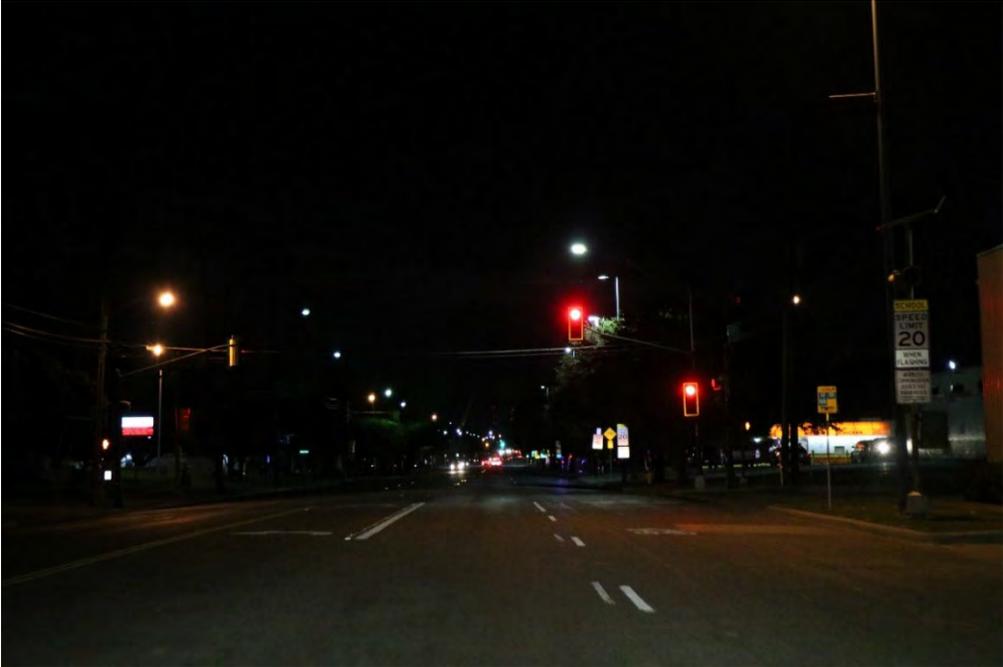
Location: James Madison High School

Figure 5: Meadow intersection at night, with missing street name sign on the westbound approach. The addition of the retroreflective background around the signal helps with visibility of the signal indications.

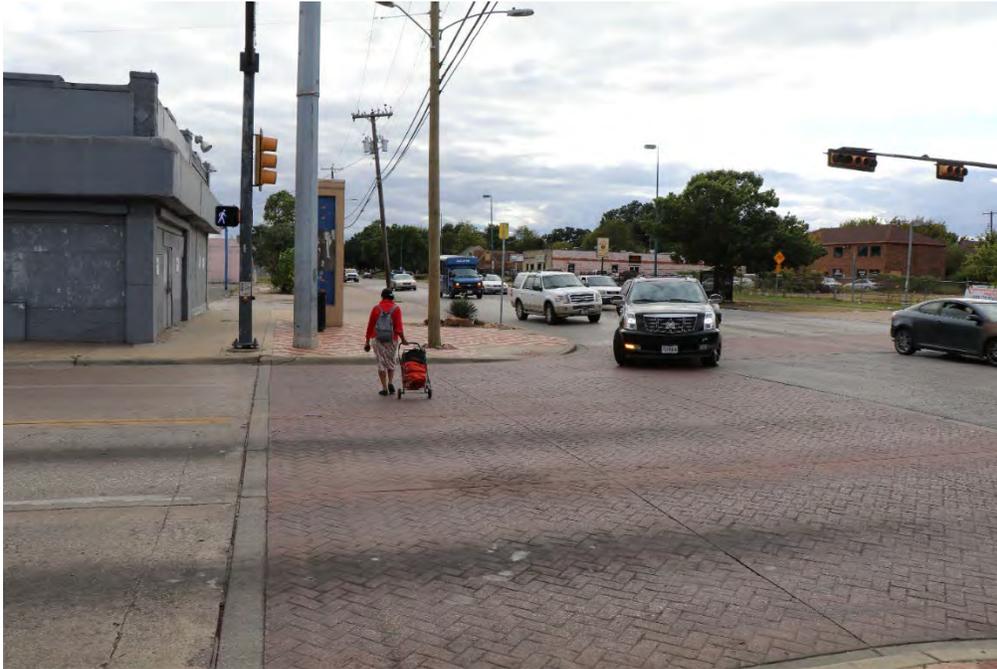
Location: Malcolm X Blvd

Figure 7: the sidewalks and crosswalk ramps along MLK don't line up, requiring out of direction travel for some users, along with push buttons in improper locations.

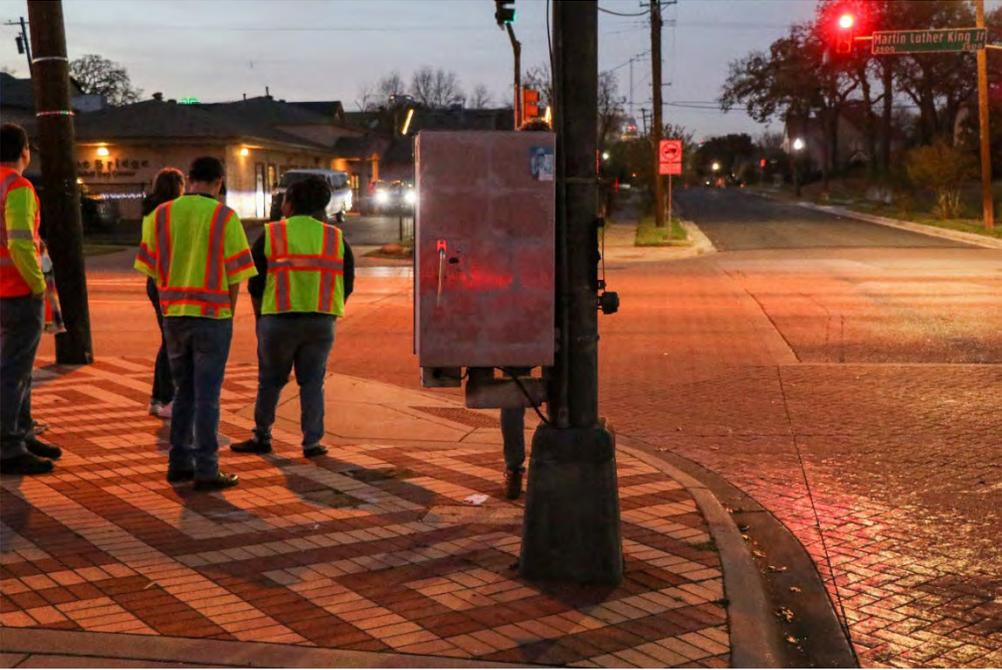
Figure 8: Push button location to cross MLK.

Recommendation: Any future work should include dual curb ramps, and when the corridor cross section is determined in the ultimate configuration, the City should work to minimize the number of times someone has to change direction laterally to walk along the corridor.

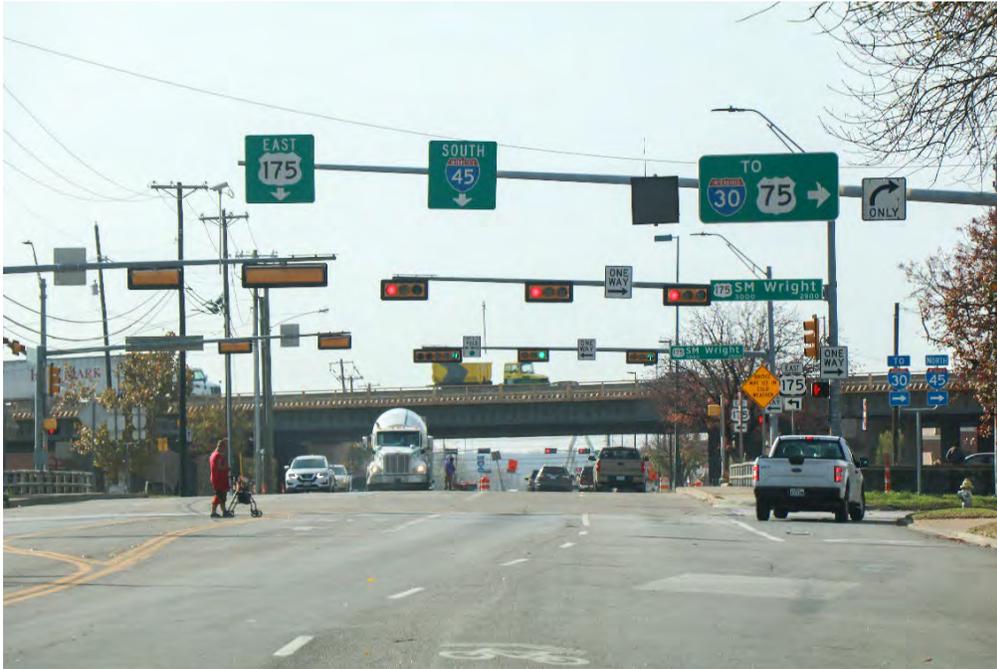
- **Observation:** On the Westbound MLK approach to SM Wright, there is what appears to be a dynamic lane use sign that was black the entire time of the review. **Recommendation:** Replace with a static standard lane use sign, so that

Figure 10: Westbound approach to S.M. Wright with inoperable dynamic lane use display sign.

the right lane is not the only lane without a lane use assignment by overhead signs.

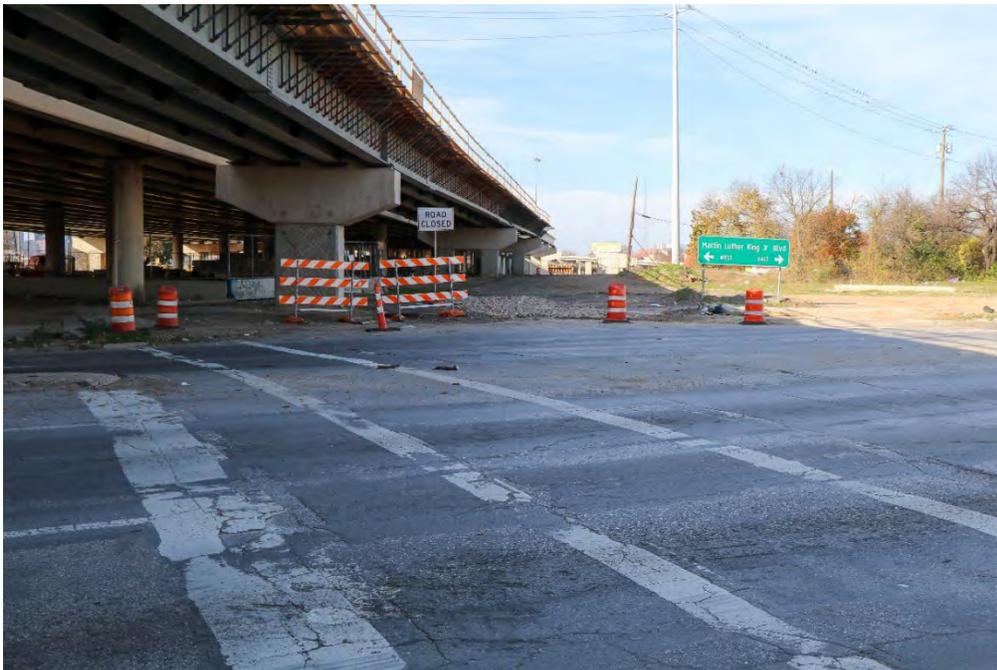
- **Observation:** At the intersection of Harwood and MLK, old pavement markings could be observed delineating the crosswalk and stop bar, although neither currently applies. On eastbound MLK, there was no advance warning or striping for the right lane closure. **Recommendation:** Pavement markings should be removed / updated per TxDOT's guidance on work zone traffic control, including removing the stop bar that is no longer applicable with the removal of the traffic signal, and for long term lane closures.

Figure 11: Stop bar and crosswalk markings that should be removed as they are no longer applicable.

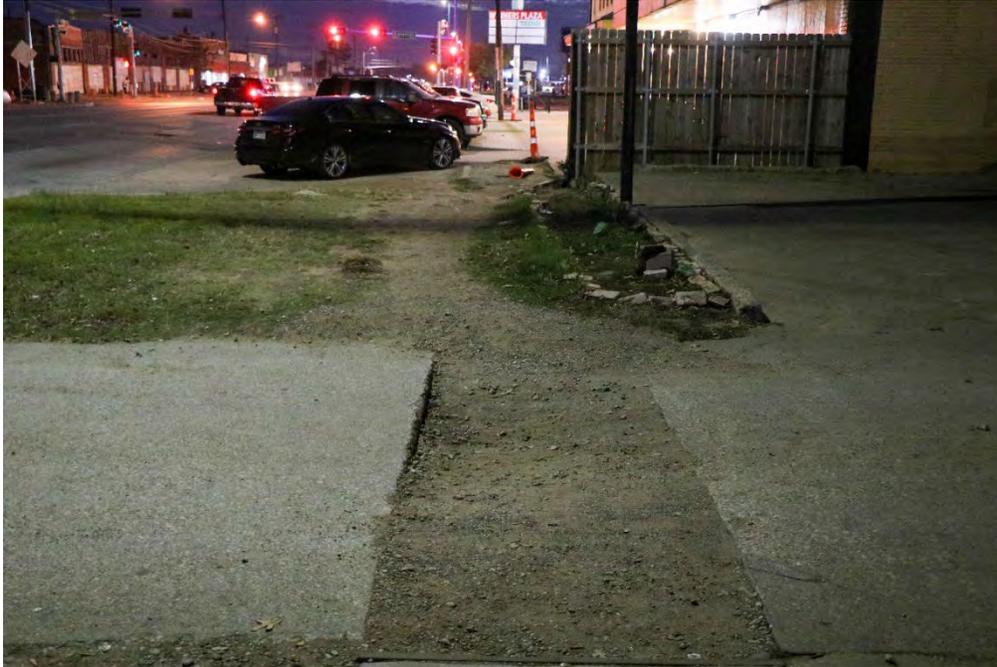
Figure 16: Sidewalk discontinuity northeast of the intersection with Colonial.

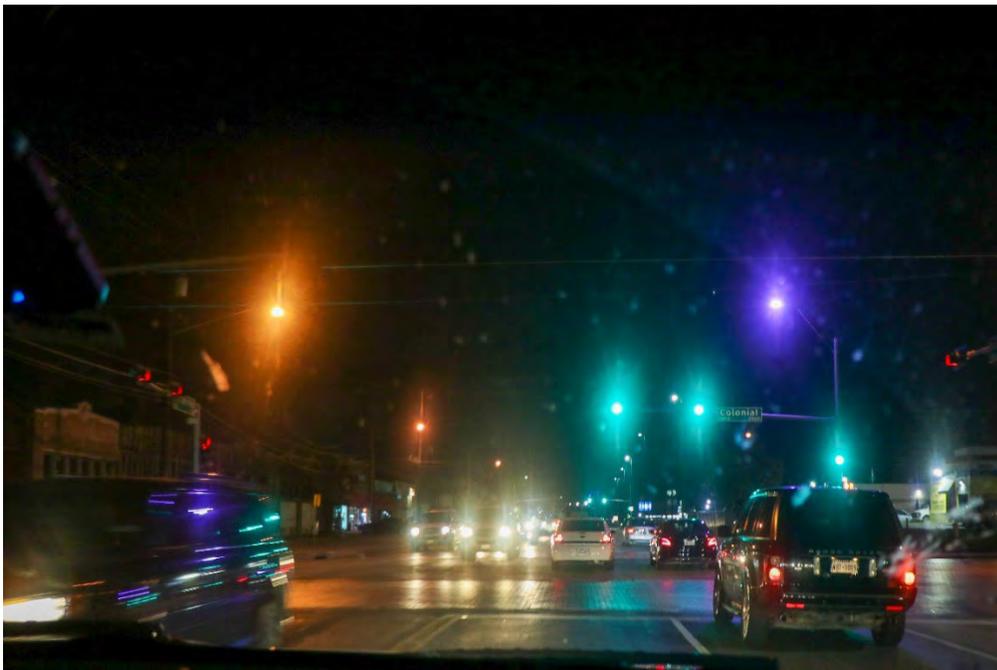
- **Observation:** One of the LED lights attached to a traffic signal pole has failed and the light emitted is purple in color, and this area had the most mismatch of lighting colors and temperatures from the various light poles in the area. **Recommendation:** The LED light should be replaced (may be under warranty), and the City should consider changing all the lighting to LED for consistent color along the corridor.

Figure 17: Night view of intersection with several colors of overhead lighting in the area.

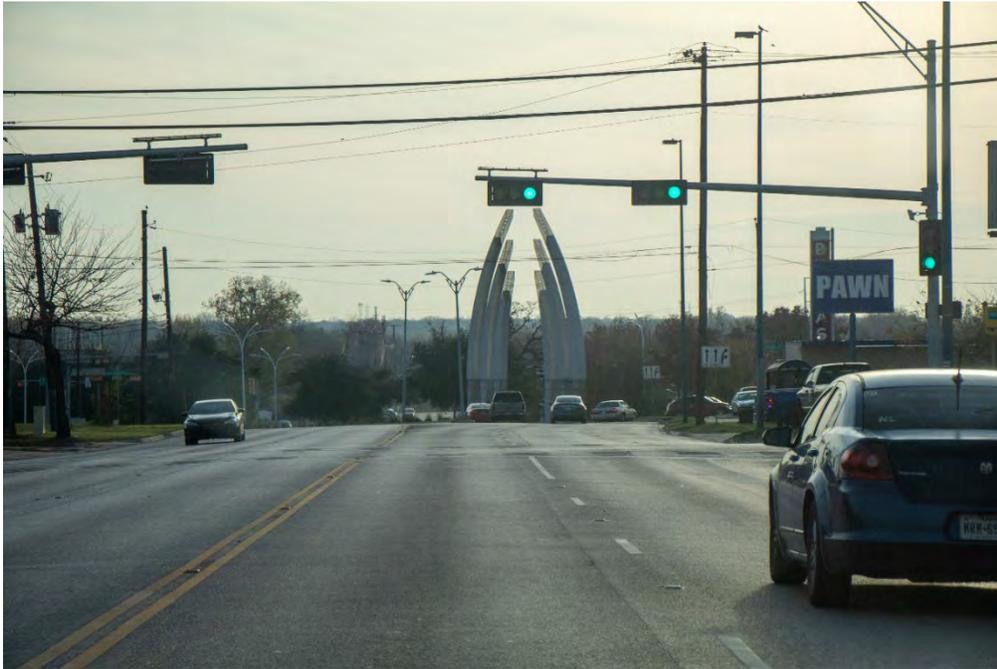
Figure 18: Westbound approach to Holmes intersection. A street name sign is missing.

- **Observation:** Street name signs for Holmes St were missing at the intersection. **Recommendation:** The street name signs should be installed.
- **Observation:** The observed pattern of crashes is a function of both social issues, the large amount of demand for crossing, and corridor wide engineering and design issues. **Recommendation:** The segment recommendations made above all apply to this location specifically – a median and lane reduction would potentially reduce speeds, which would reduce injury severities. The median would allow for a refuge area and result in shorter, easier crossings, and it would reduce the conflicts related to the nearby driveway openings. Parking, driveway access, and other issues should be addressed as part of the larger corridor conversation and ultimate cross section discussion.

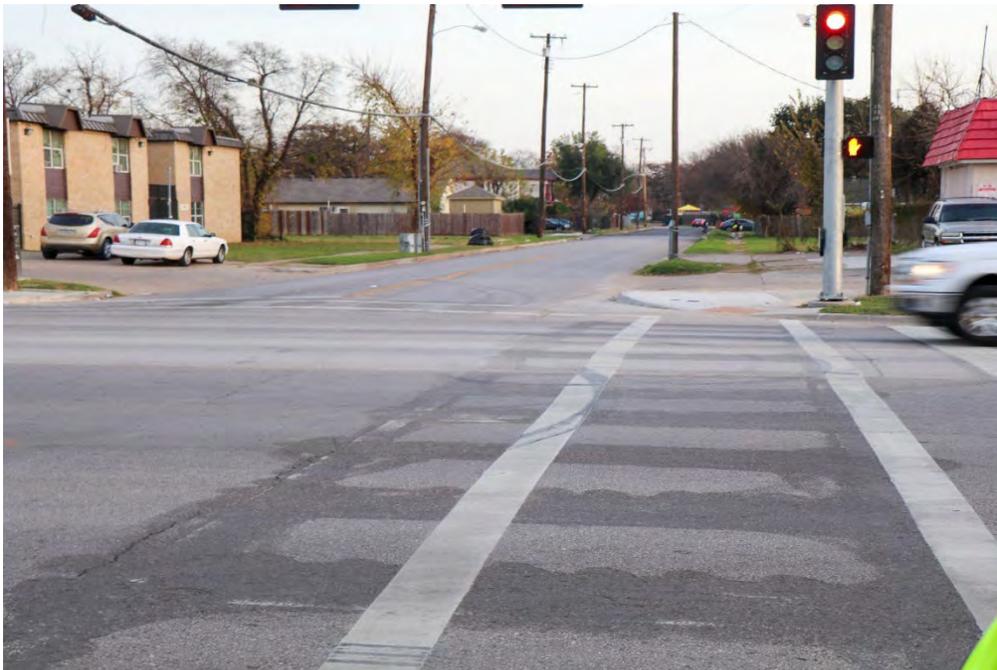
Figure 19: Crosswalk at Holmes, showing removed ladder style markings, and tire marks from cars doing "donuts."

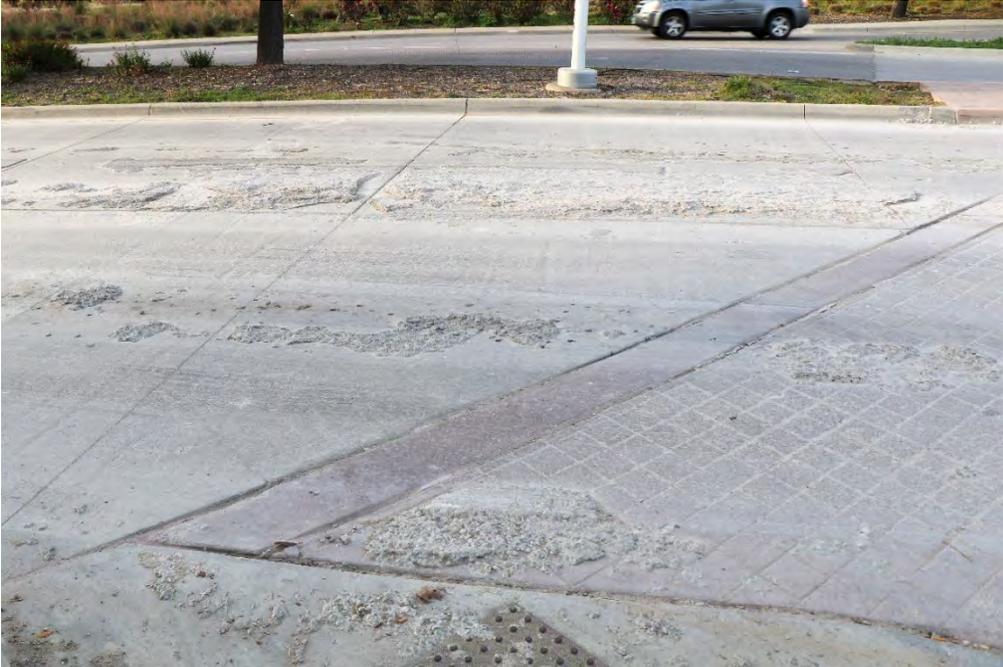
Location: Forest Ave

Figure 20: Build-up of Debris on the Forest approach to MLK.

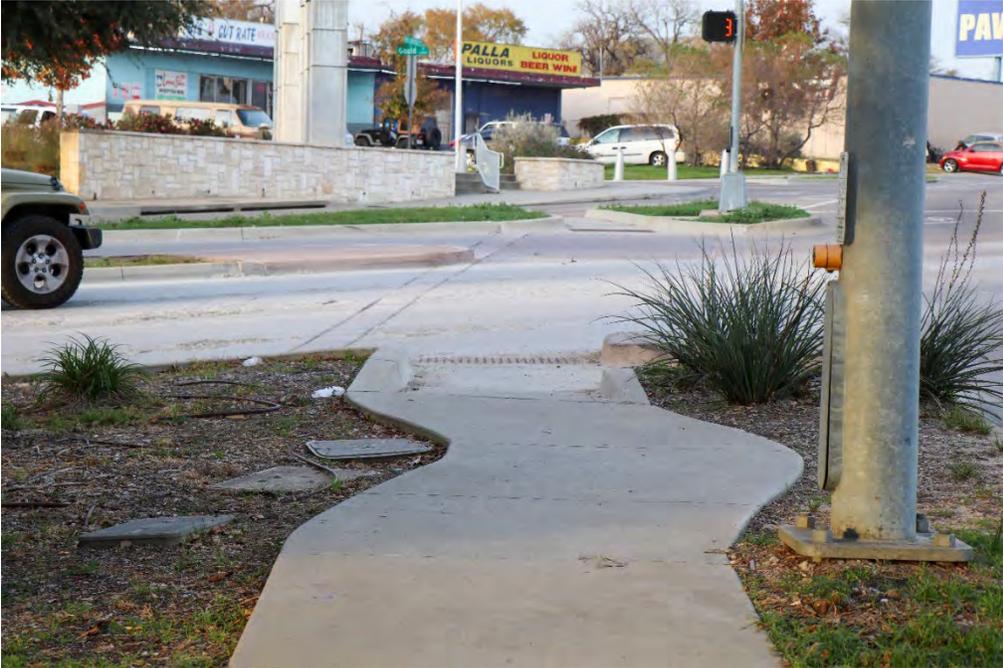
Figure 21: Several of the push buttons were placed away from the crossing point and had incorrect arrows on the plaques.
