Illicit Discharge Detection and Elimination

City of Denton – January, 2020

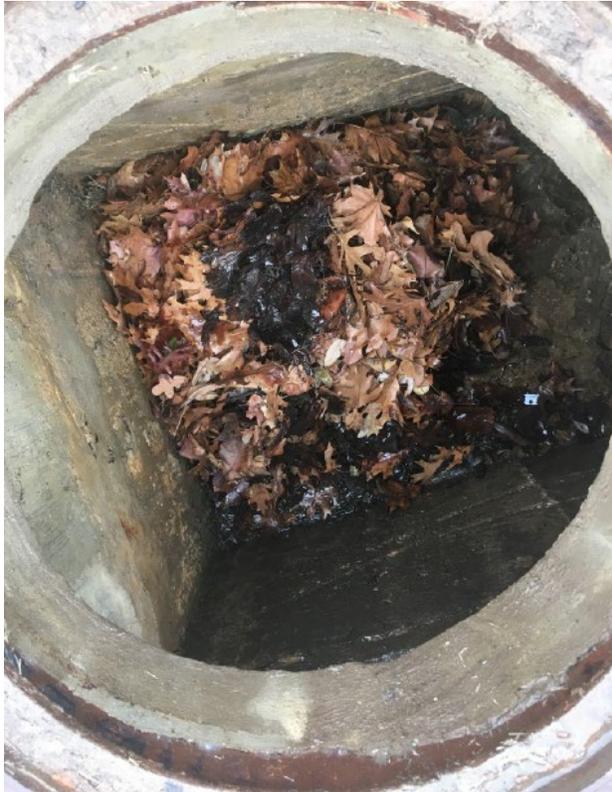
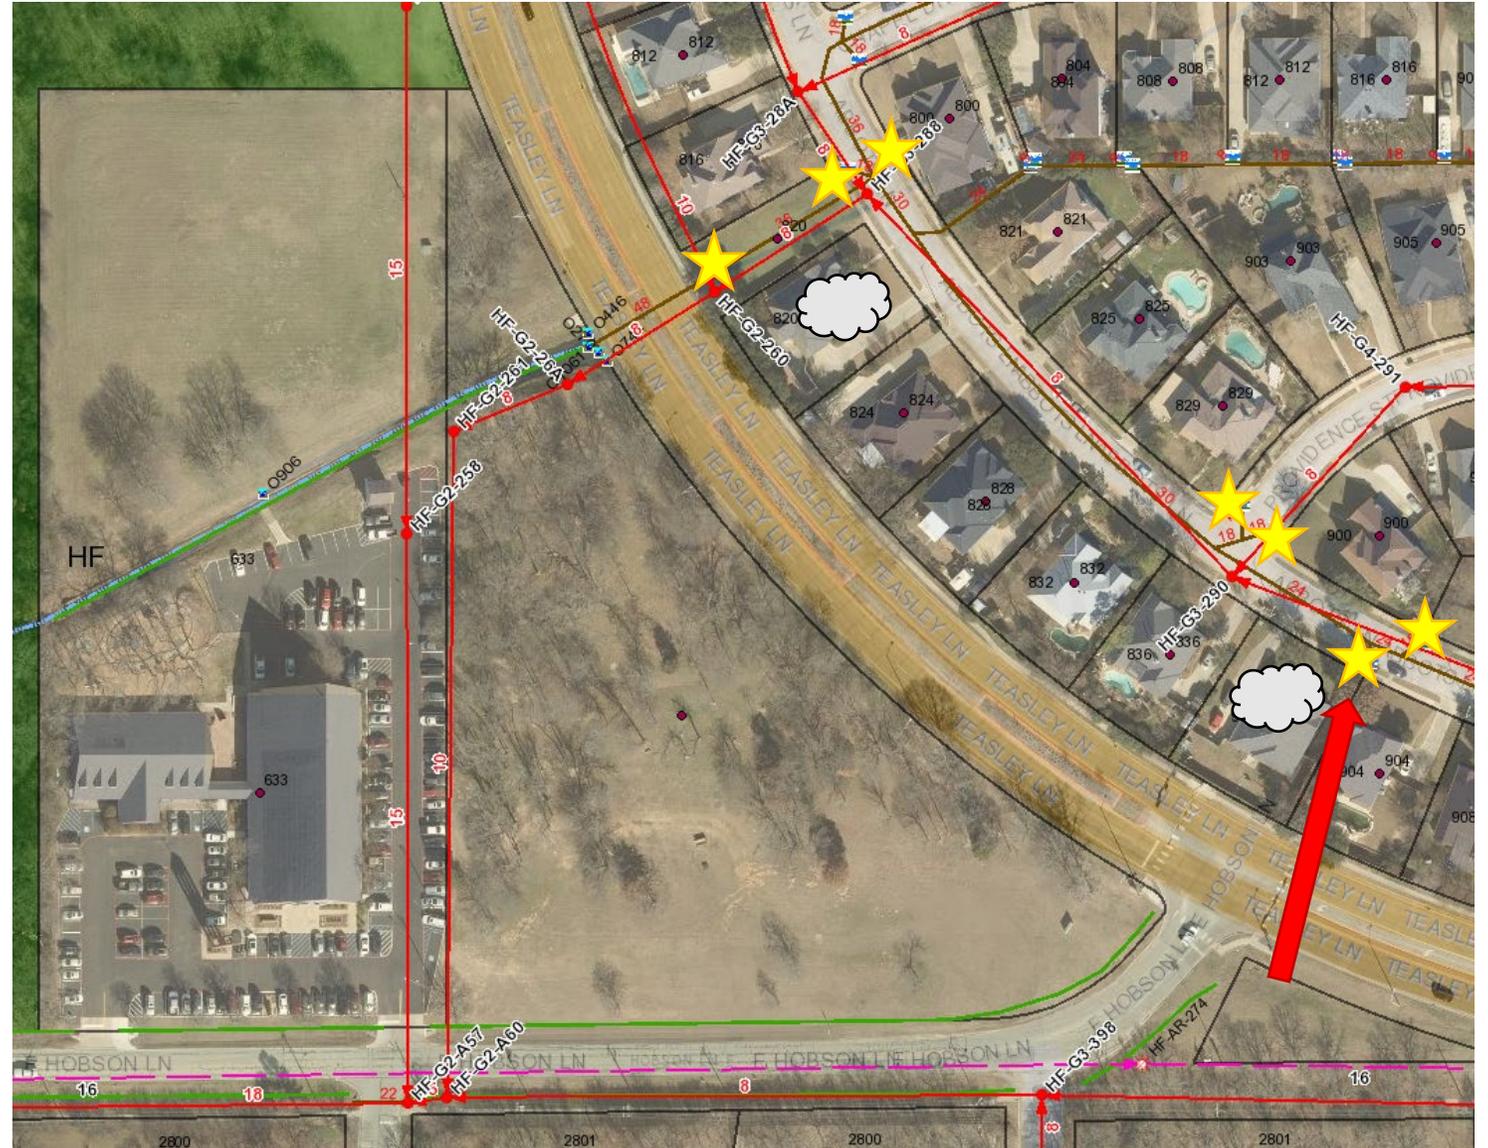
- Pulled manhole covers

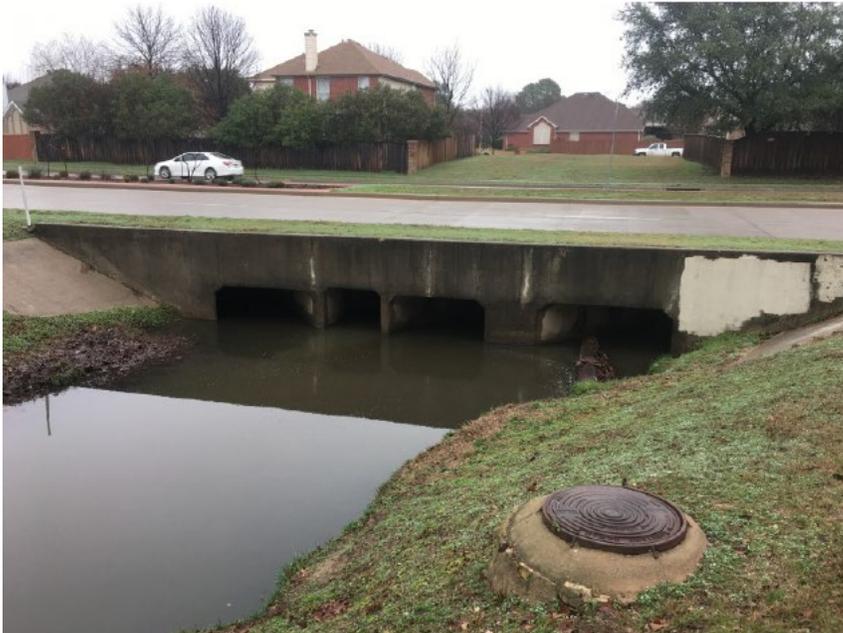
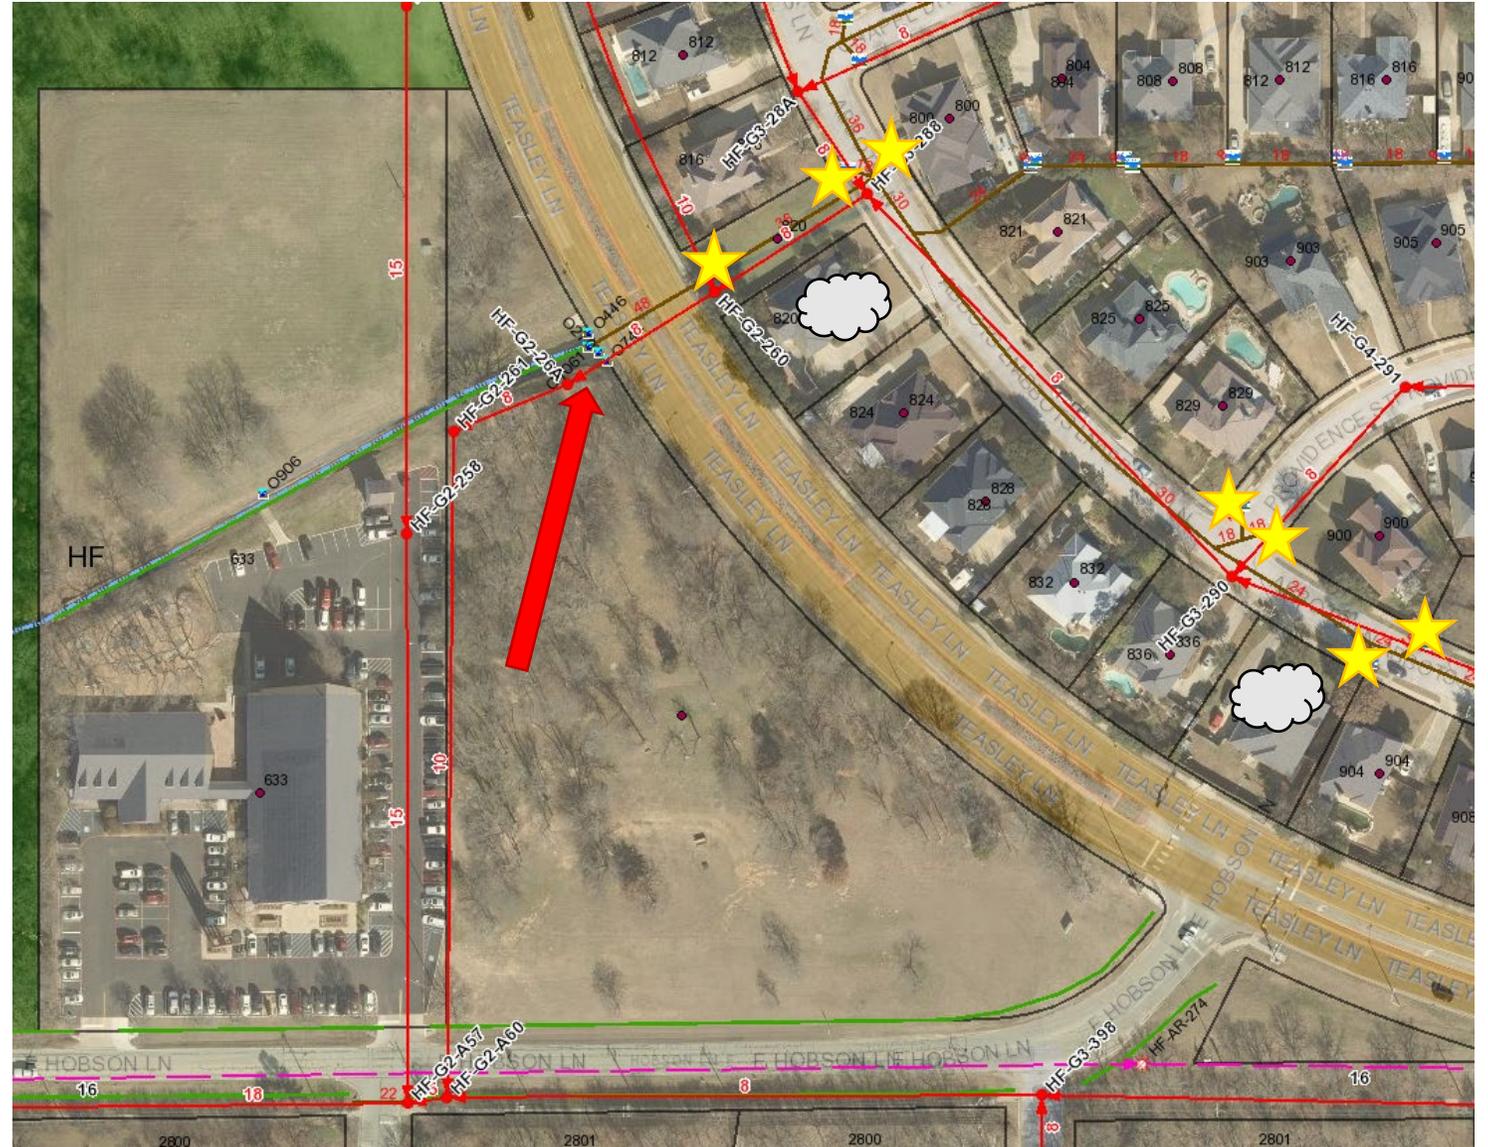
- Inspected outfall where daylights

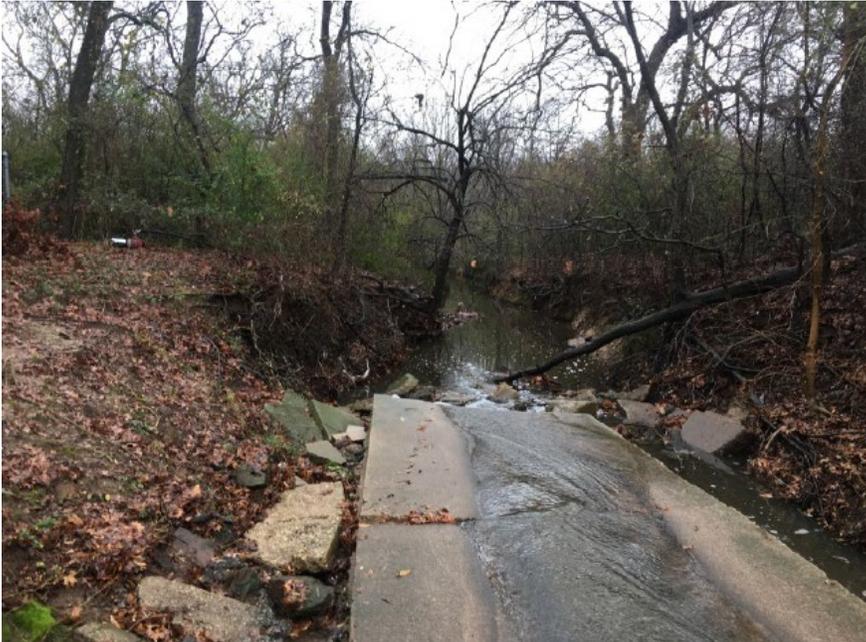
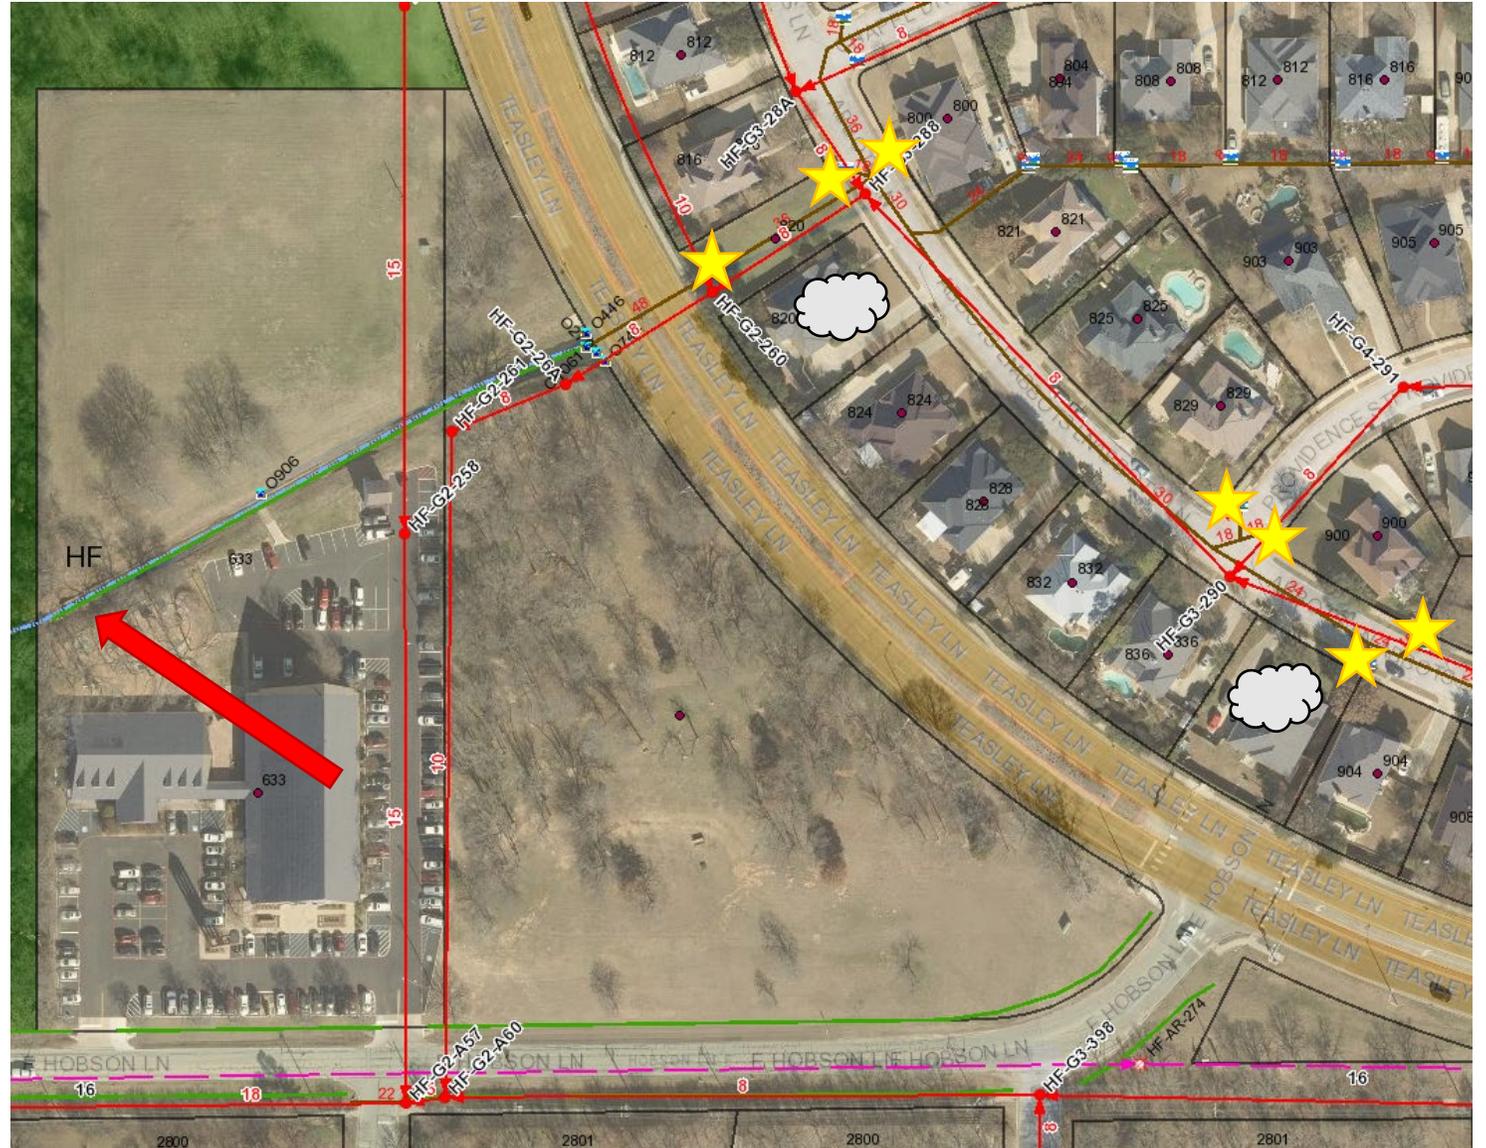
- Inspected end of concrete flume

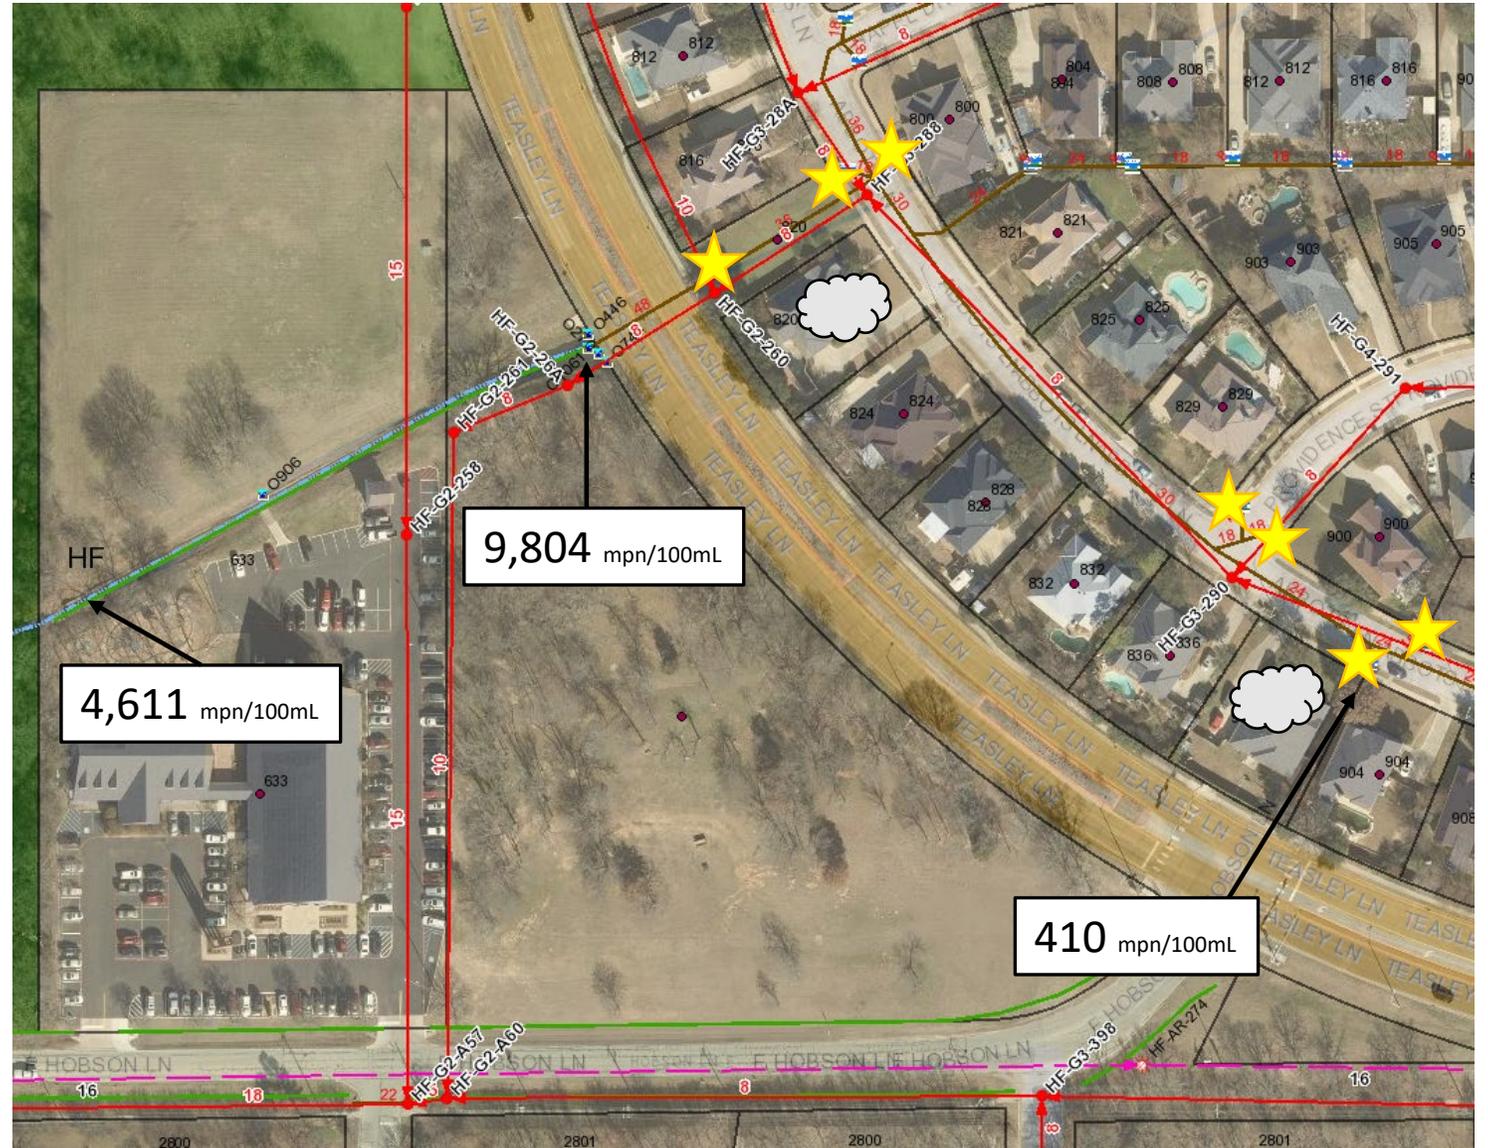
- Collected samples for E Coli for quick test
- Follow up testing warranted

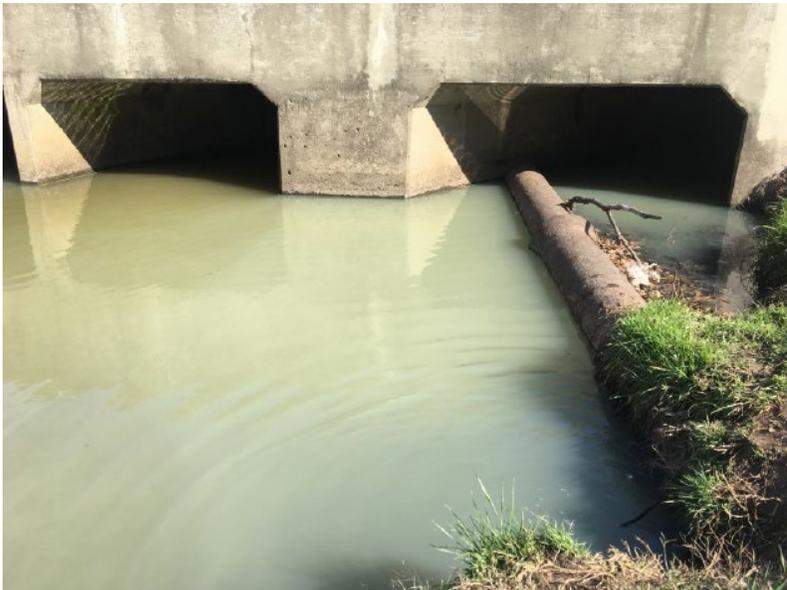
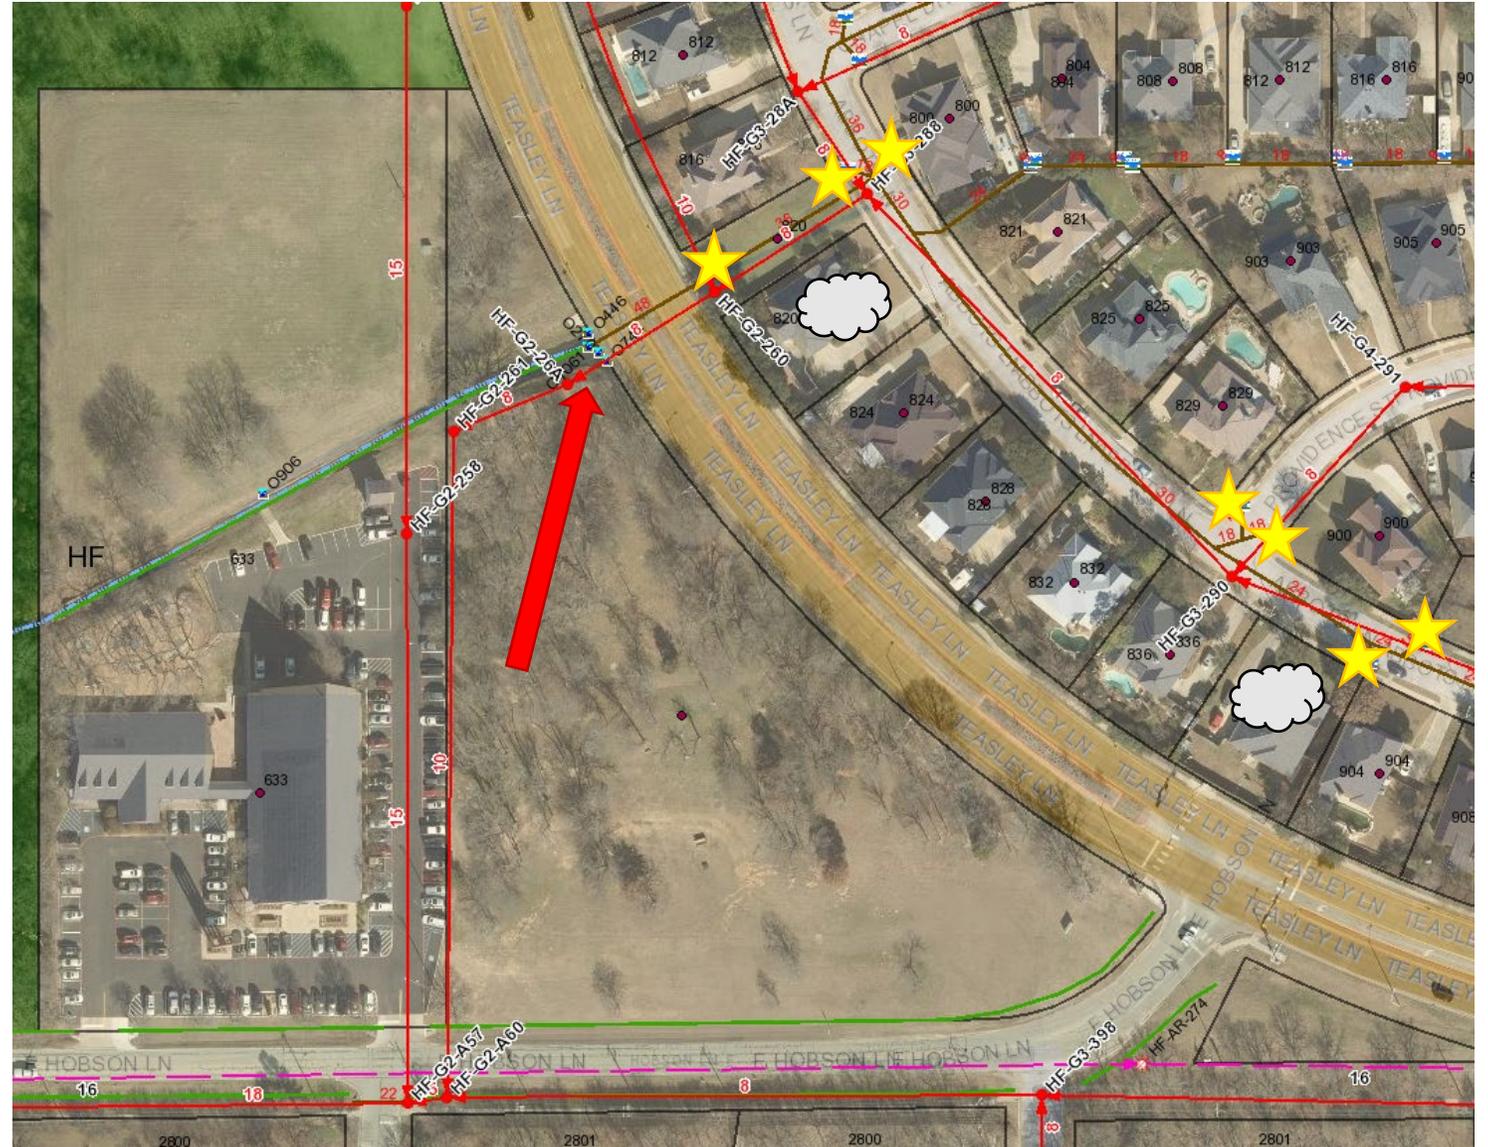
- Resampled next week
- White precipitate/turbidity
- Strong odor of sulfur

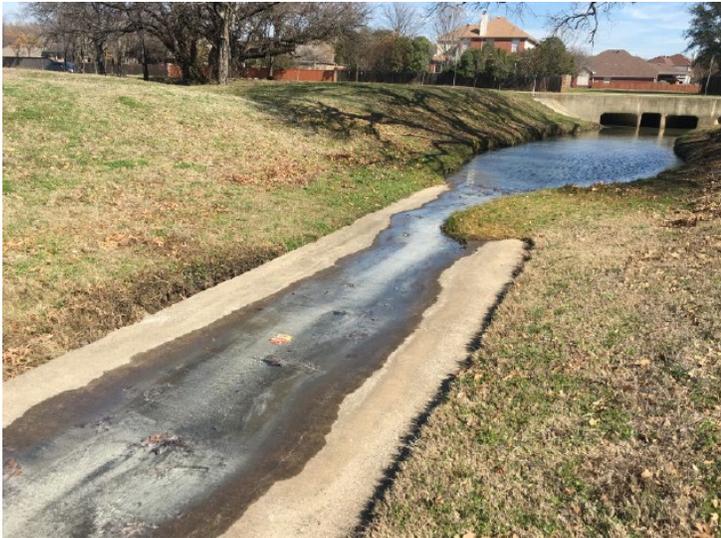
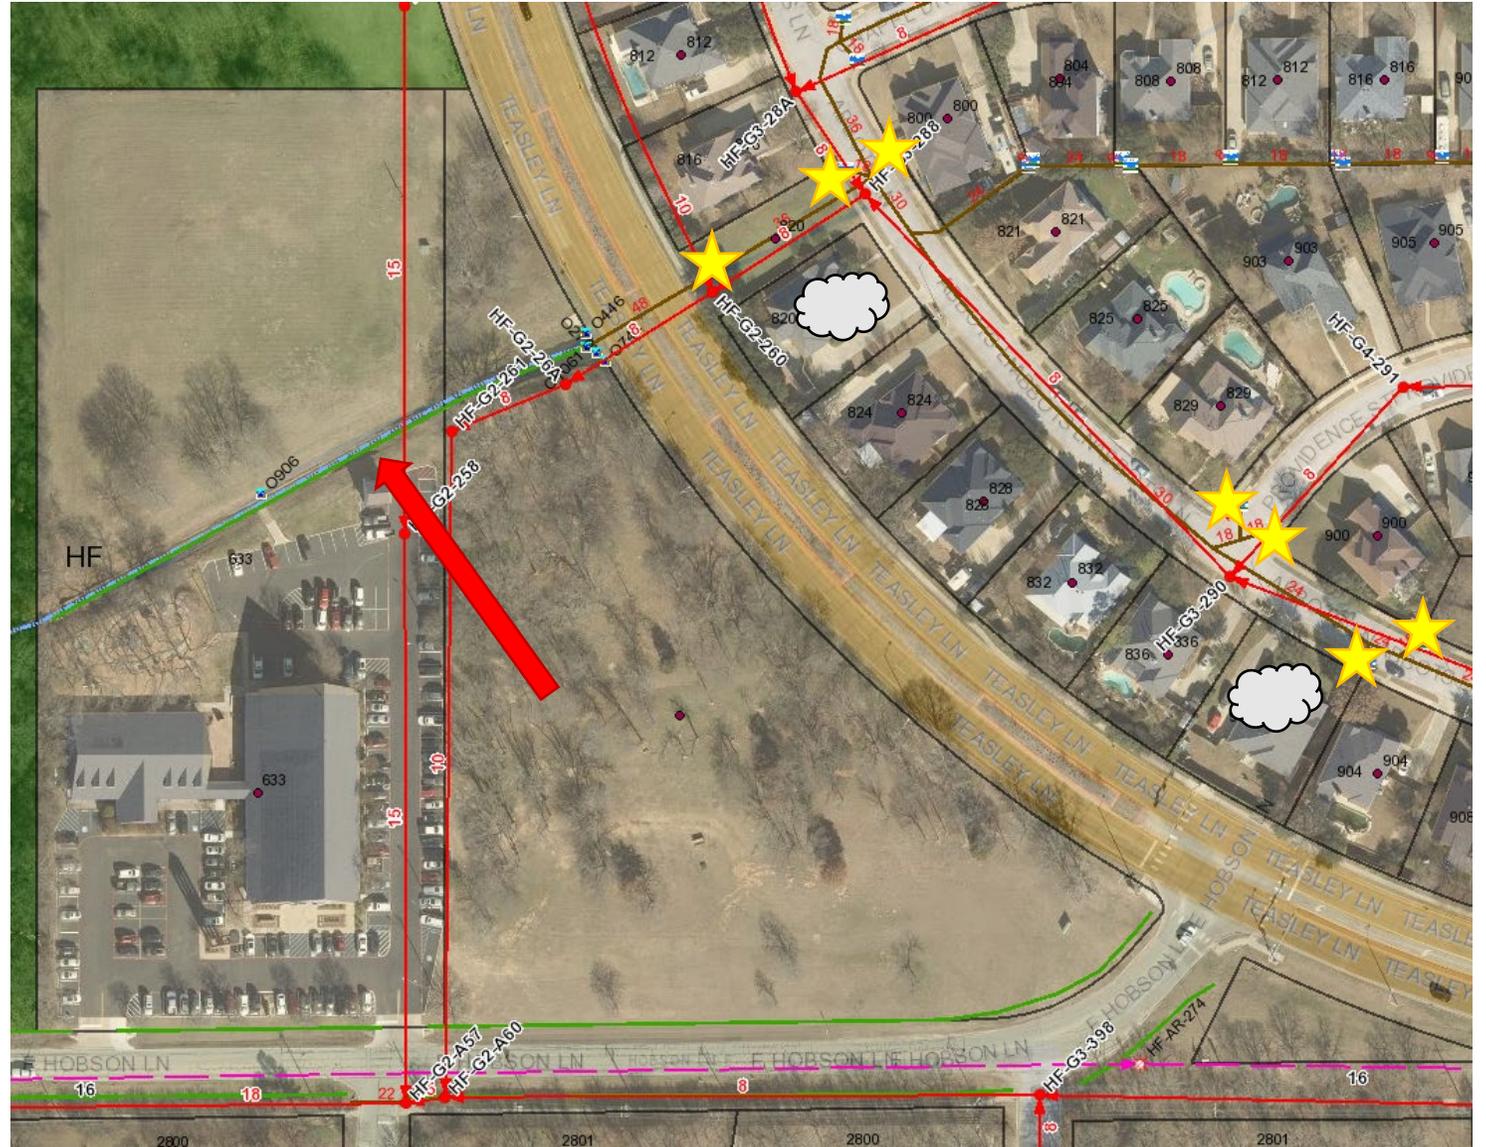
- Resampled next week
- White precipitate/turbidity
- Strong odor of sulfur

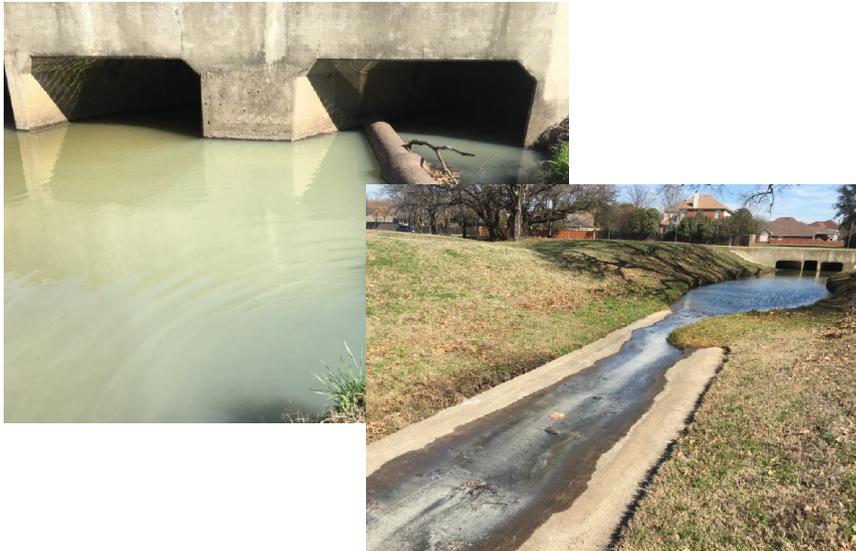
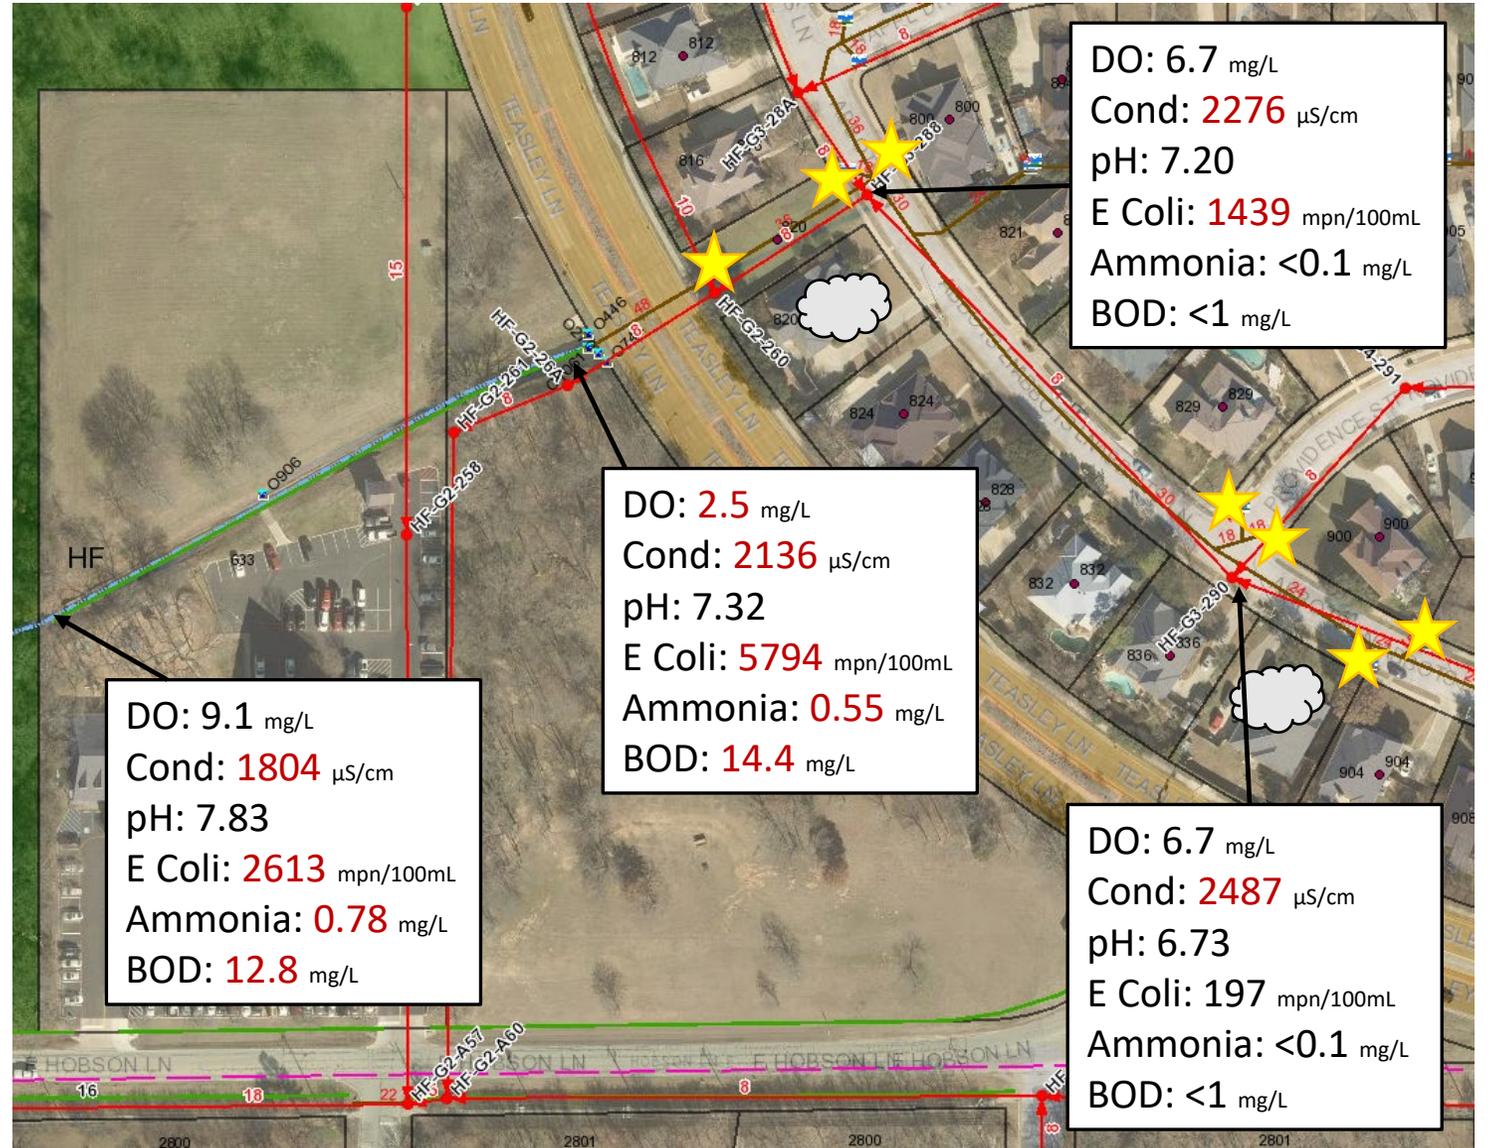
- Collected samples
- Moderately high Cond, E Coli, Ammonia, BOD.
- No significant metals indicated
