Illicit Discharge in an Industrial Park

Dry Weather Outfall Field Screening Discovery

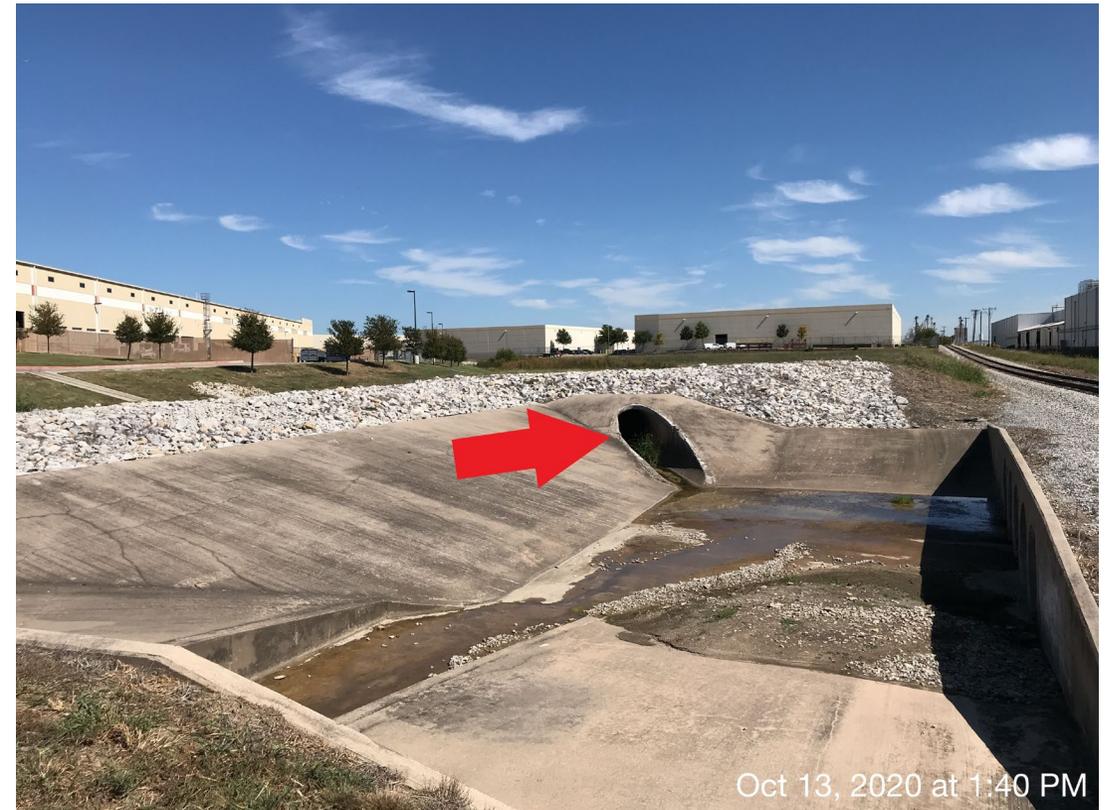
- During scheduled Dry Weather Field Screening, a flow was observed during the second site visit.
- Sample results indicated detergent at above trigger levels (over 0.2 mg/L)

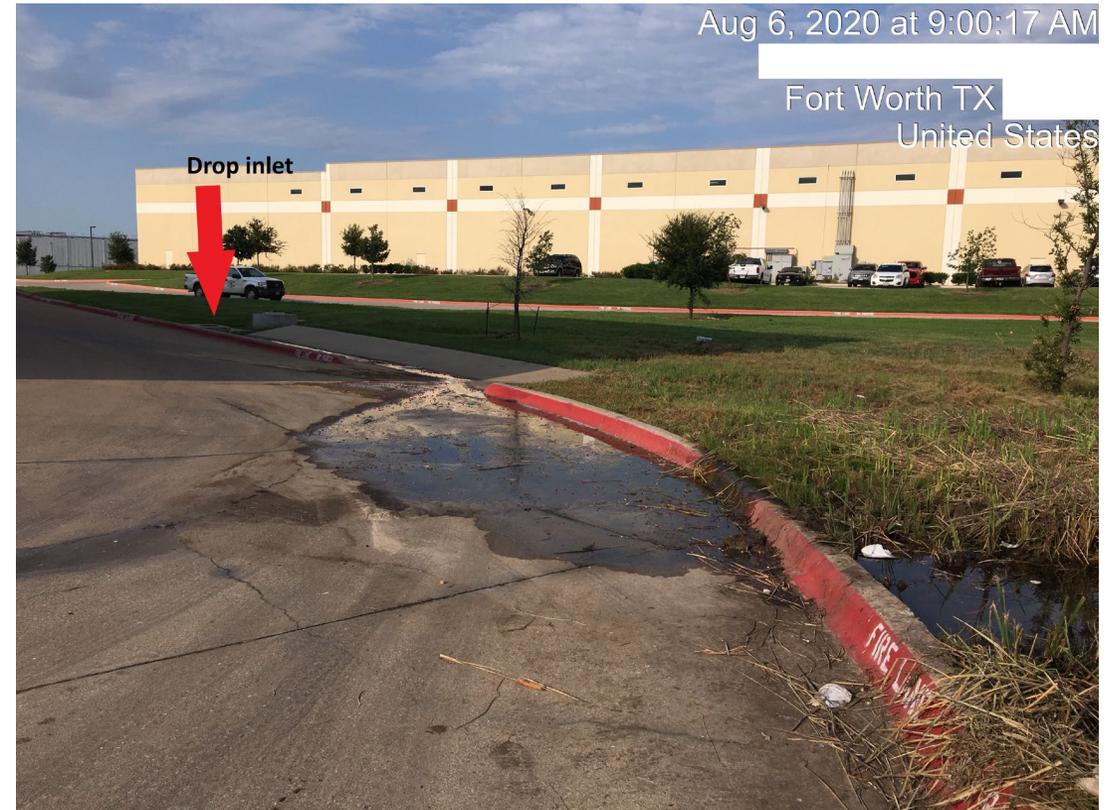
- Traceback was initiated through the detention pond
- There were two flows observed above the original detention pond contributing to the outfall drainage:
 - an above ground water leak leading to a drop inlet
 - the outfall to the second detention pond had above trigger levels for detergent, ammonia and phenol. Also noted was strong sewage odor, and gray water appearance.

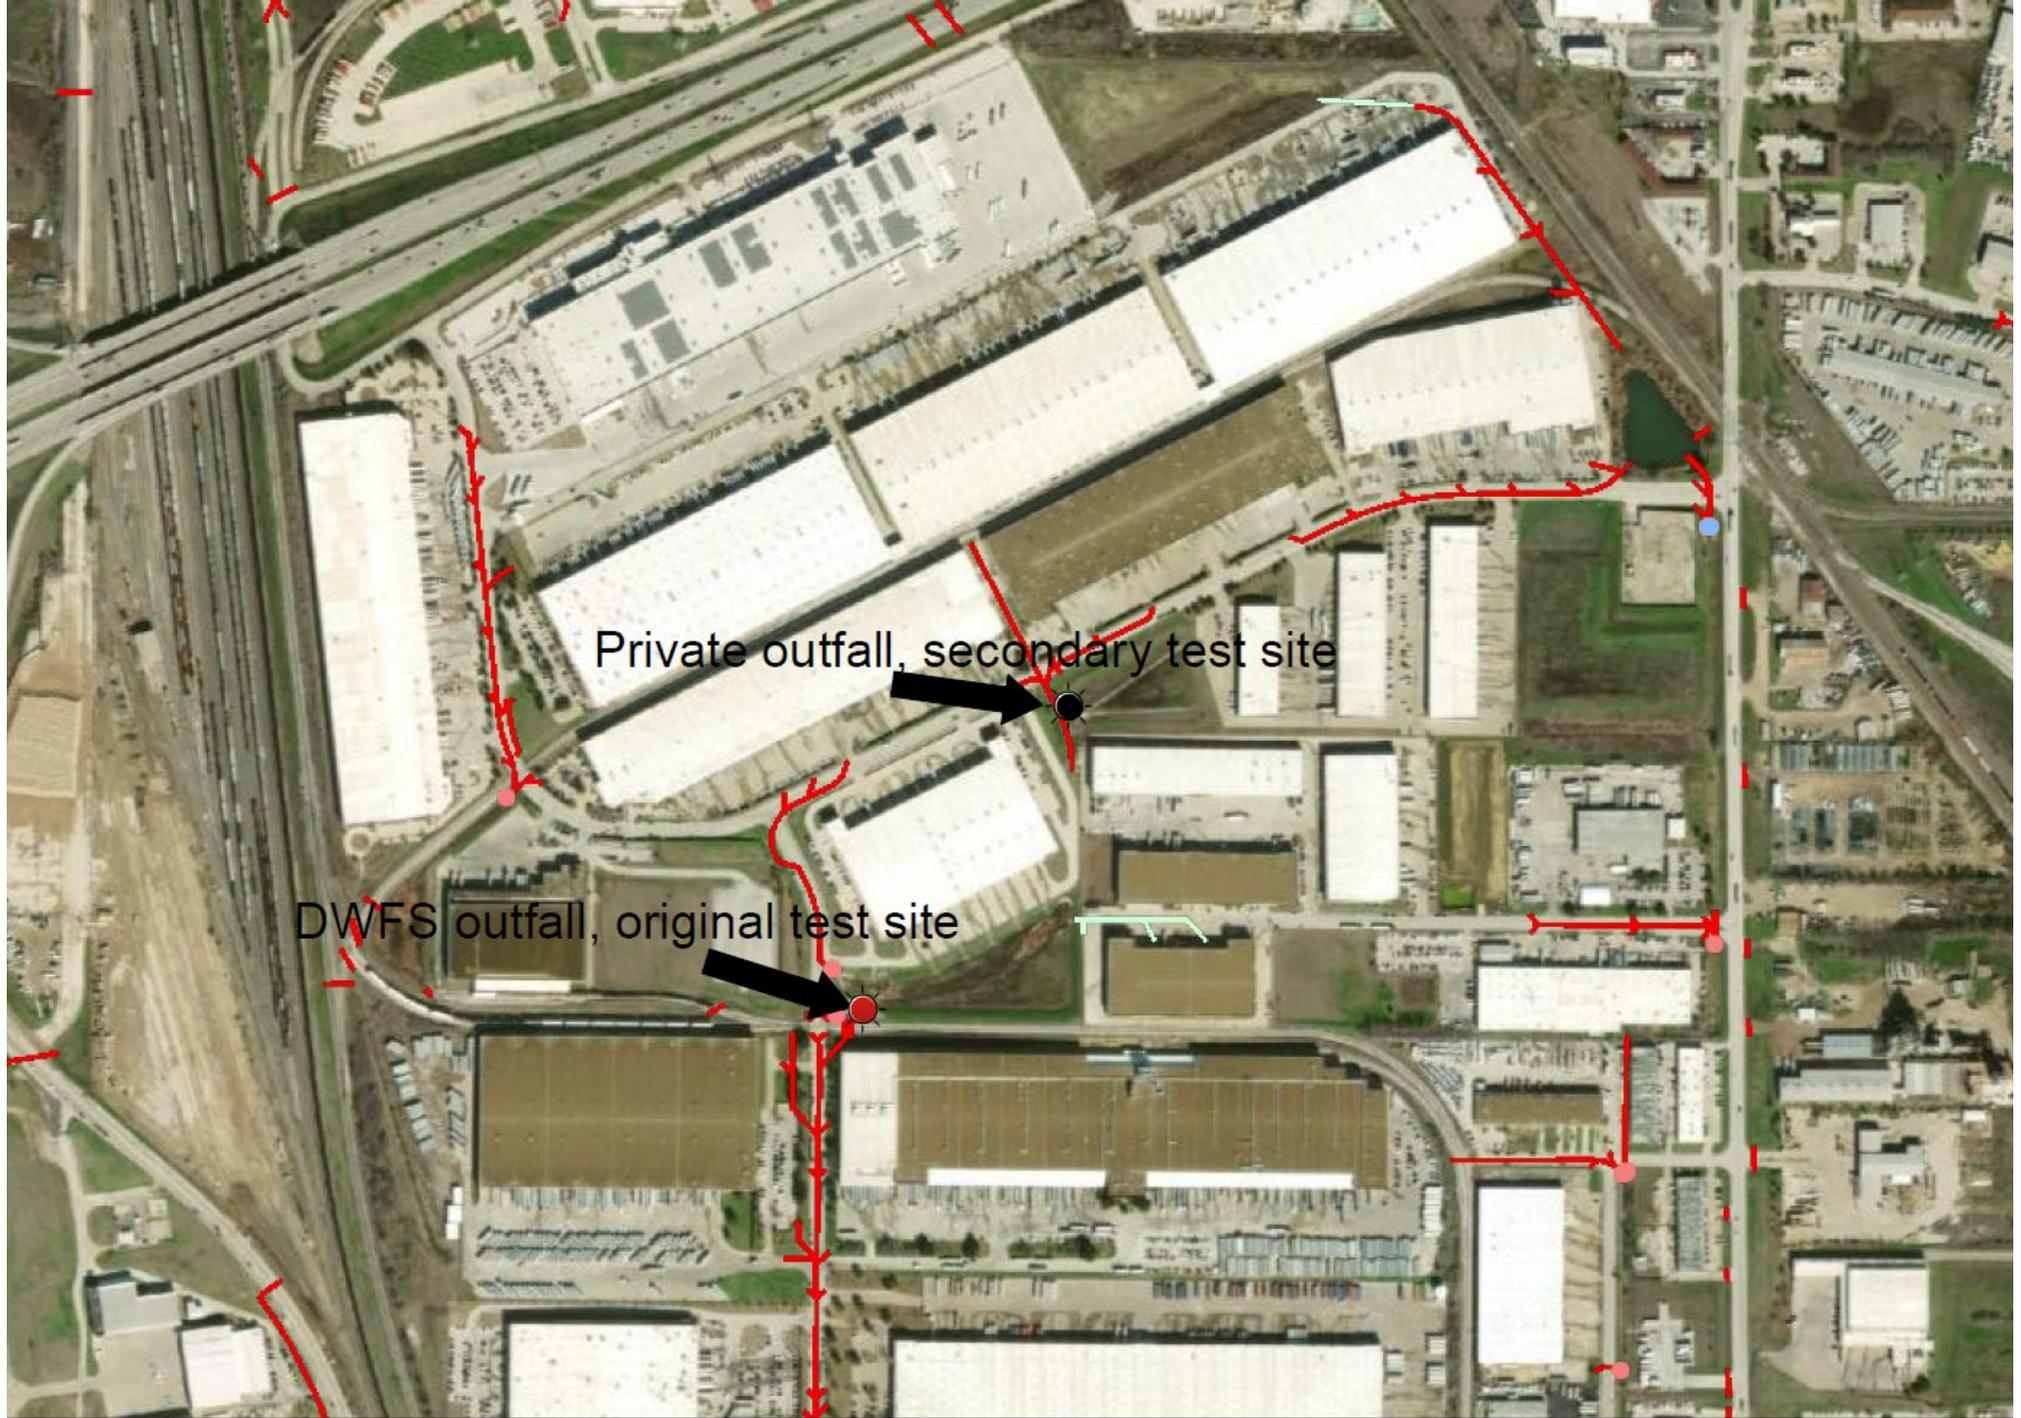
Private outfall, secondary test site

DWFS outfall, original test site

- Water Department was notified and determined the above ground water was from a fire riser vault (private). The owner was notified and the issue was repaired.
- Additional testing at the outfall indicated potential sewage; Water Department dye tested the public sewer system with no leak detected.
- TPW Stormwater could not place a camera in the system as it was a private system leading to the outfall.

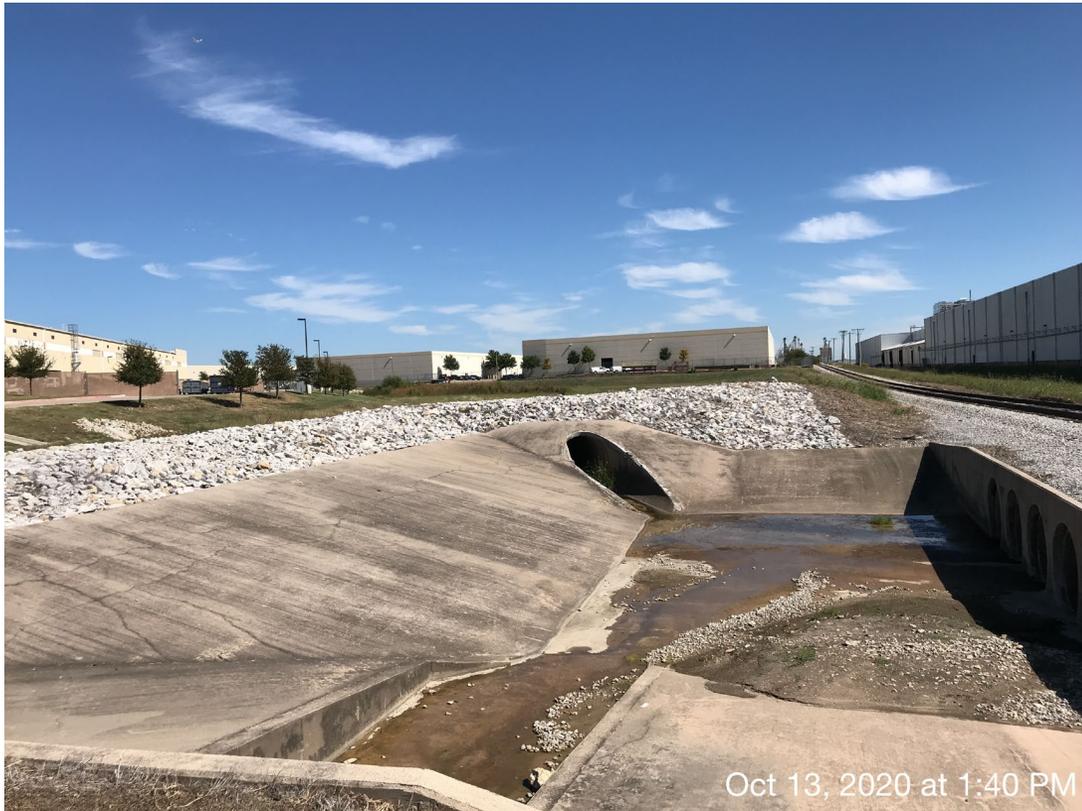
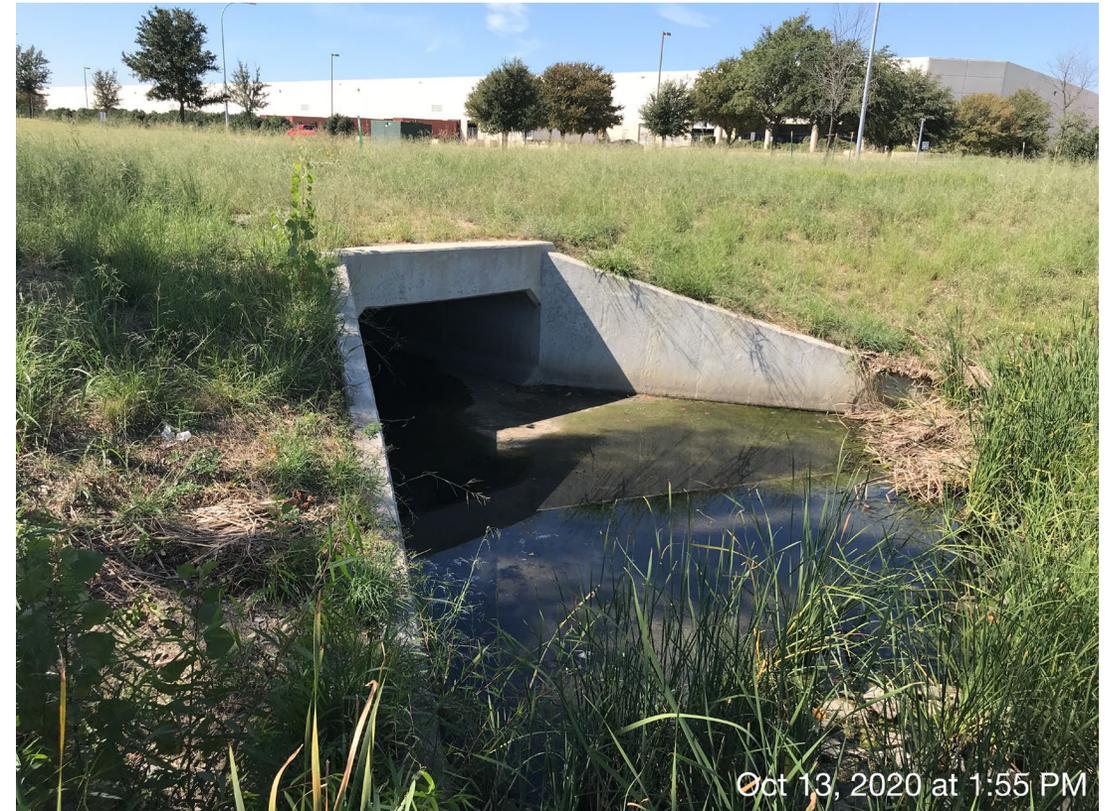
- The owner of the detention pond was notified and a plan was implemented for them to find and eliminate the discharge.
- This included dye testing their private system and inserting a camera in lines to determine connectivity to the storm drain system.
- It was ultimately determined that the can crushing area within their facility was incorrectly plumbed to the storm drain system.
- Follow up testing at the outfall indicated detergent and other parameters were below the trigger levels.
