IDDE

At DART Rail Right-of-Way (ROW)

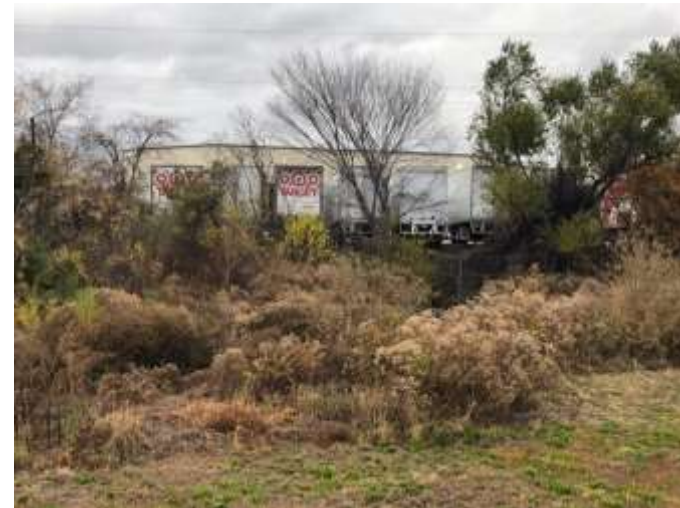
- 11/30/2018: DART track inspector discovers sheen on creek flowing onto DART ROW.
- Inspector reports the sheen to his supervisor; and calls DART Environmental.
- DART Environmental conducts on-site inspection and determines source of sheen appears to be from northern property. Call Garland Stormwater to help locate source. Meet onsite with Garland stormwater representative to initiate off-site investigation.

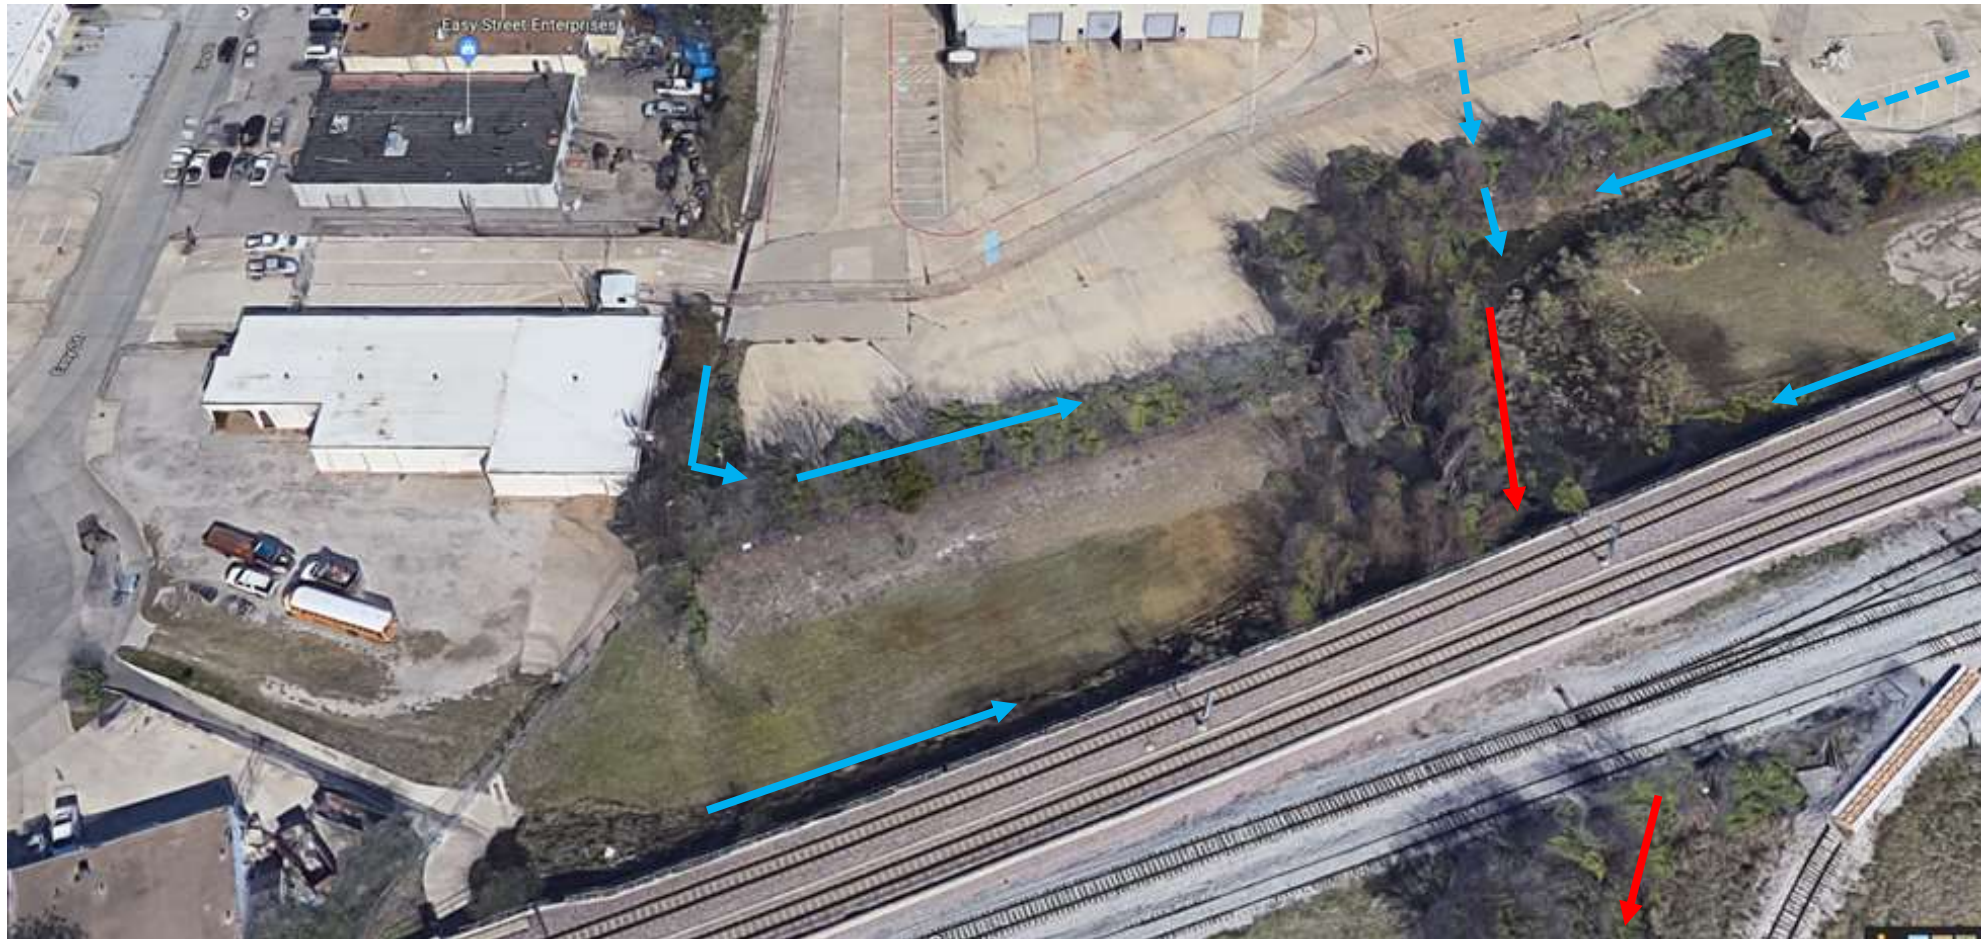
Sheen flowing from north to south. Various outfalls combine and continue south, under the track ROW.

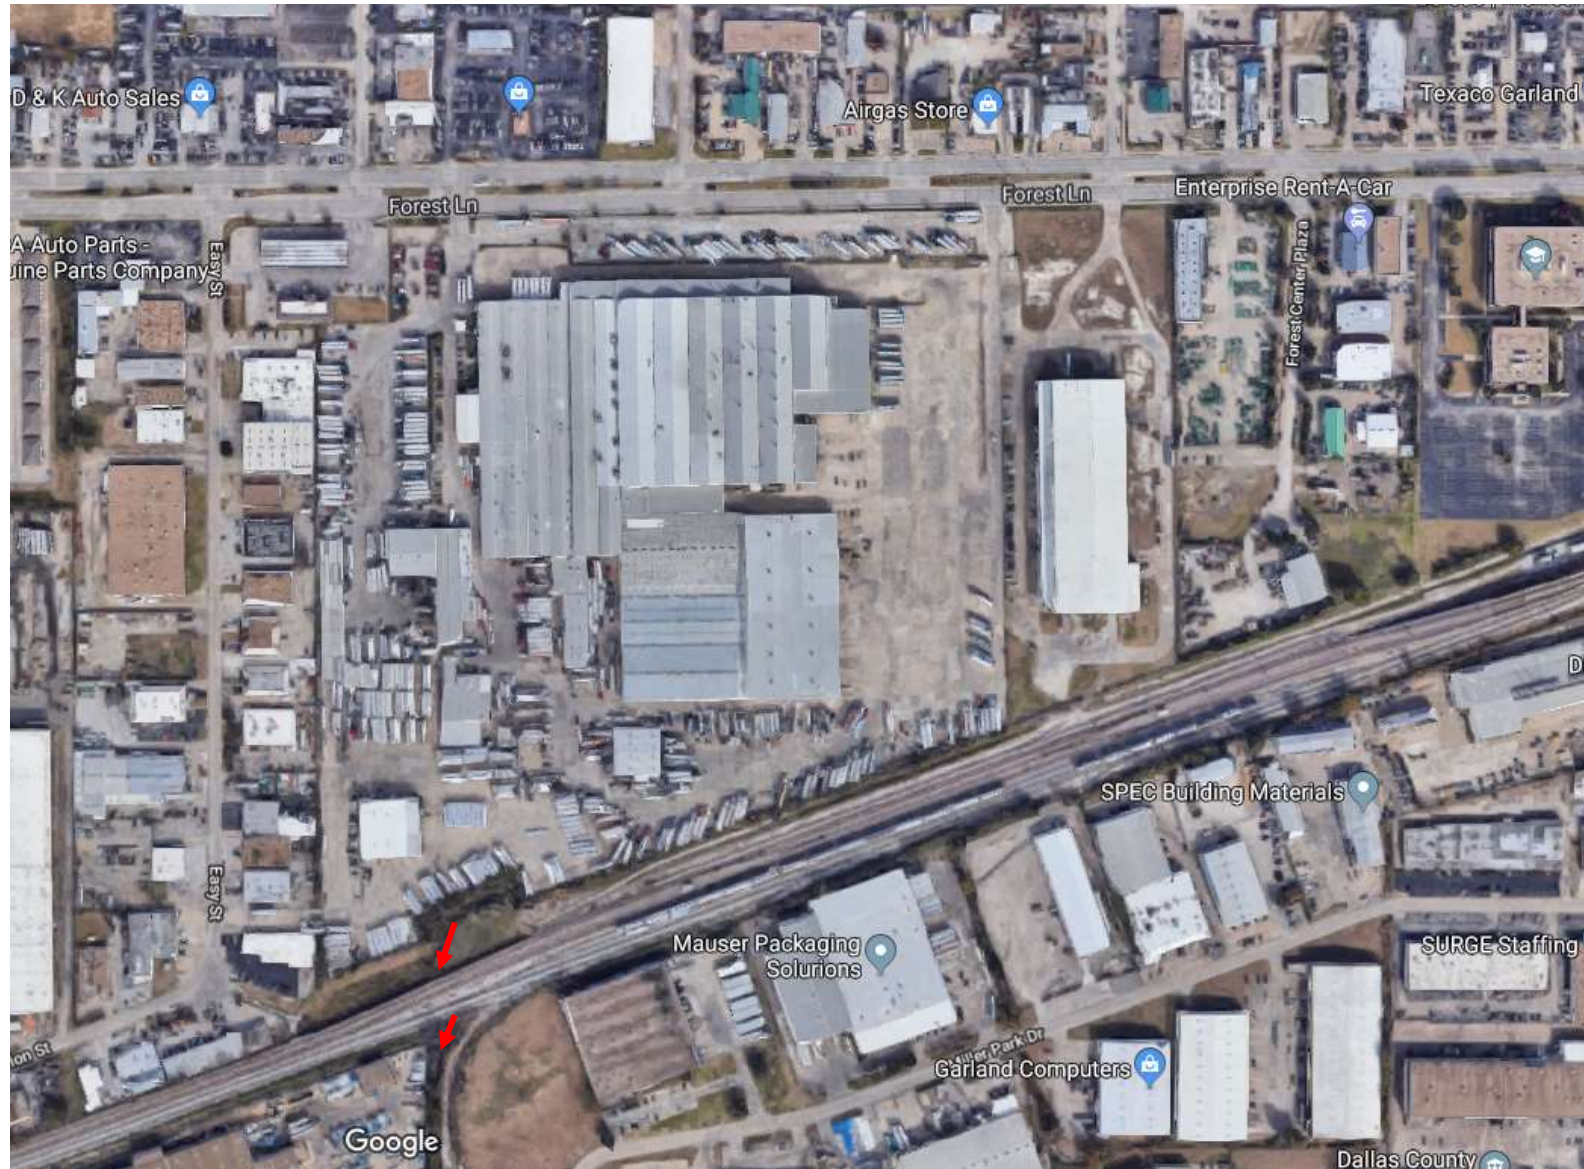
Aerial view of industries upgradient of the site.

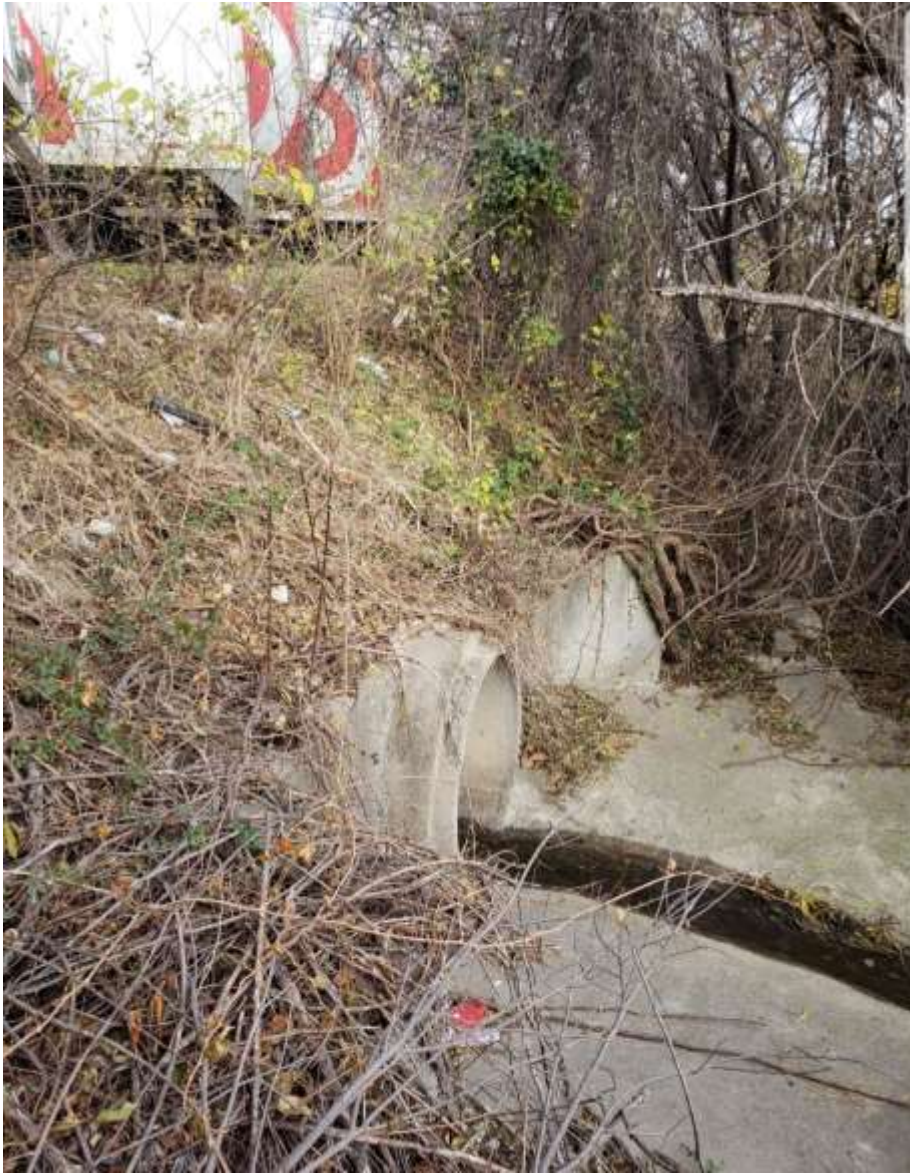
Outfall from commercial property flows south onto DART.

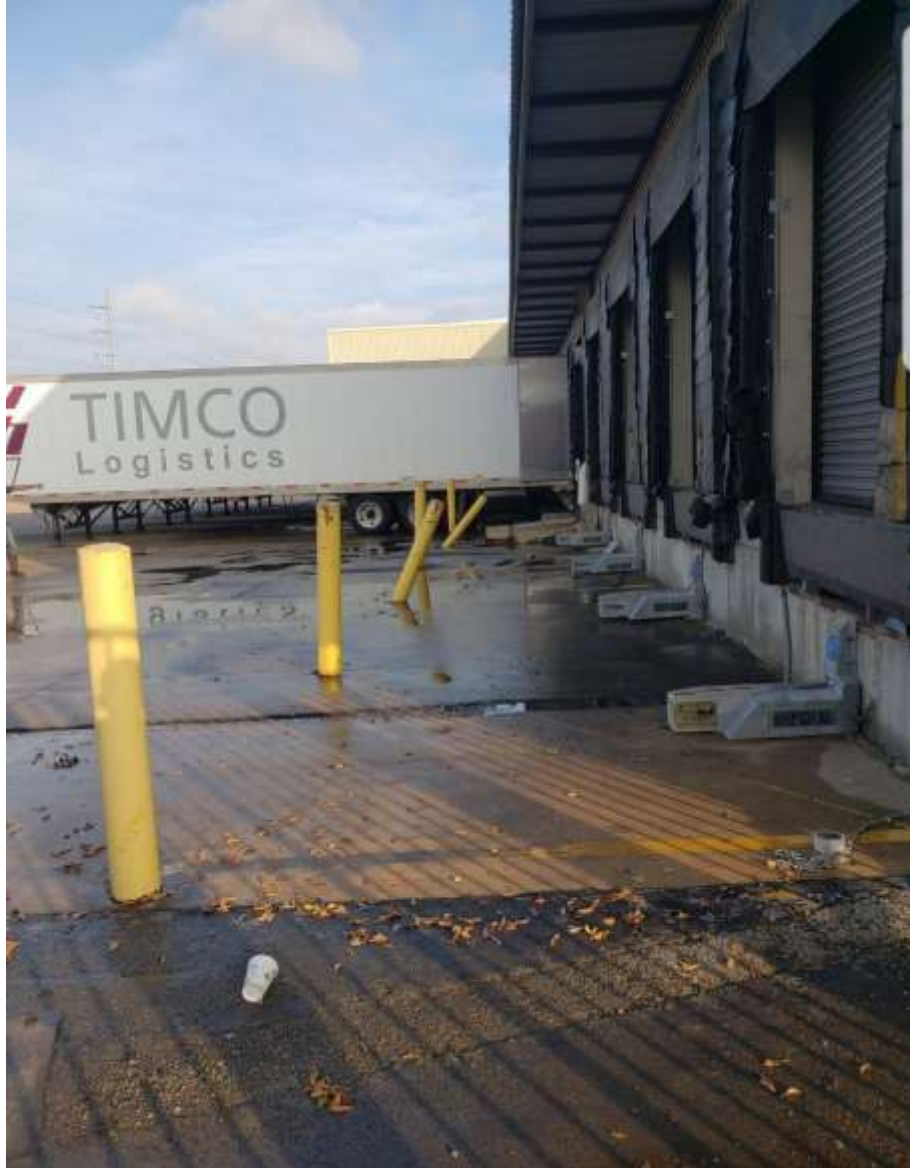
4040 Forest

Fire hydrant system flushing was being done at 4040 Forest.

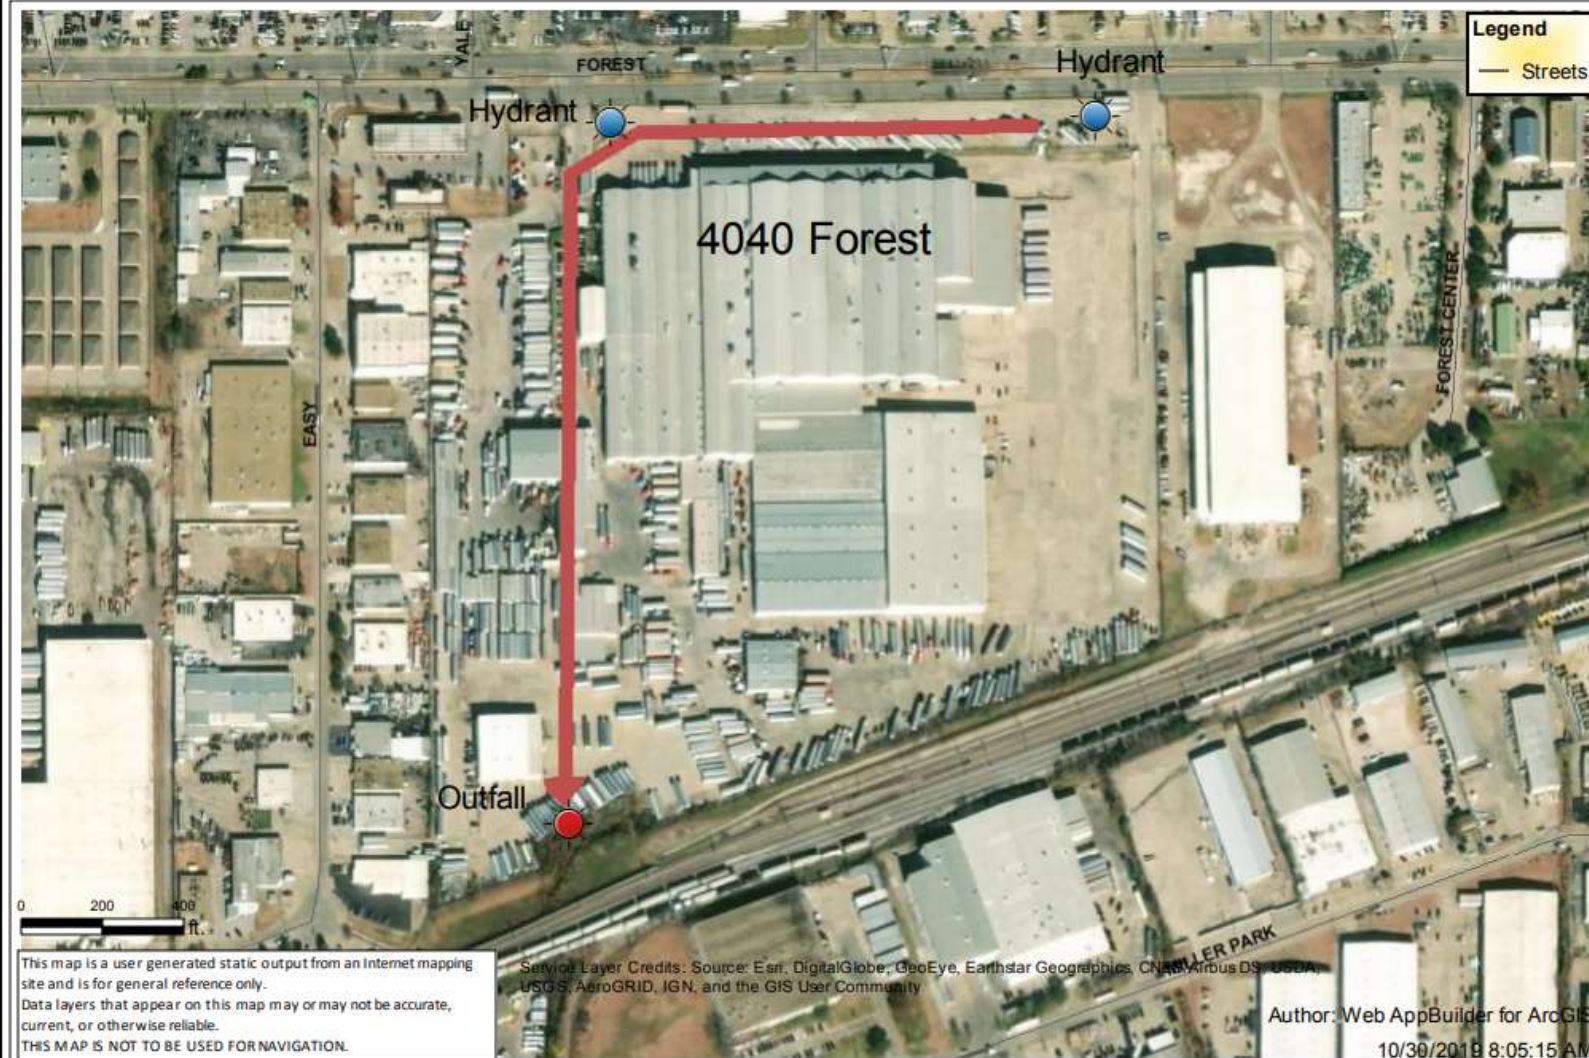
Source of oil is approx. 2000ft north of the DART rail.
