Asset Management Software Survey

Kori Mullen, NCTCOG

NCTCOG Public Works Roundup

May 9, 2017

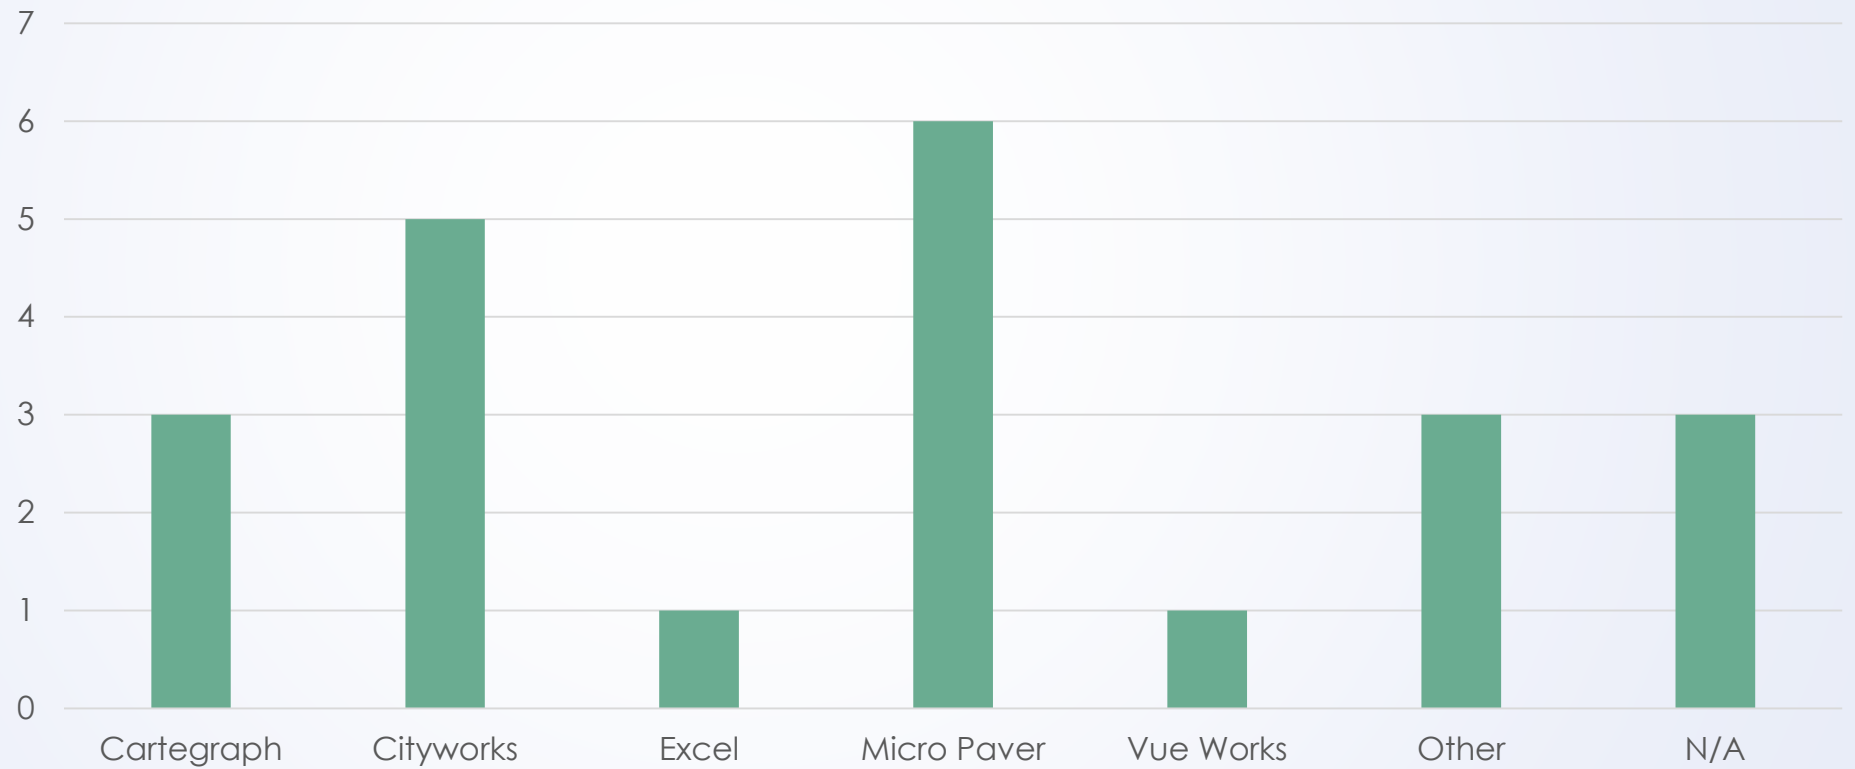
What asset management software do you use for streets and pavement?

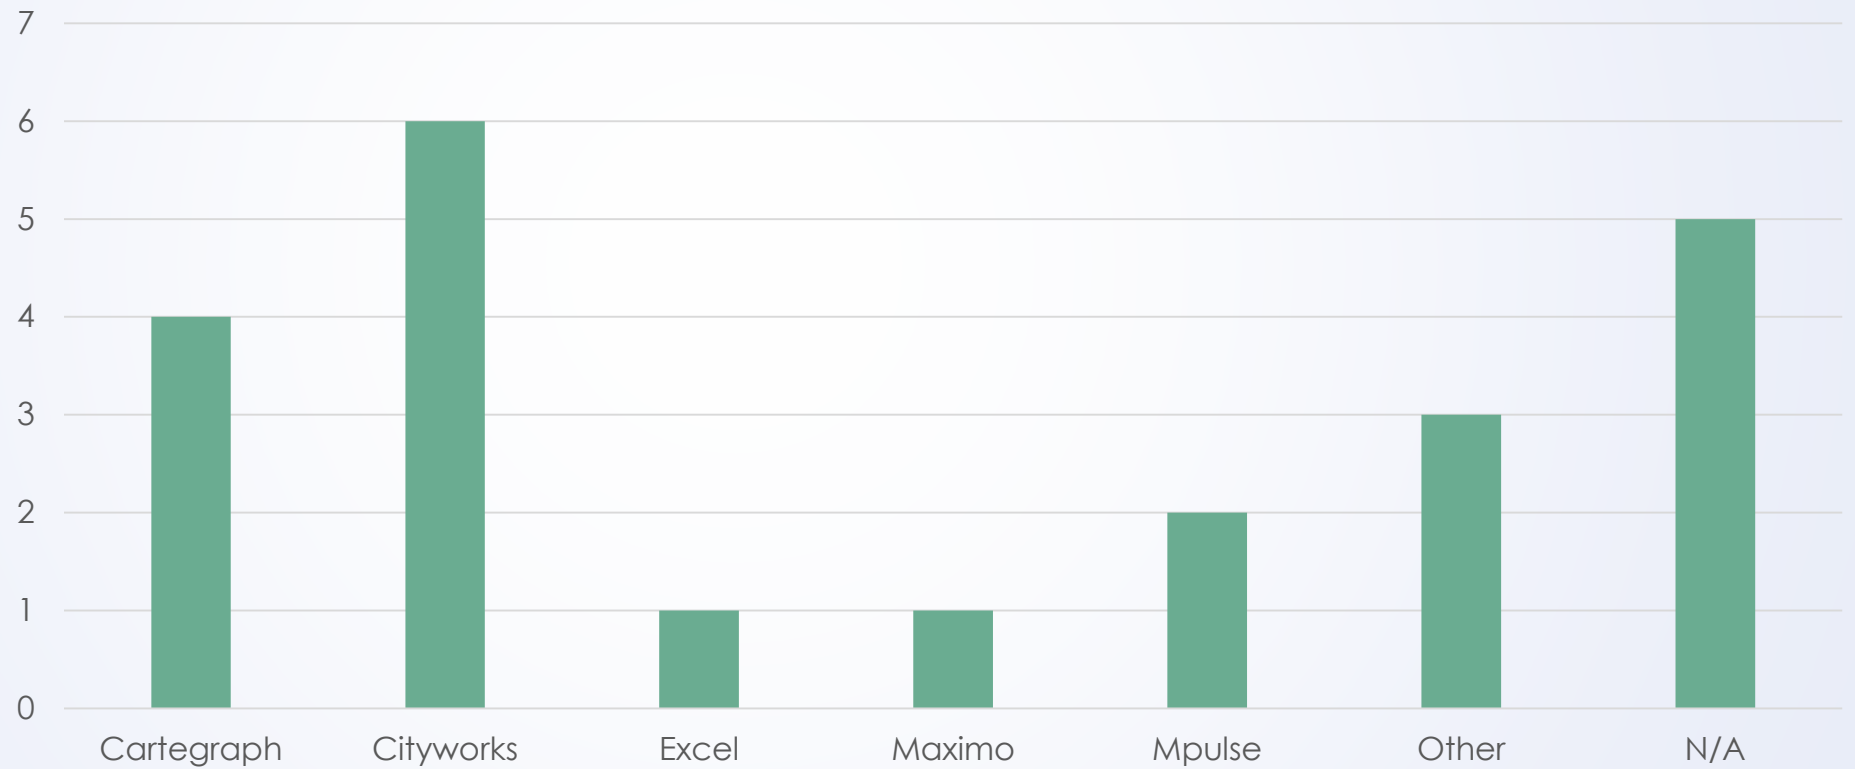
What asset management software do you use for water?

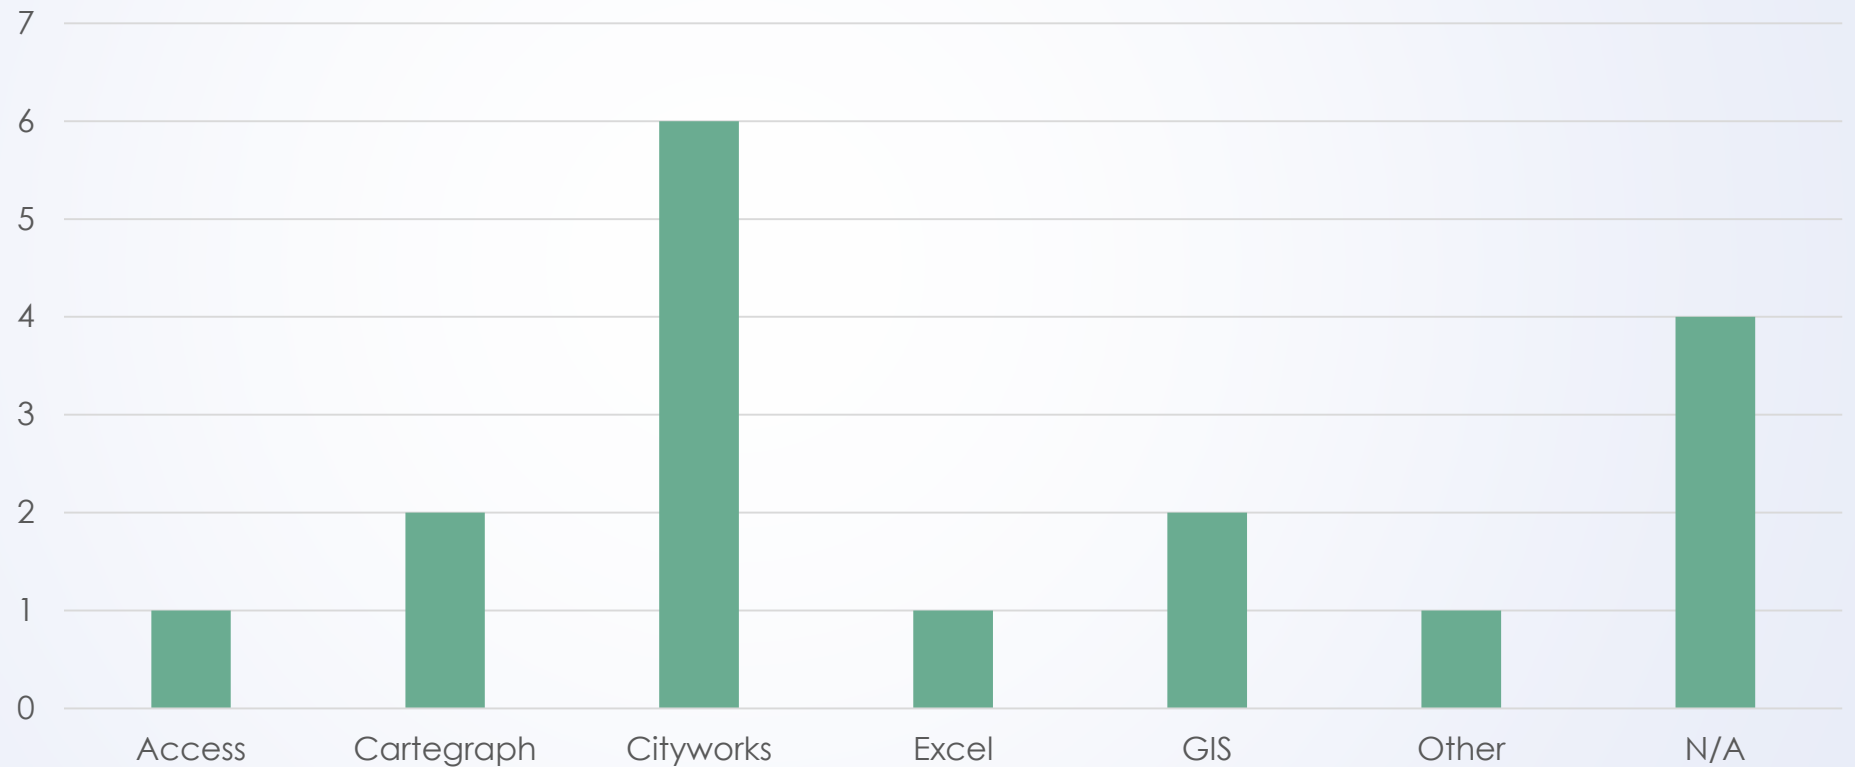
What asset management software do you use for sanitary sewer?

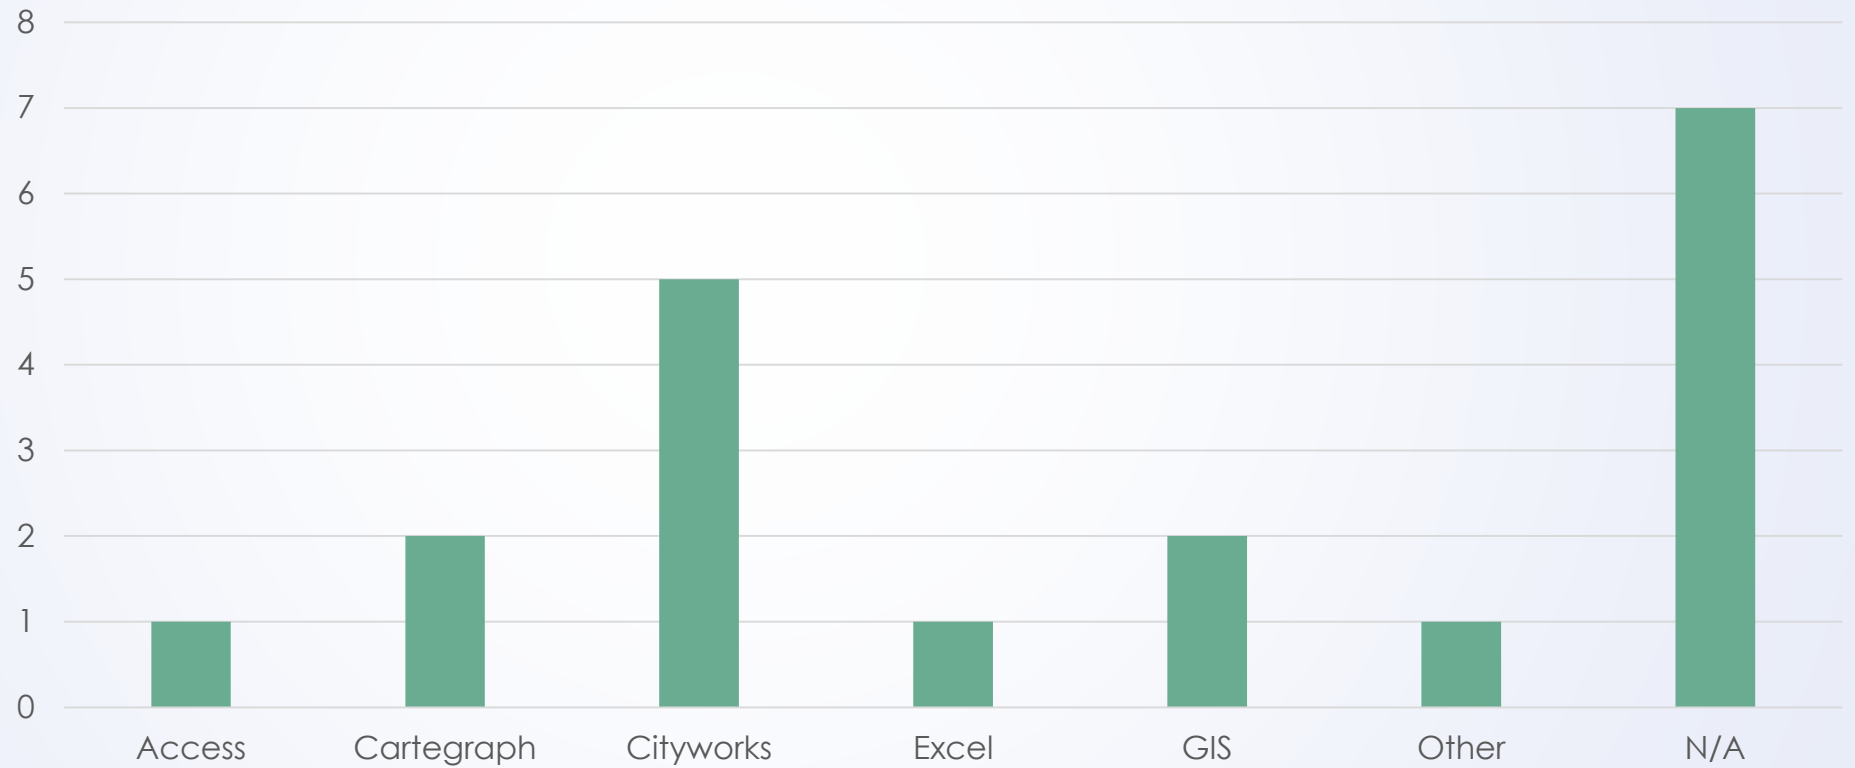
What asset management software do you use for drainage?

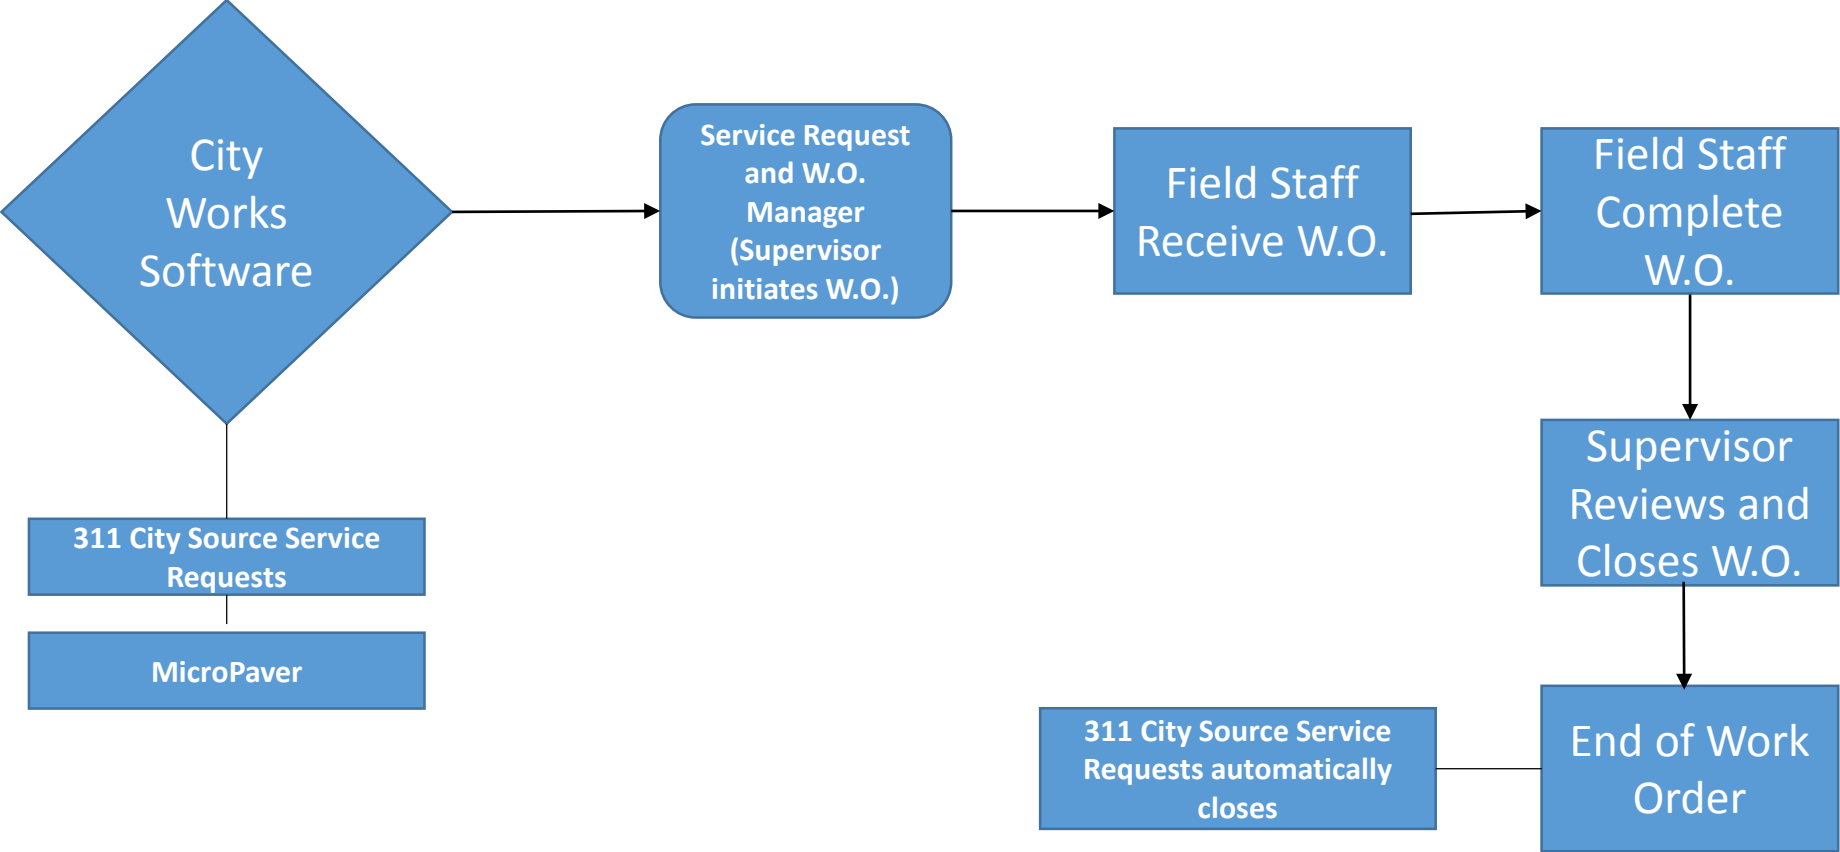
WORK FLOW FOR WORK ORDERS

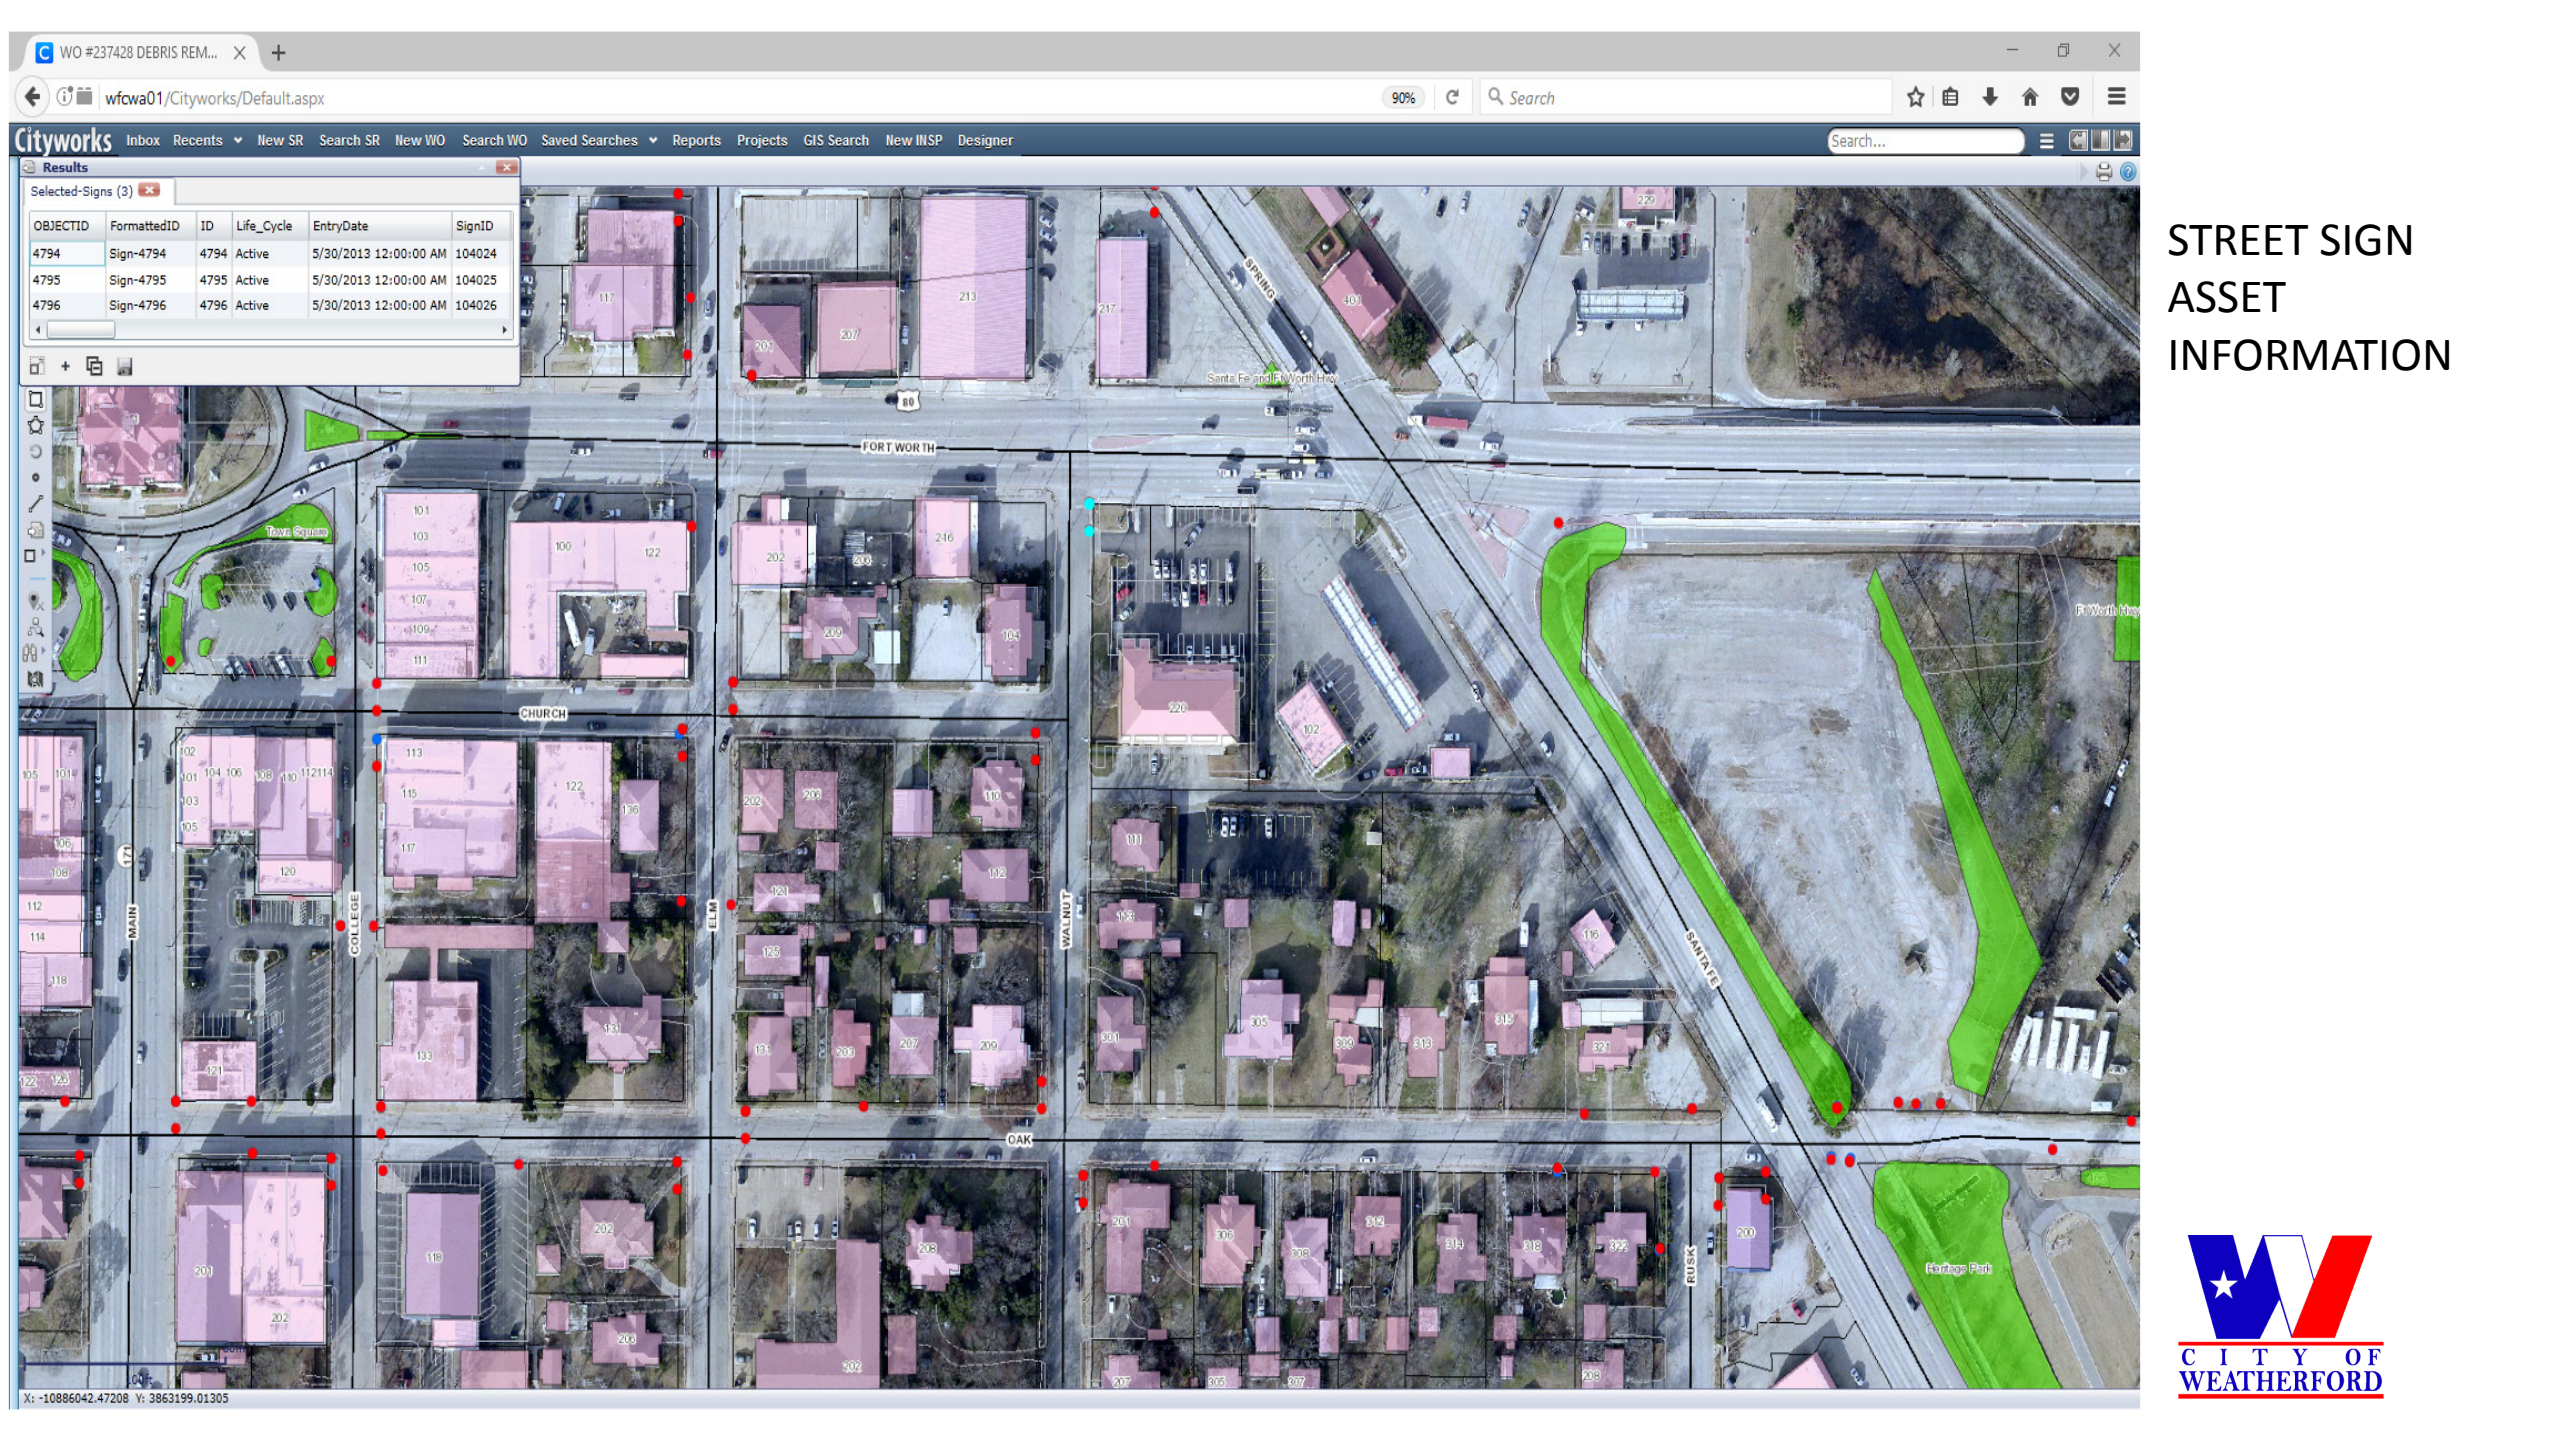
HEAT MAPS TO
PINPOINT
POTENTIAL
PROBLEM AREAS

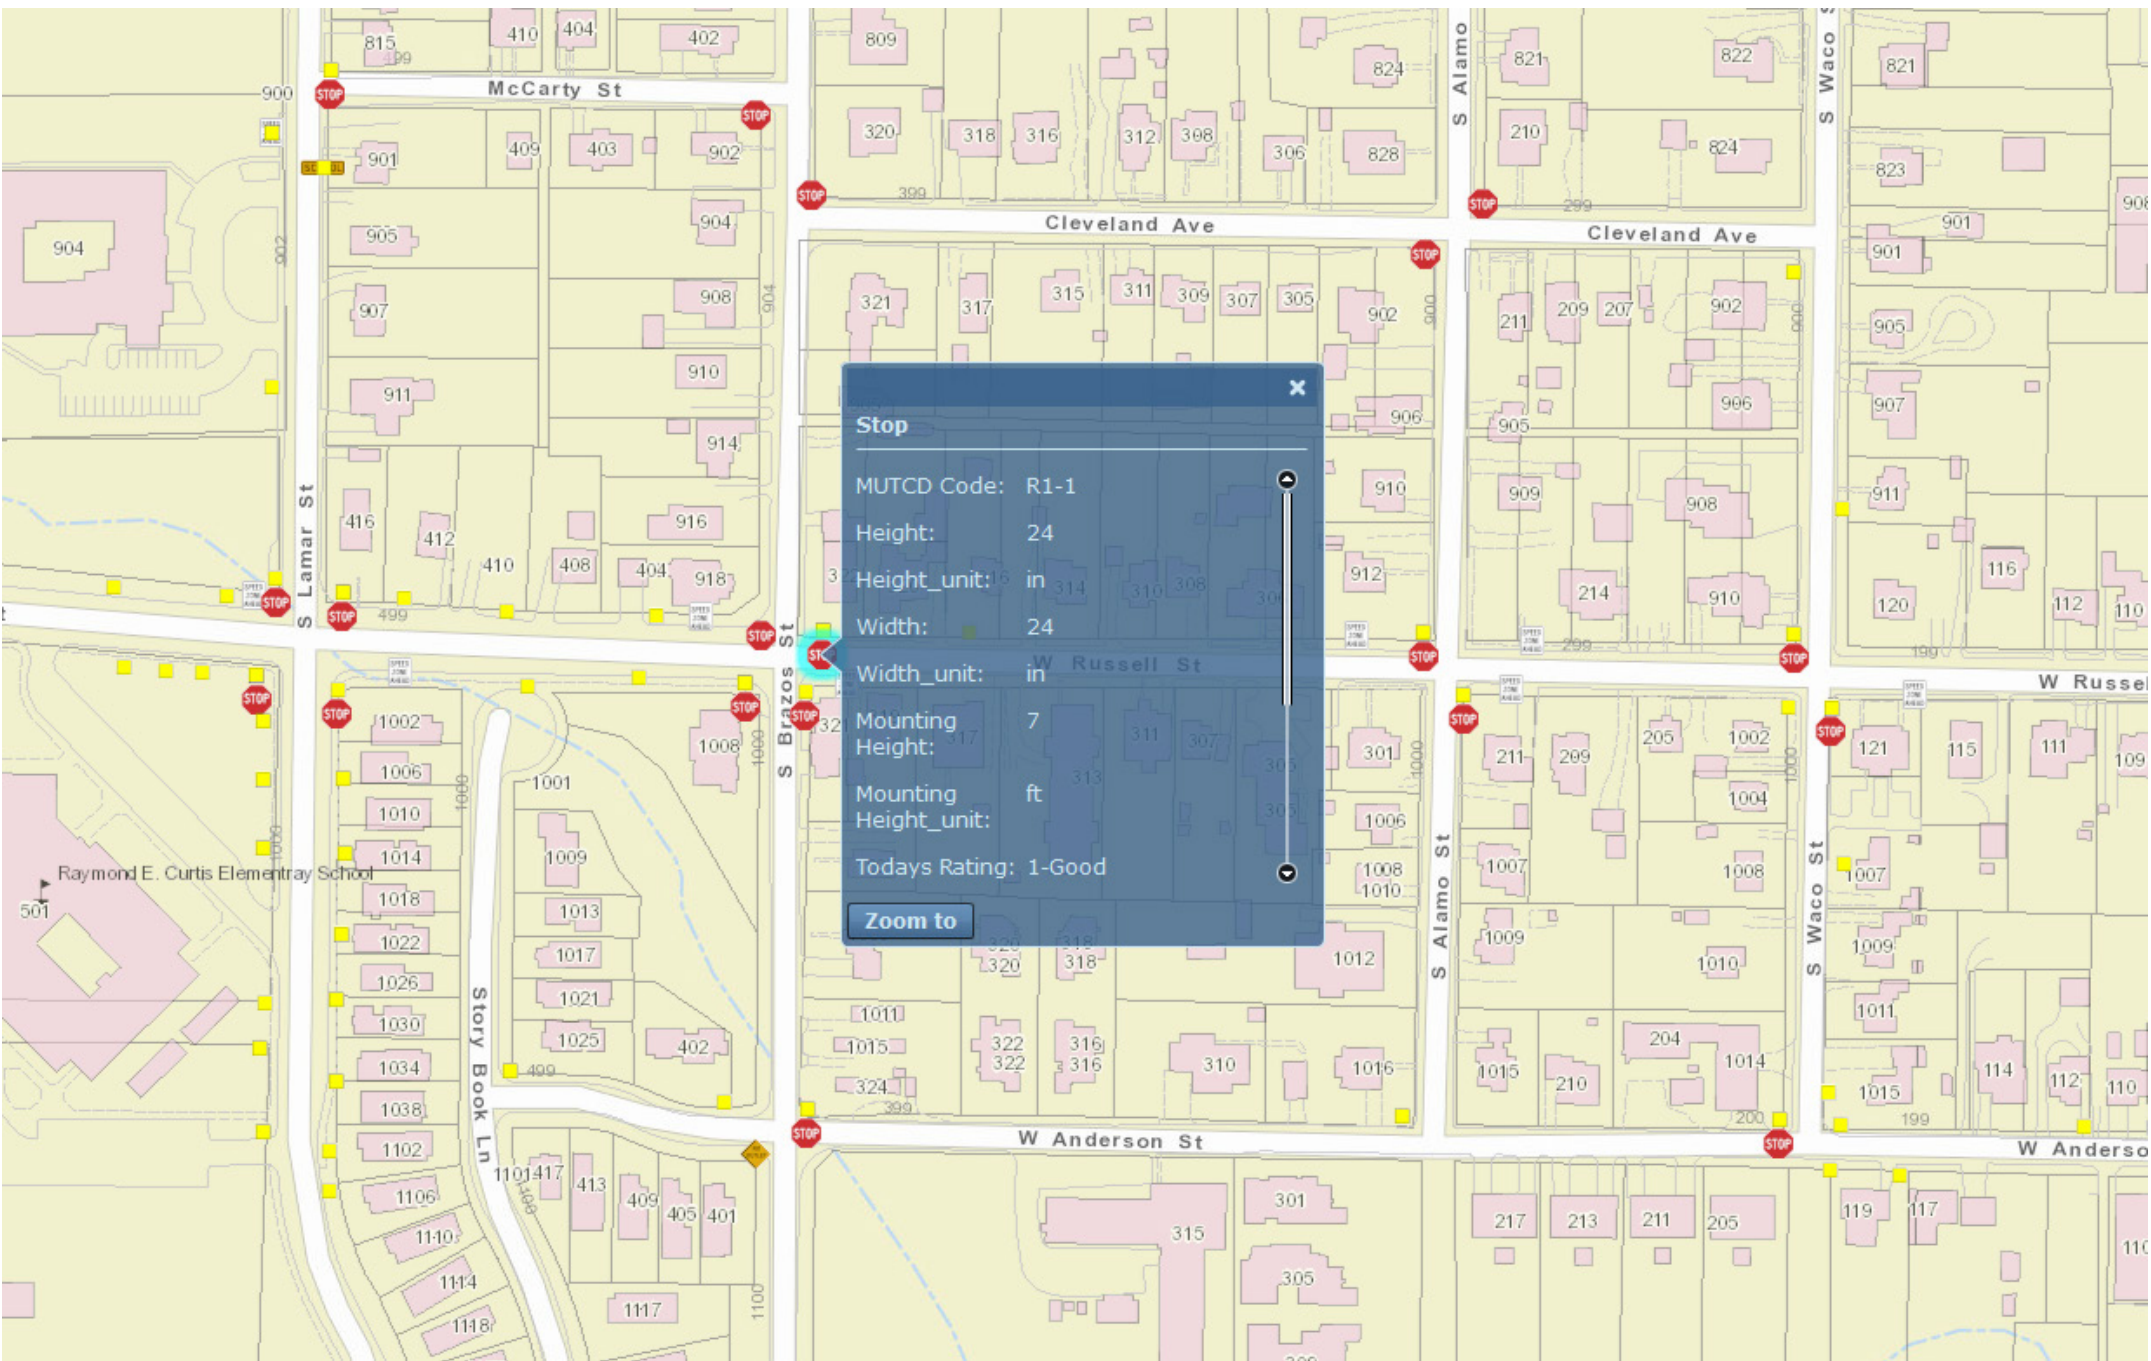
STREET SIGN ASSET INFORMATION

Stop

MUTCD Code: R1-1

Height: 24

Width: 24

Mounting Height: 7

Today's Rating: 1-Good

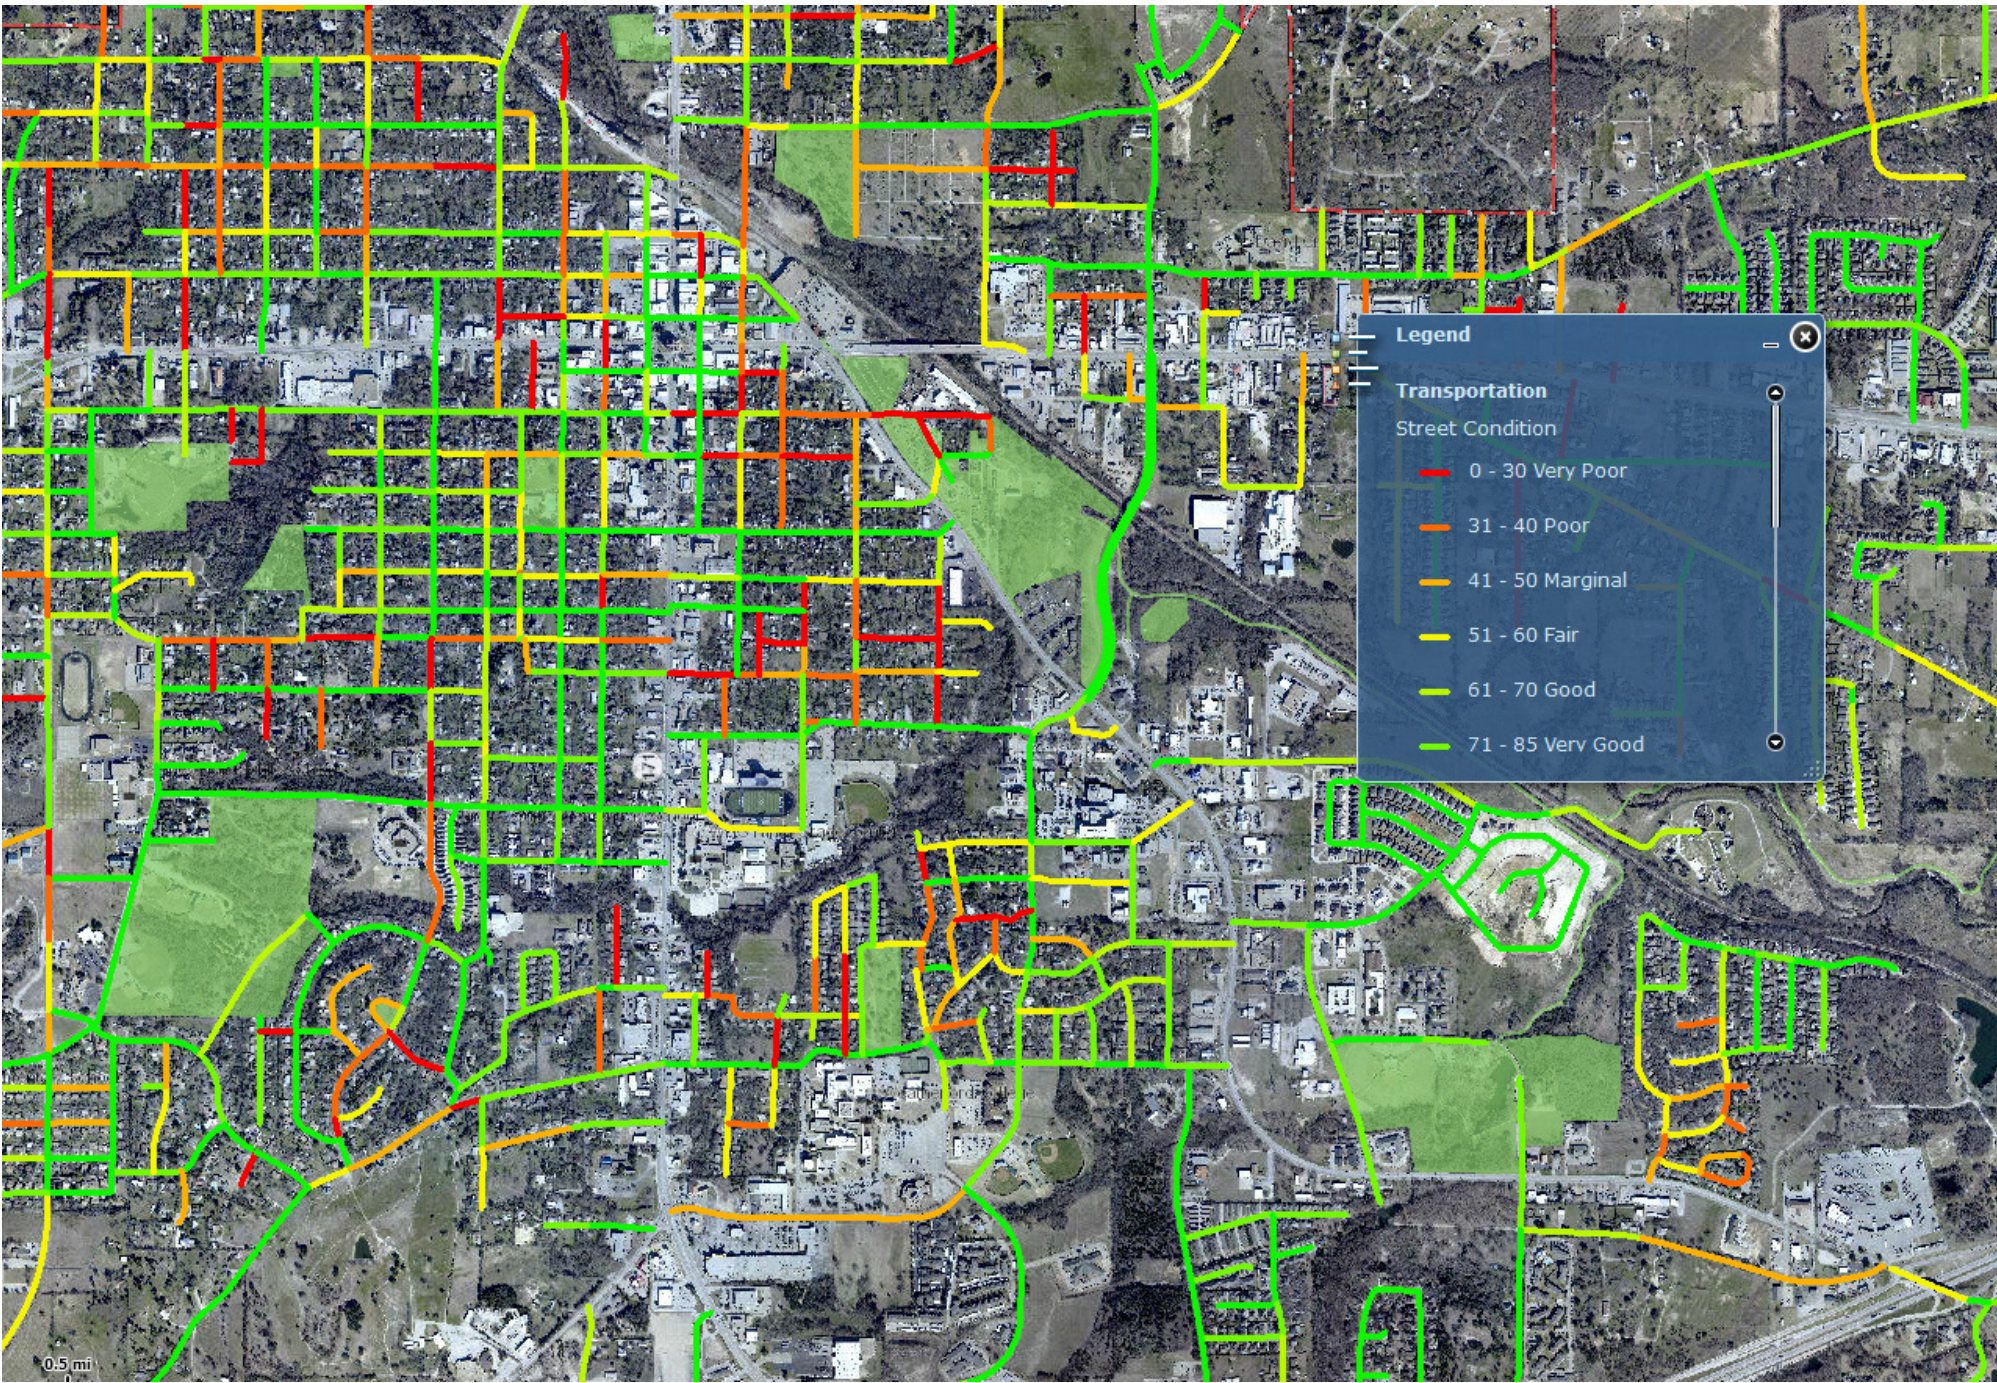
STREET CONDITION

INTRANET
ONLINE
MAPPING

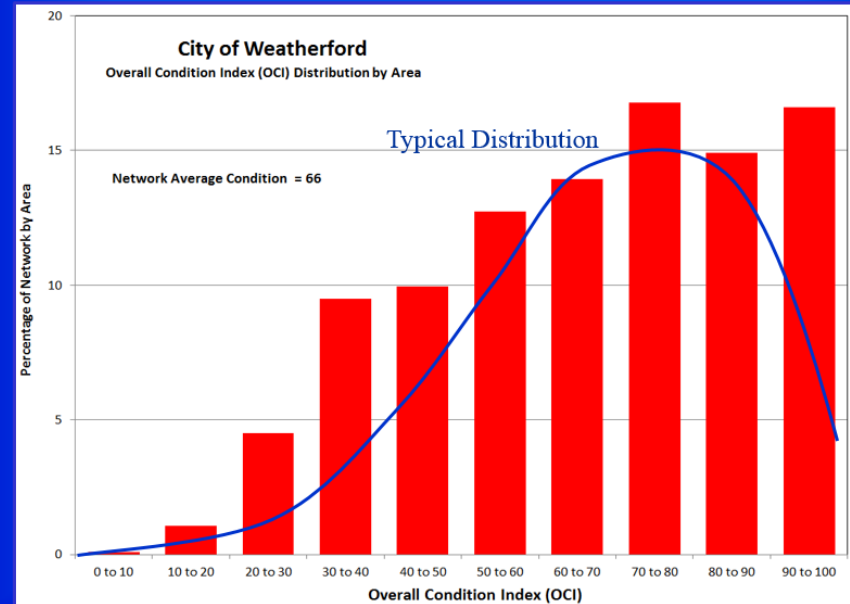
Weatherford OCI Results for 2013....

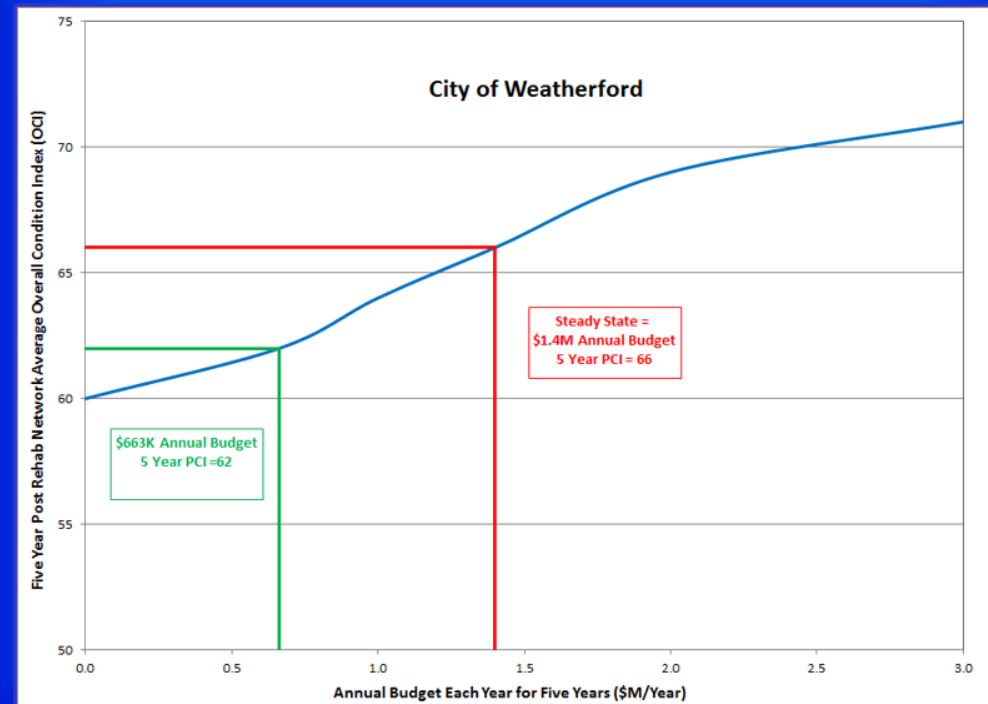
Steady State Budget vs. City's Actual Budget....

1. **Target OCI of 66 and backlog below 15% for entire roadway network.**

This equates to a \$1.4M annual budget

A budget of \$663k is not sufficient .

Results in an OCI of 62 with an increase in backlog

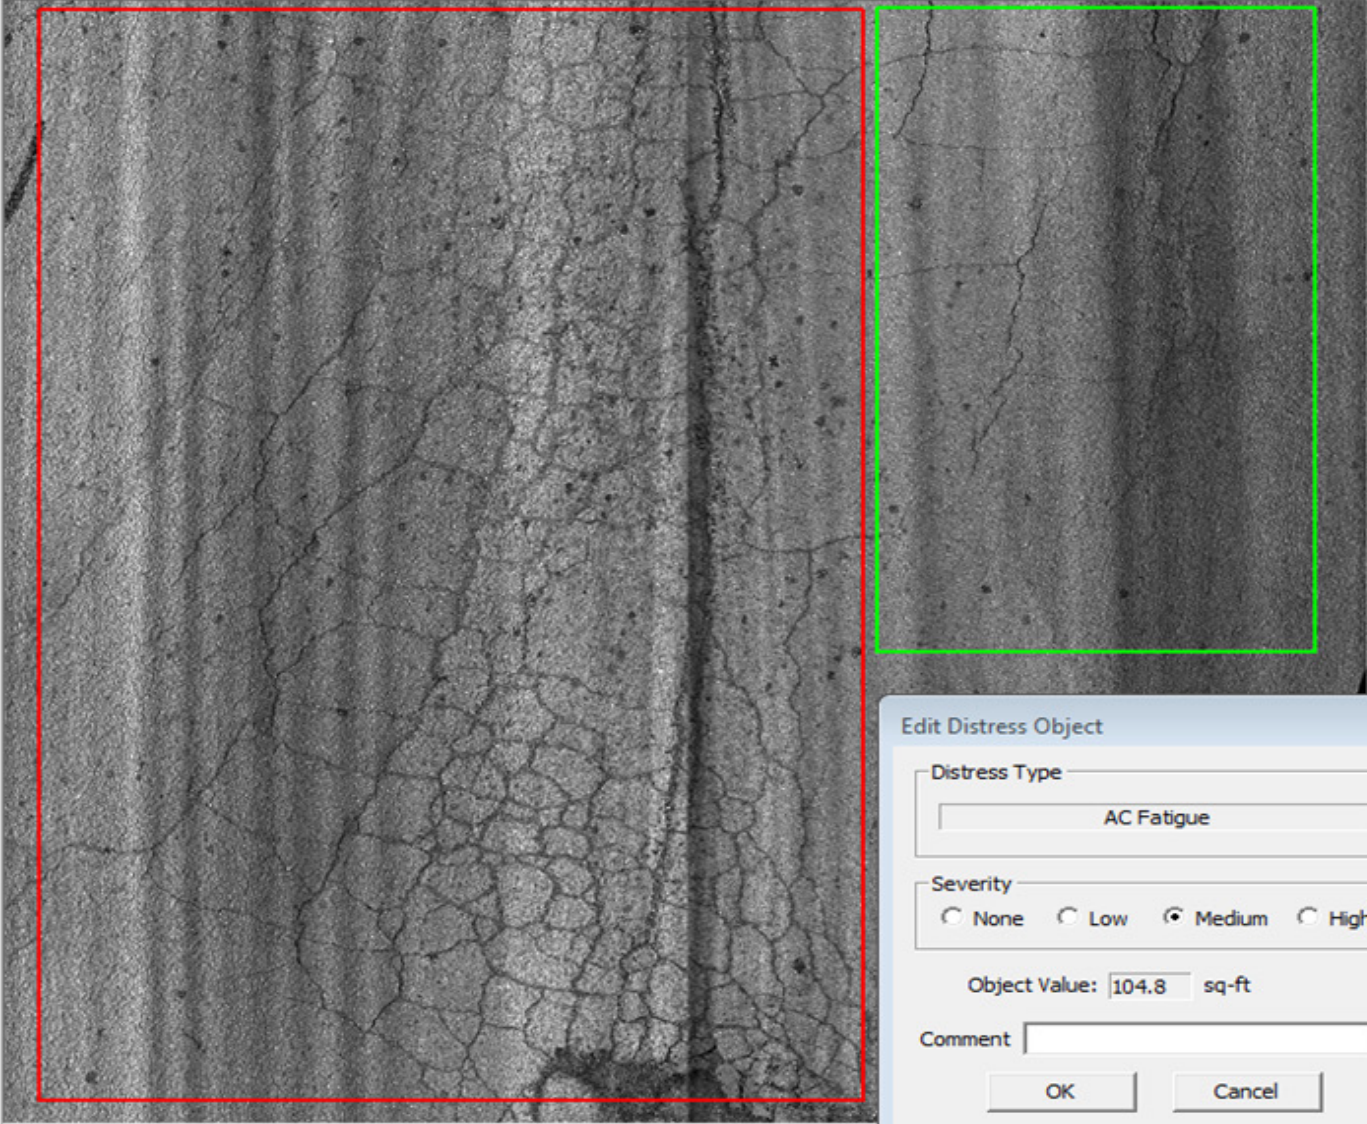
Distress Rating per the ASTM D6433-11

Edit Distress Object

Distress Type

AC Fatigue

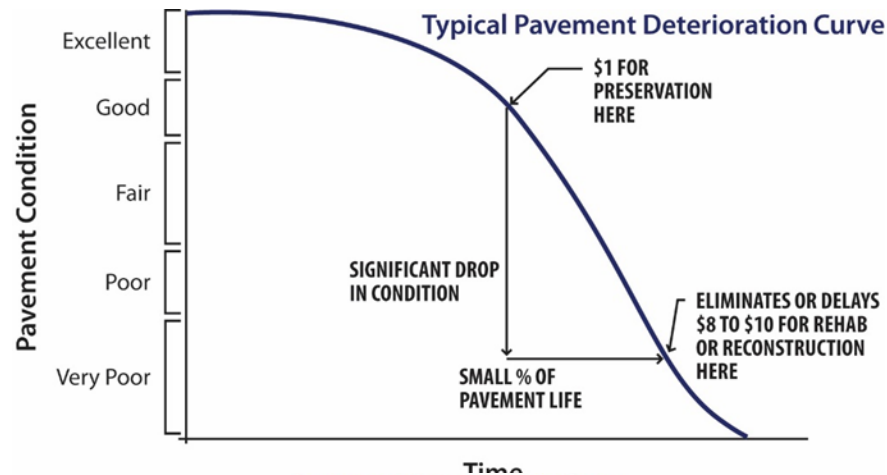
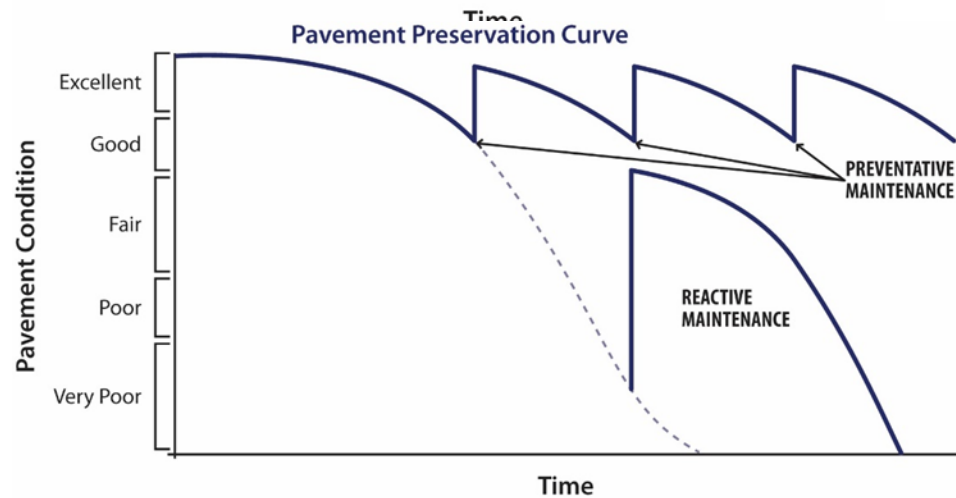
Typical Pavement Deterioration Curve

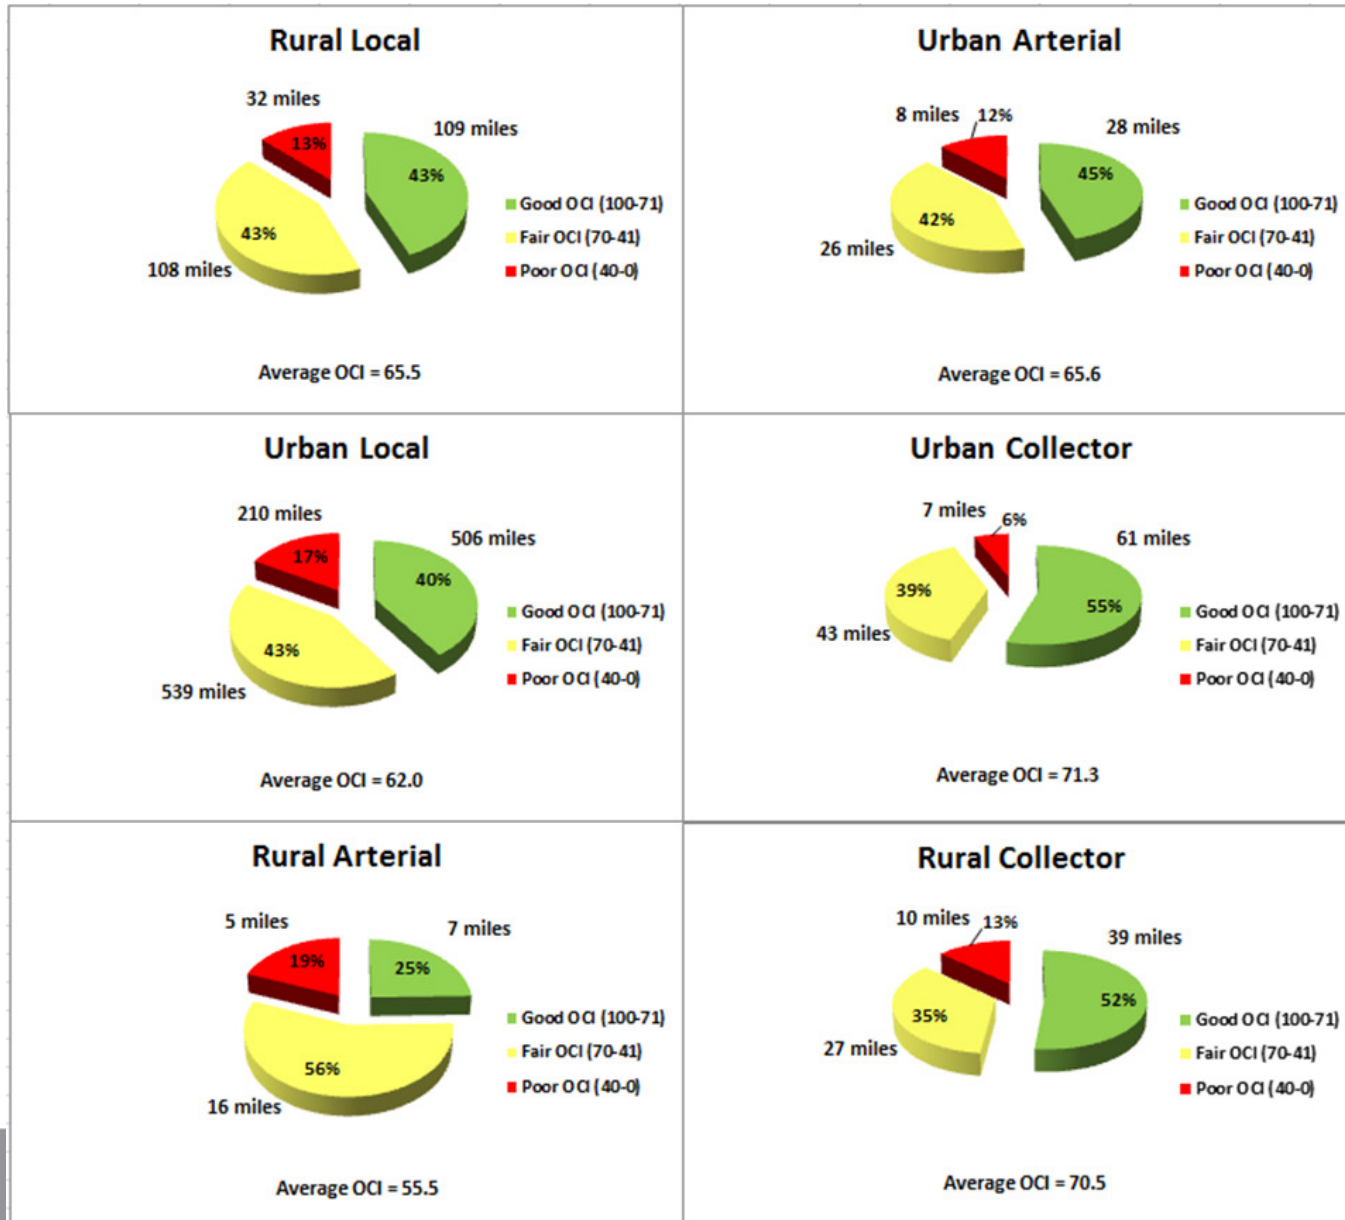
Develop of a Pavement Management Plan
