Asset Management Software Survey

Kori Mullen, NCTCOG

NCTCOG Public Works Roundup

May 9, 2017

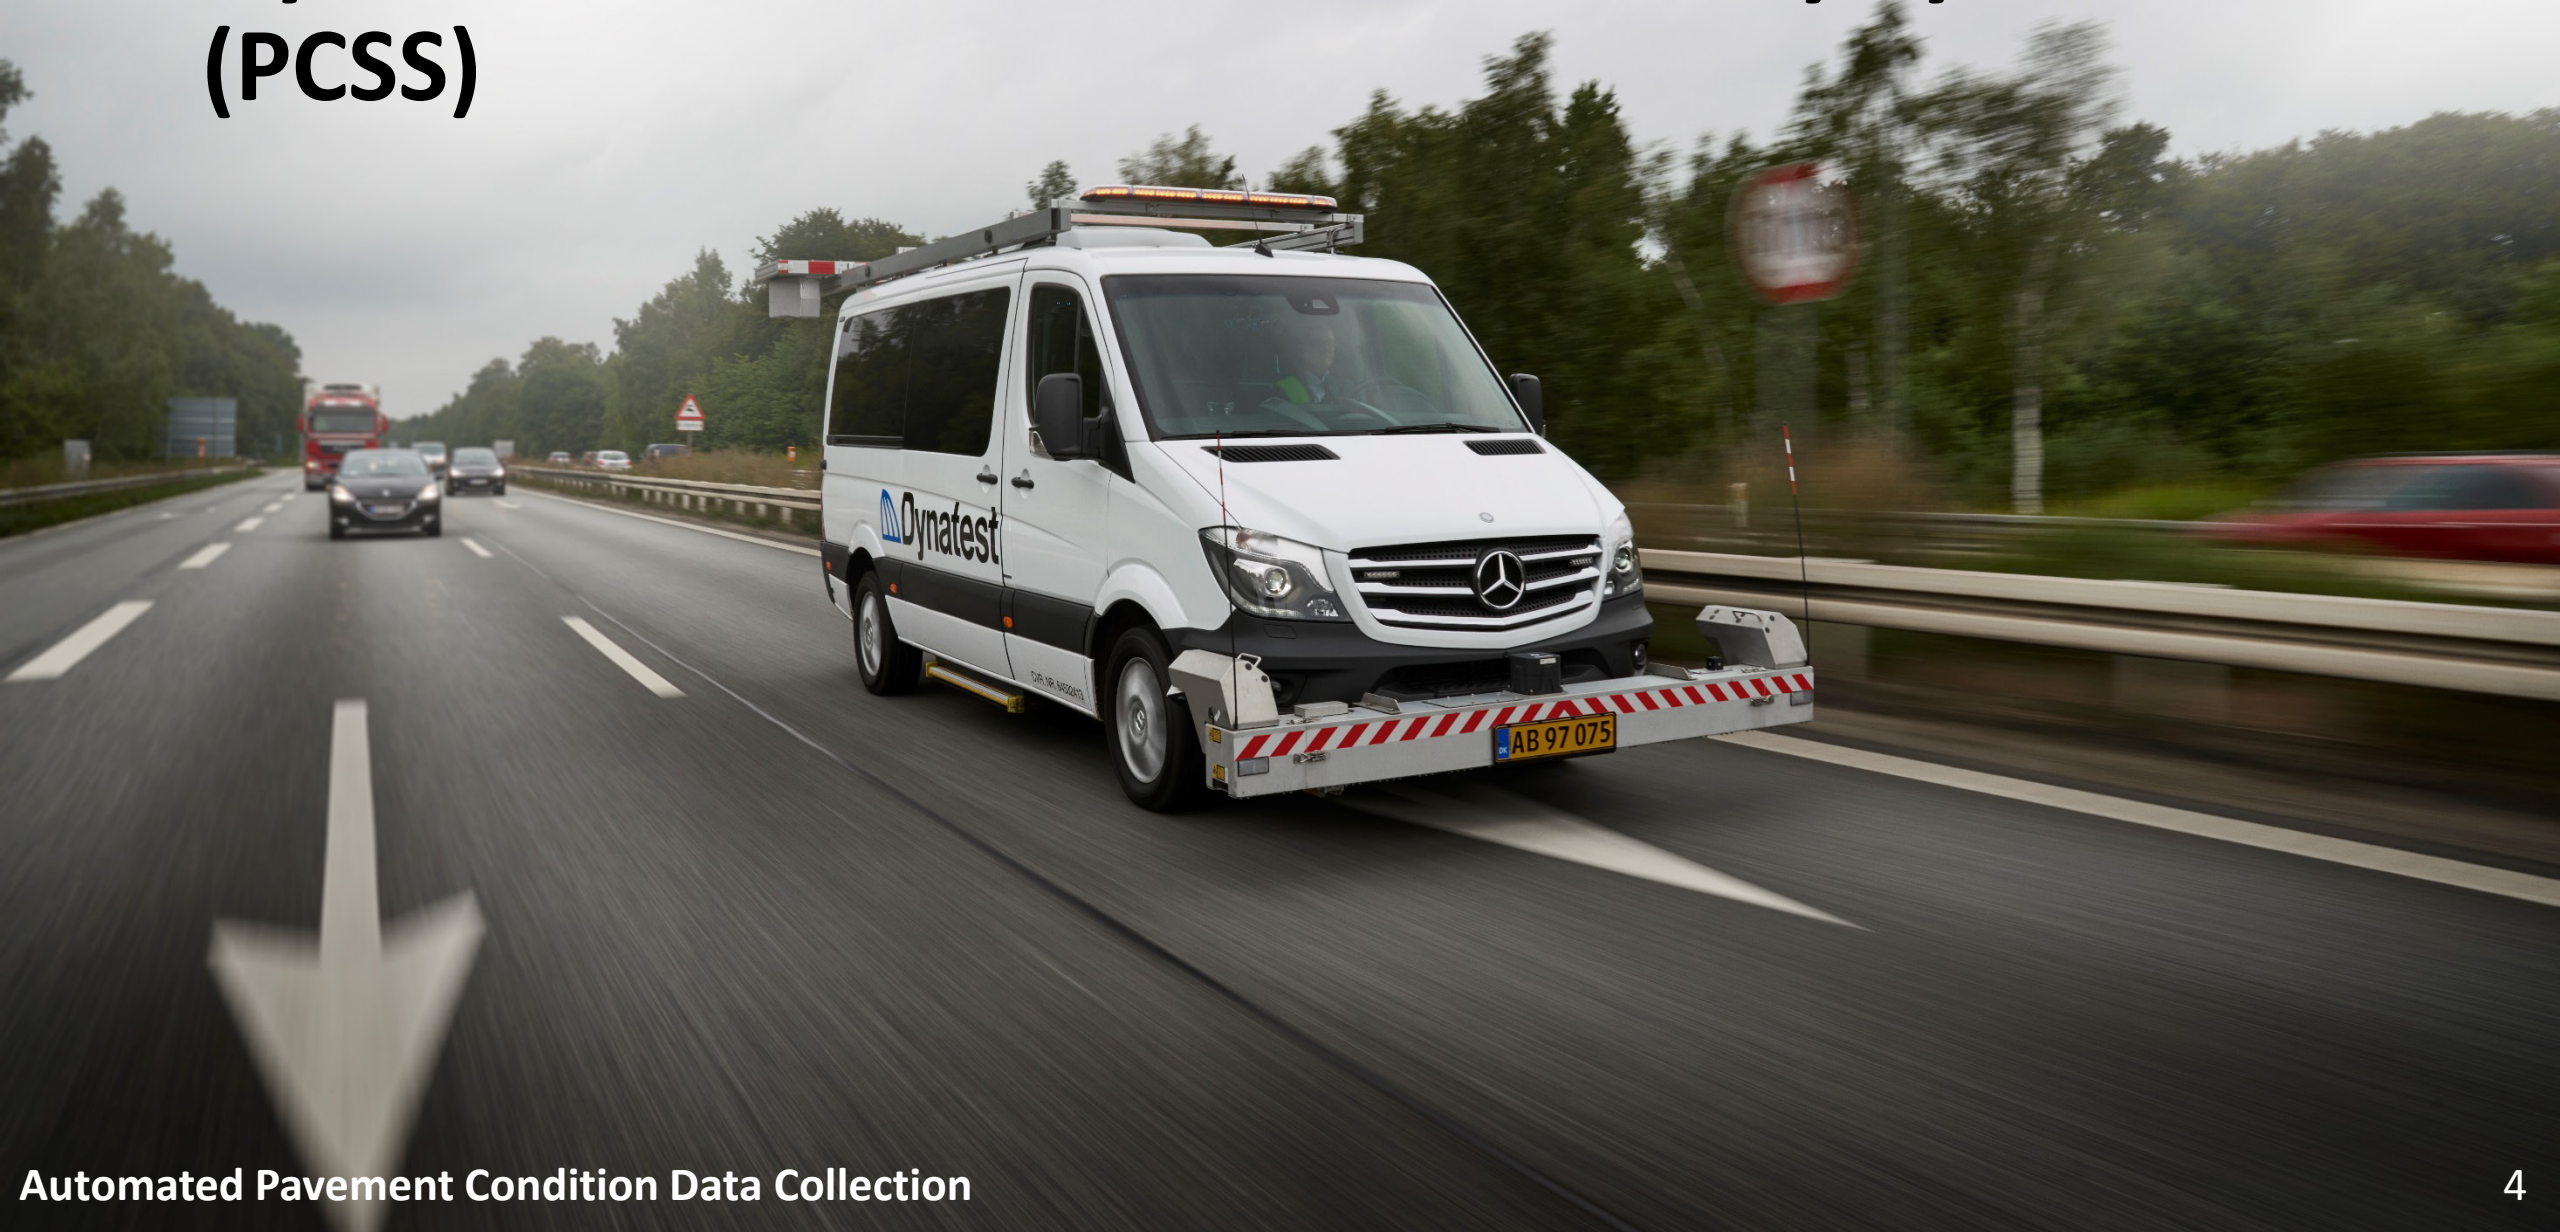
Dynatest Pavement Condition Survey System (PCSS)
