ILLICIT DISCHARGE DETECTION AND ELIMINATION CASE STUDY

CITY OF GRAND PRAIRIE

MARCH 23, 2021

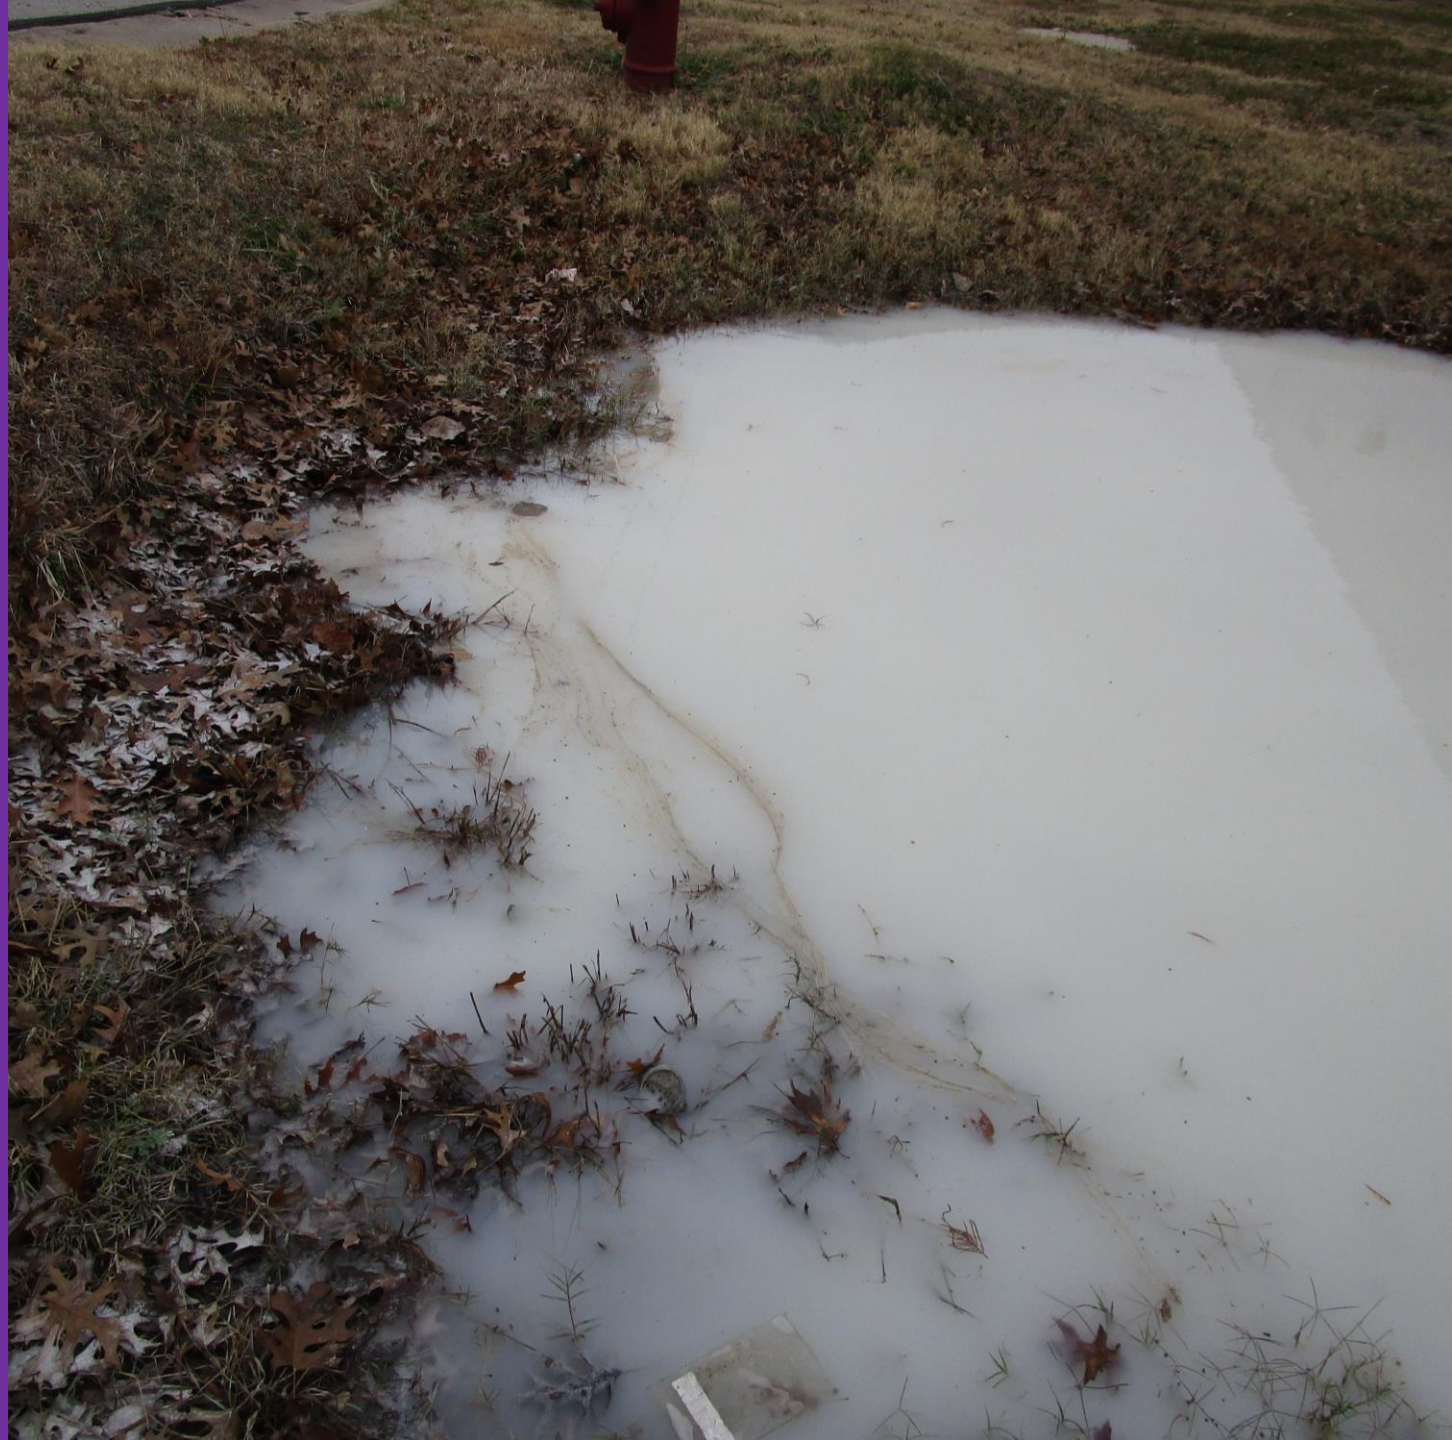
Complaint received- White substance observed in a standing pool of water on the SW corner of the property located at 1174 N Great South West Pkwy.

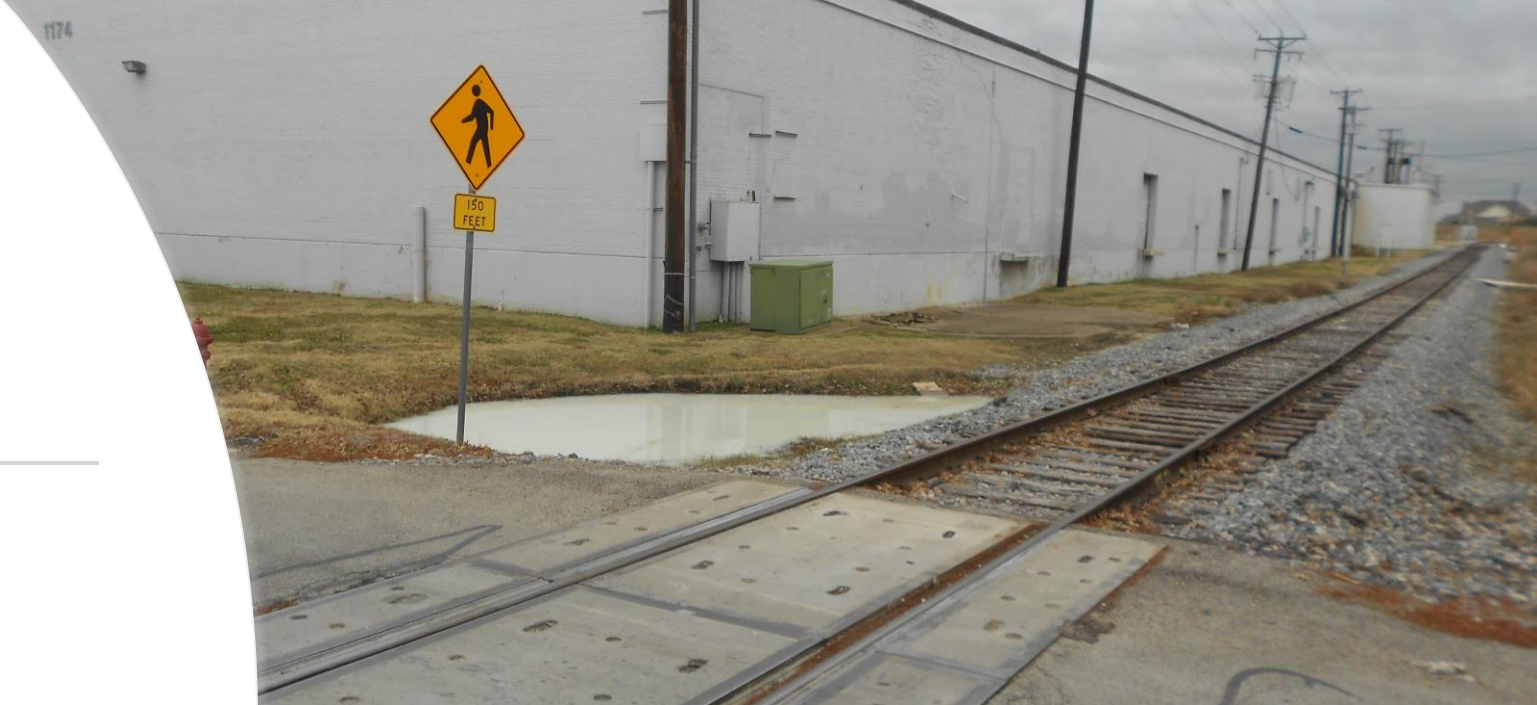
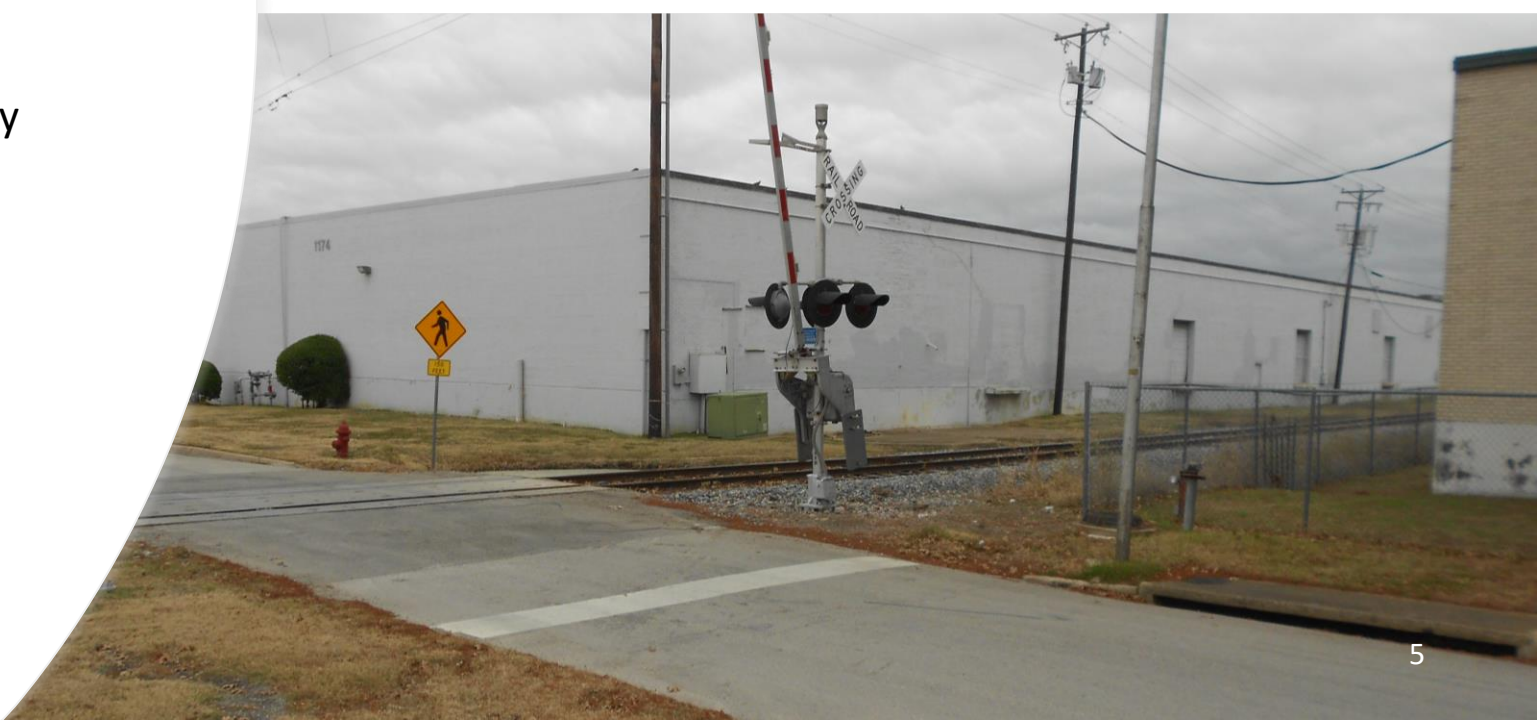
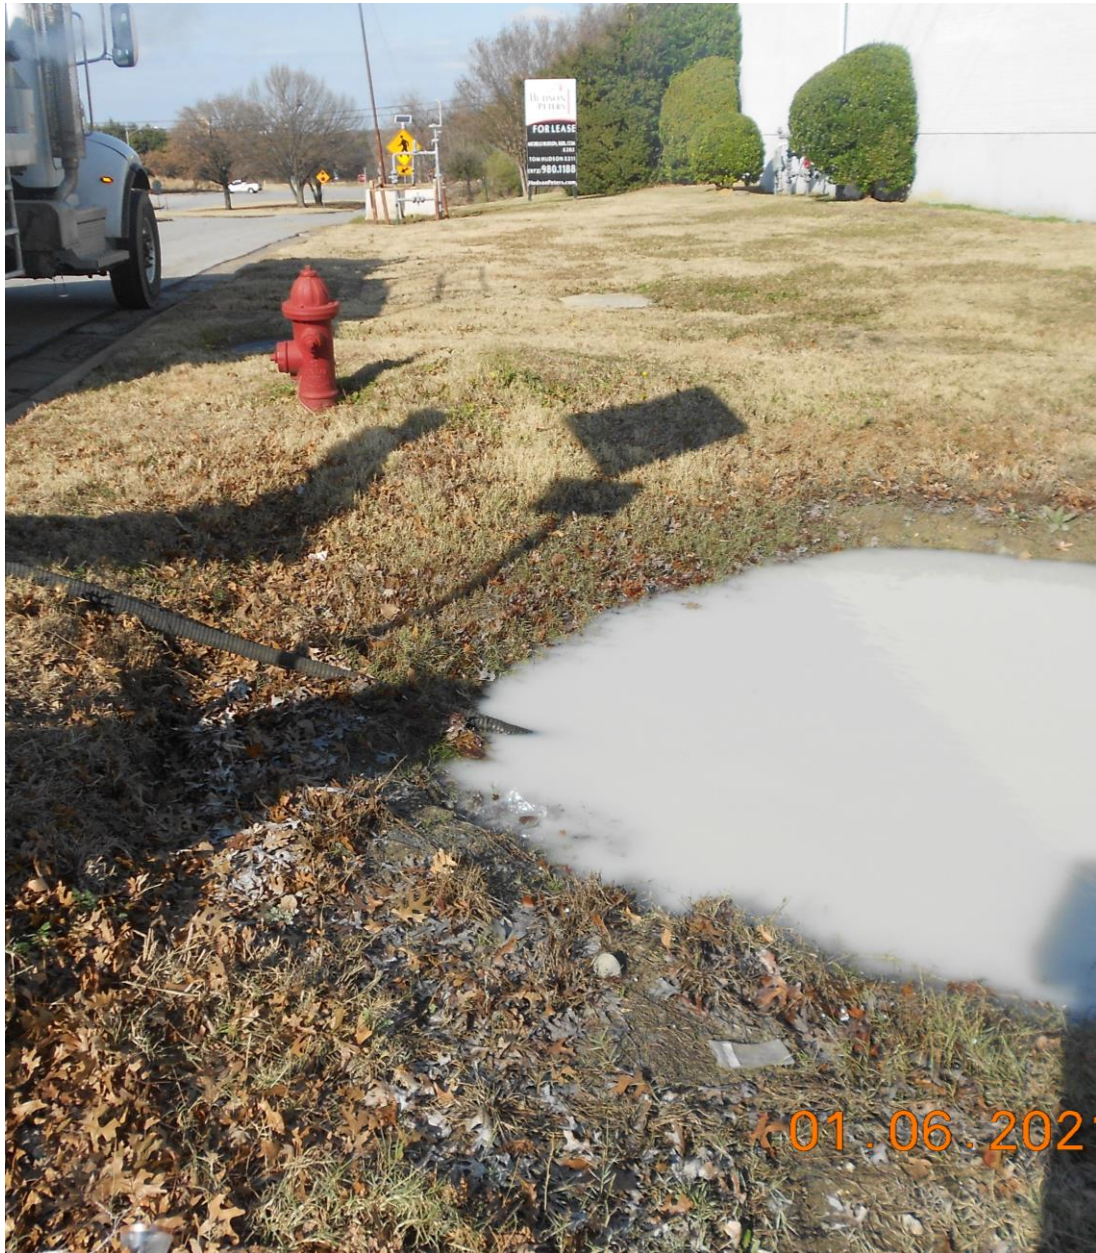
- Shallow standing pool of water.
- Did not overflow to any nearby storm drains.
- Inspected nearby creek (Johnson Creek) for any visible discharge. None was observed.

- Illegal dumping of abandoned paint cans and recent rain filled depression resulting in water contaminated with paint.
- No obvious responsible party.

January 6, 2021: City's Emergency Response contractor (US Ecology) onsite to clean up the white discharge.

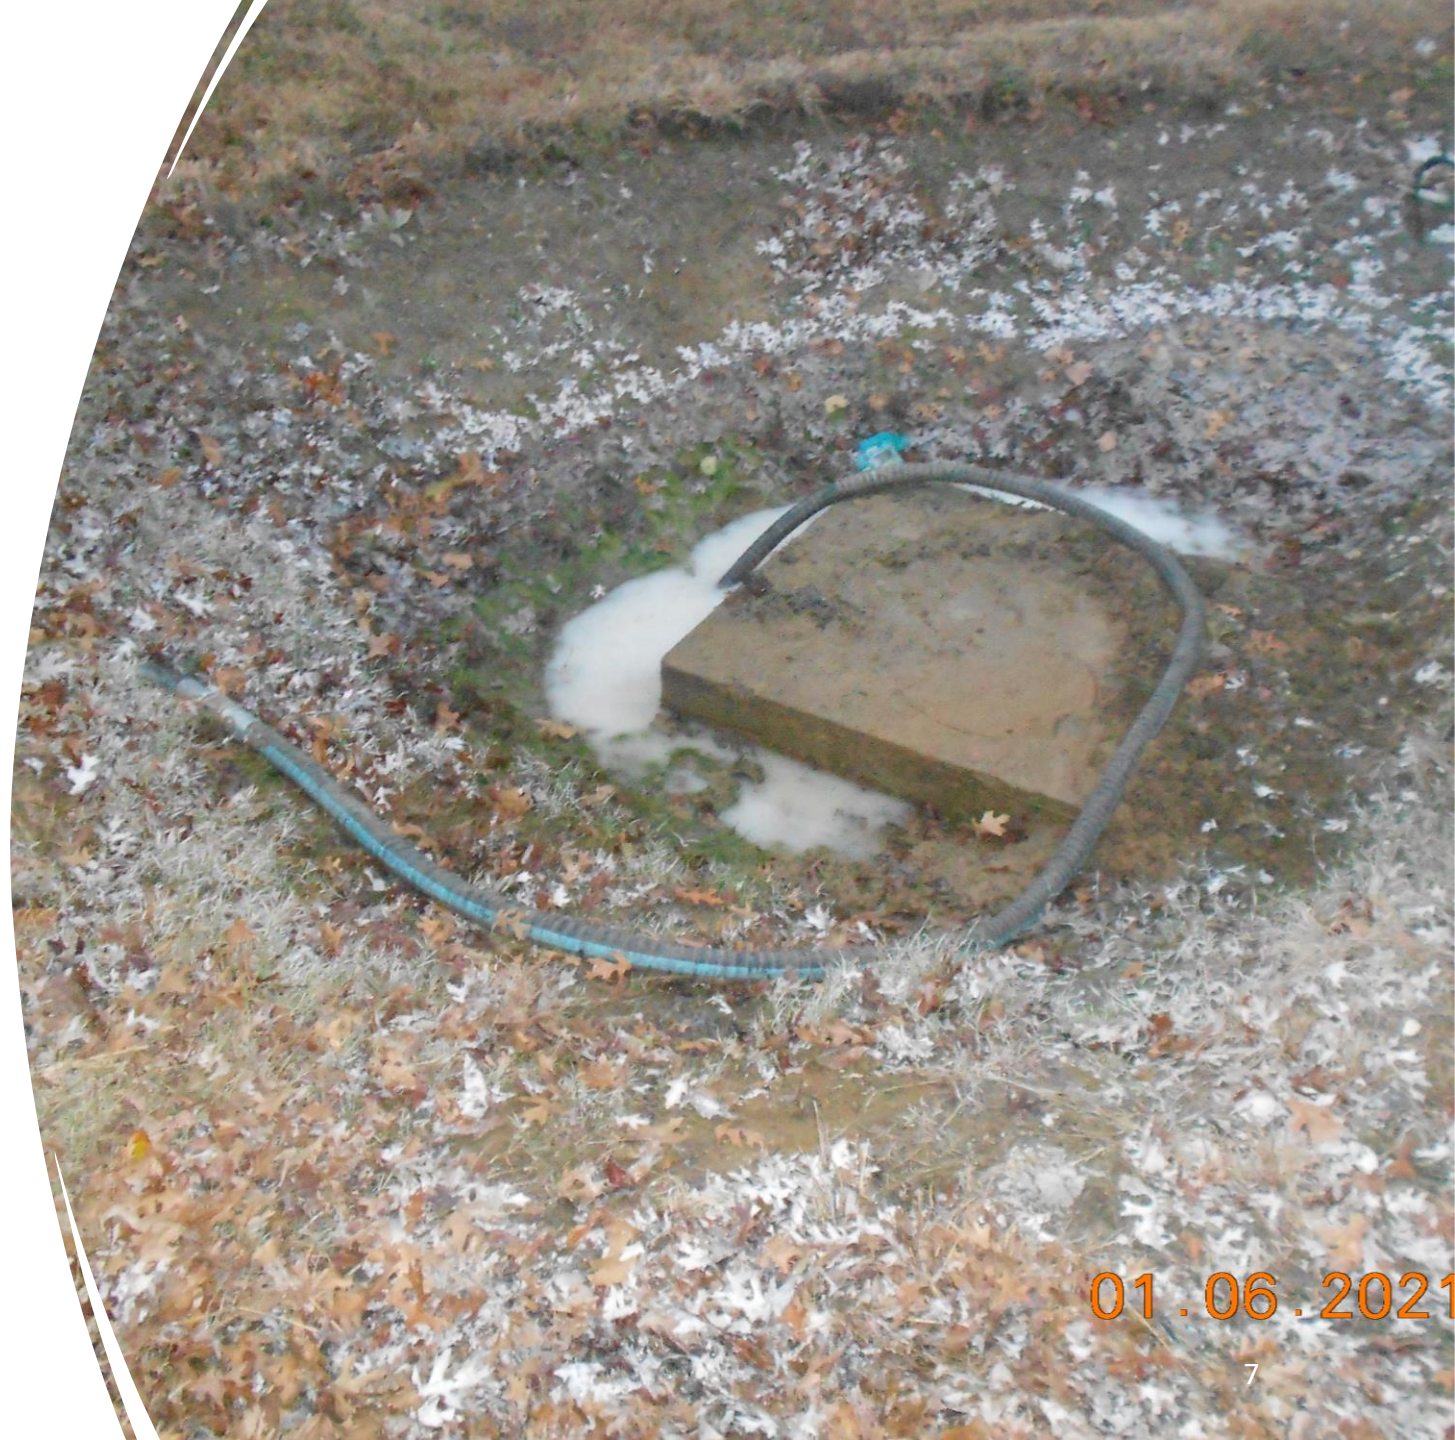
- January 7, 2021: The discharge was continued to be cleaned by the contractor.
- After approximately 4,000 gallons of discharge was collected, a storm drain was observed.
- A sample of the white discharge was collected and sent to lab for enforcement action.

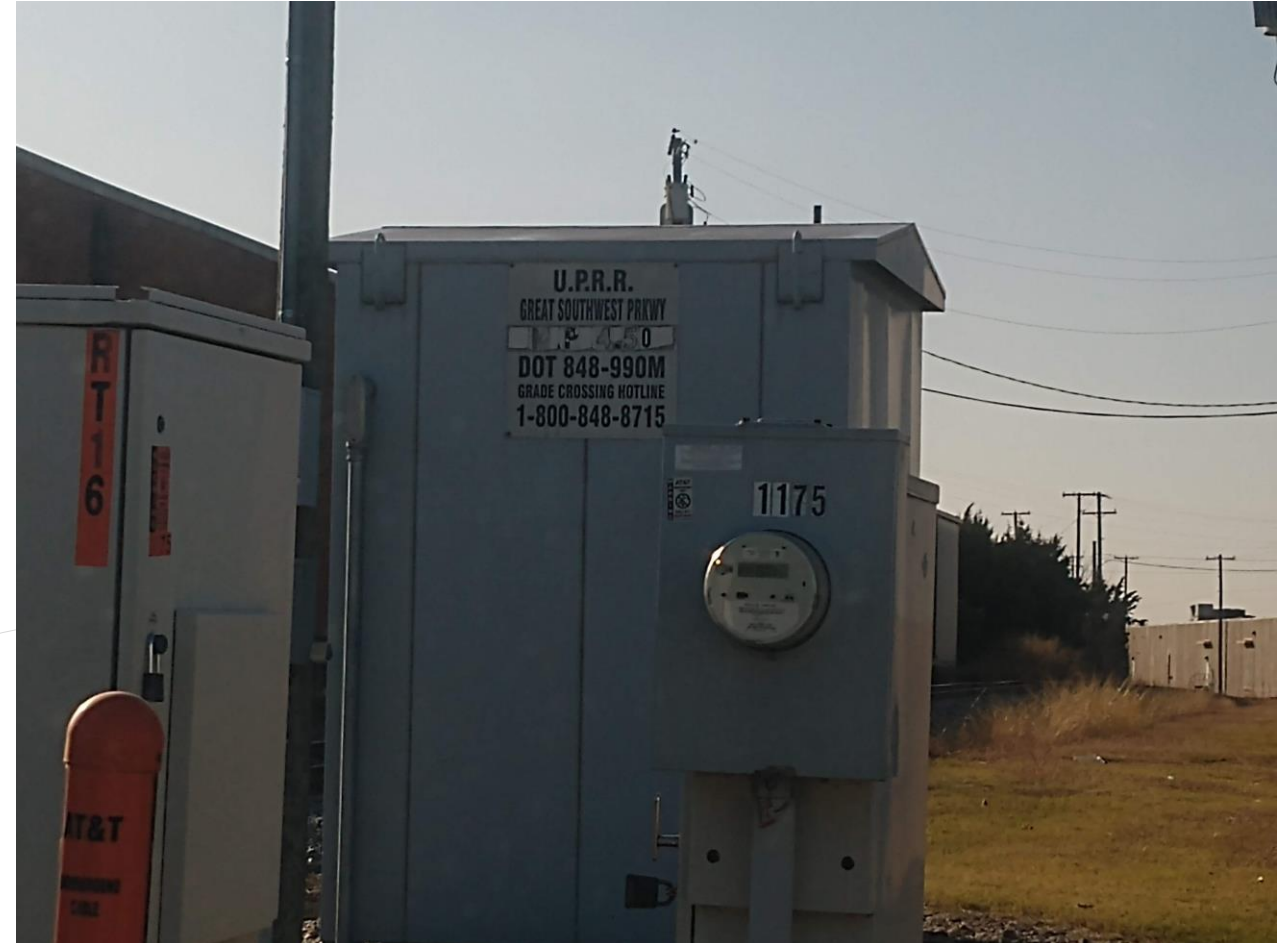
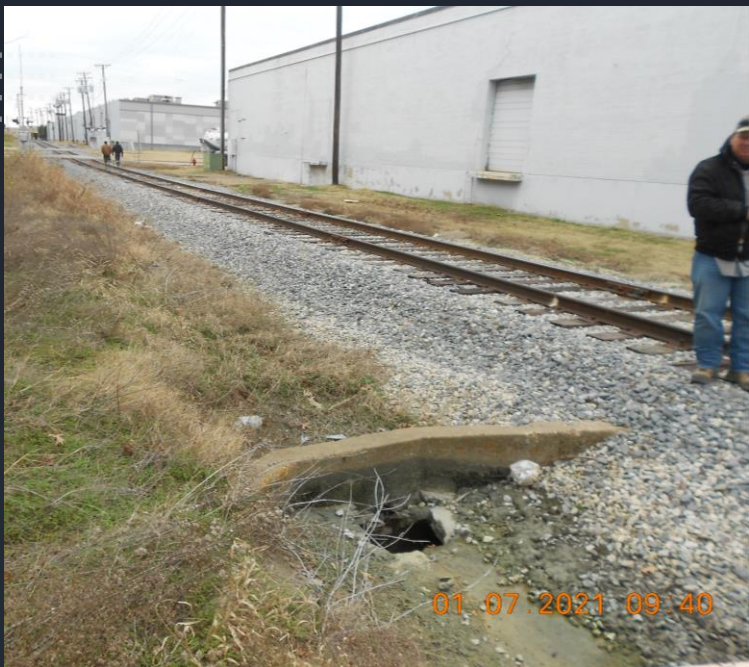
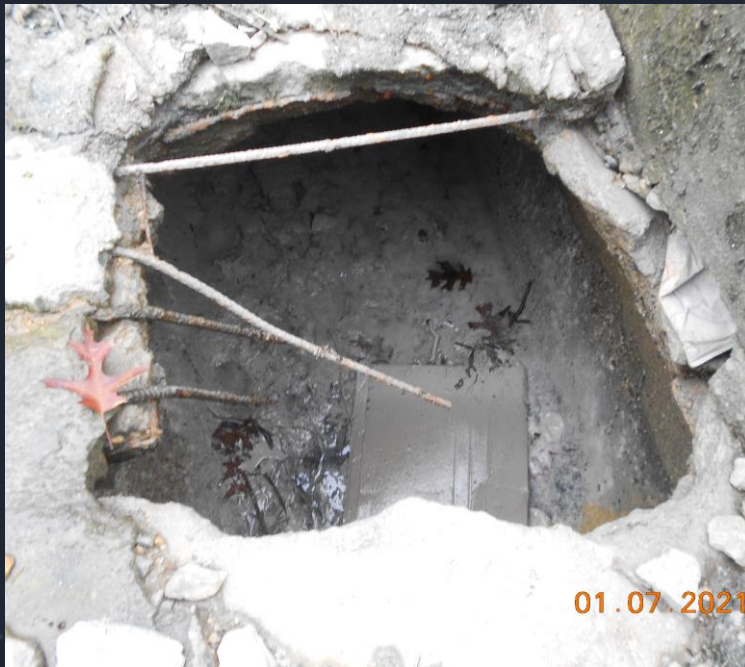
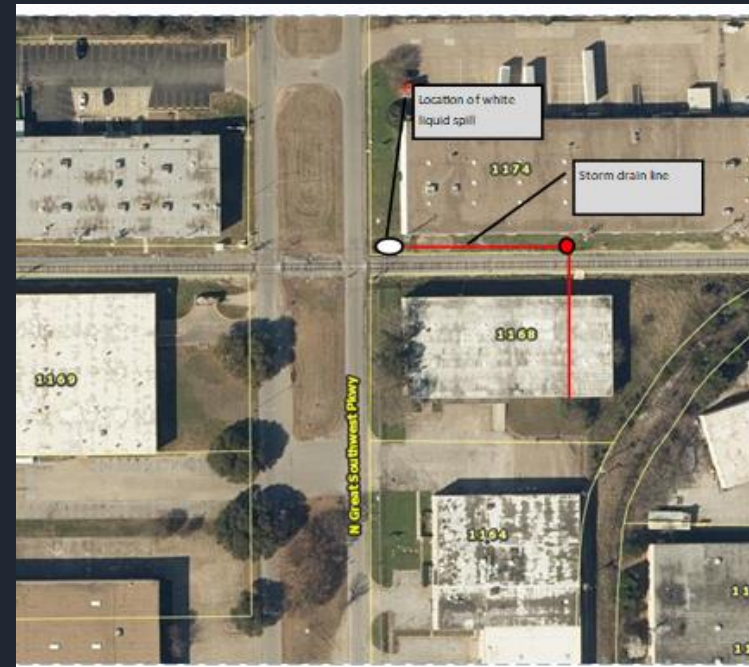
“THE STORM DRAIN”

- Called City of GP Drainage Dept.
 - Not our storm drain
 - Railroad has their own drainage system along tracks
- Informed Union Pacific Railroad about the clogged storm drain.

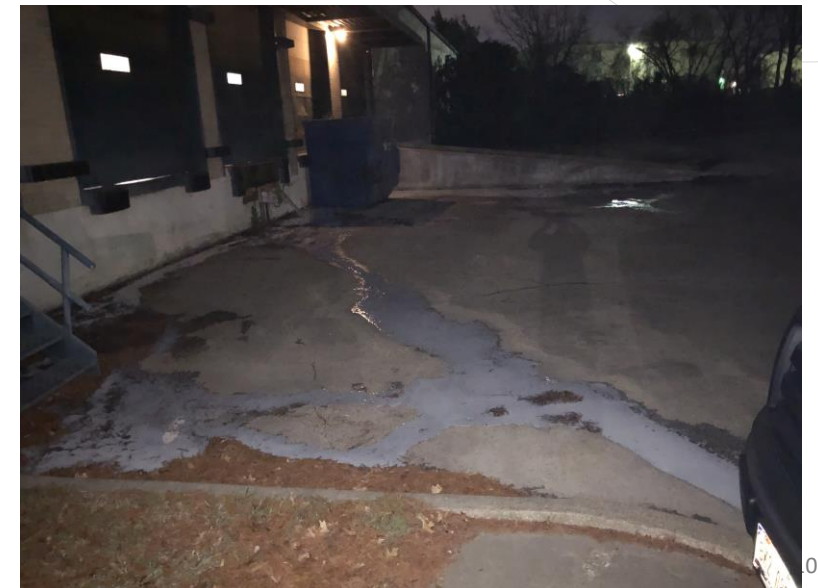
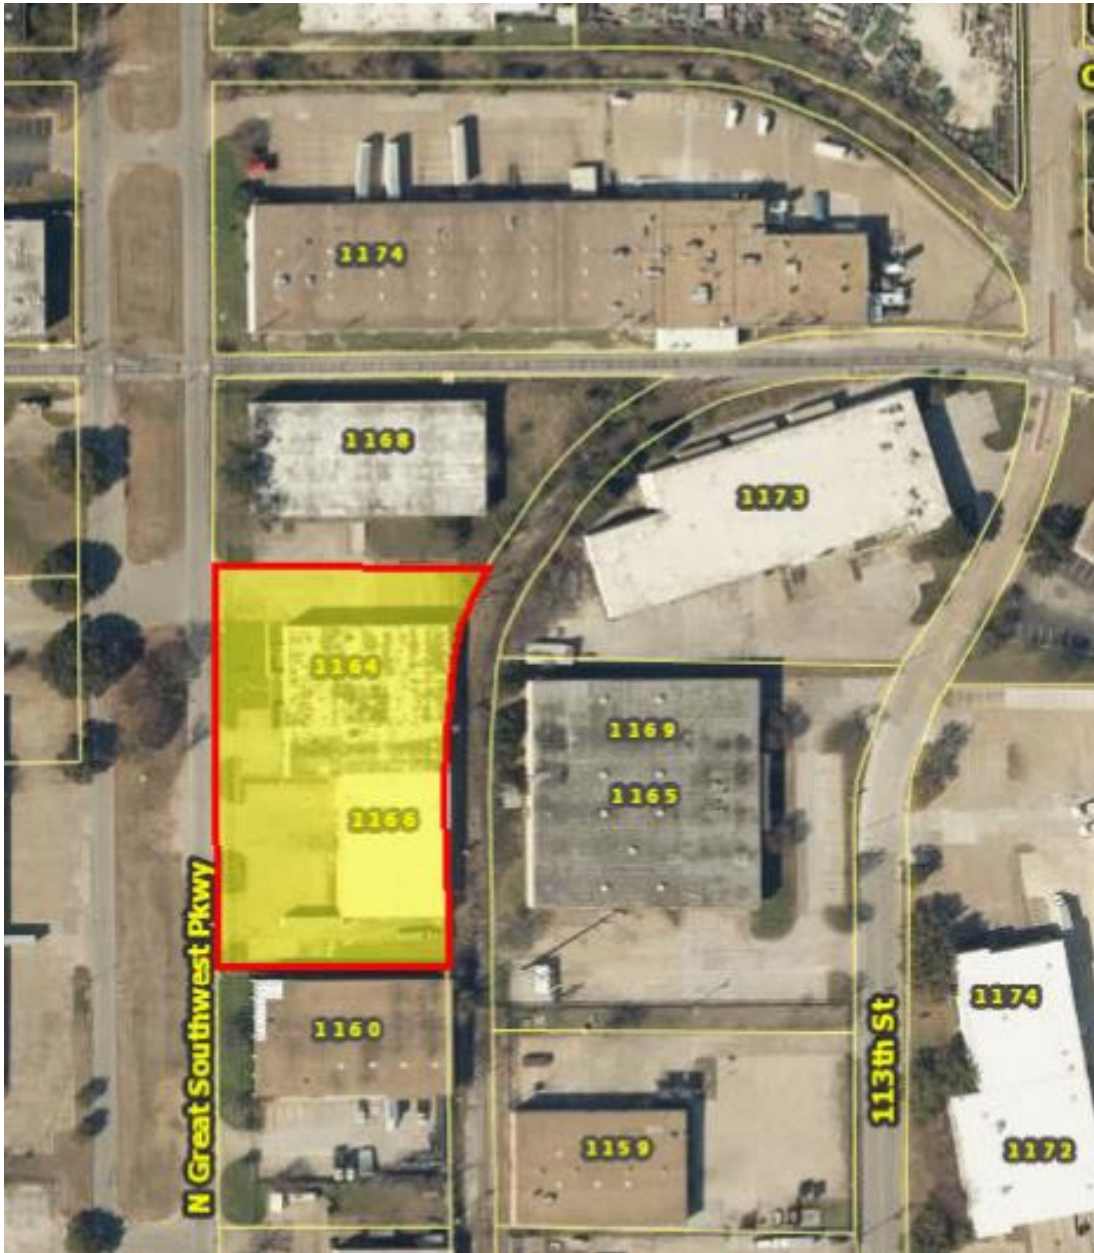
- Interviewed the nearby businesses regarding possible recent spills or system failures.
- Witnesses confirmed sewer overflow had occurred in the early hours of January 4, 2021 with pictures.

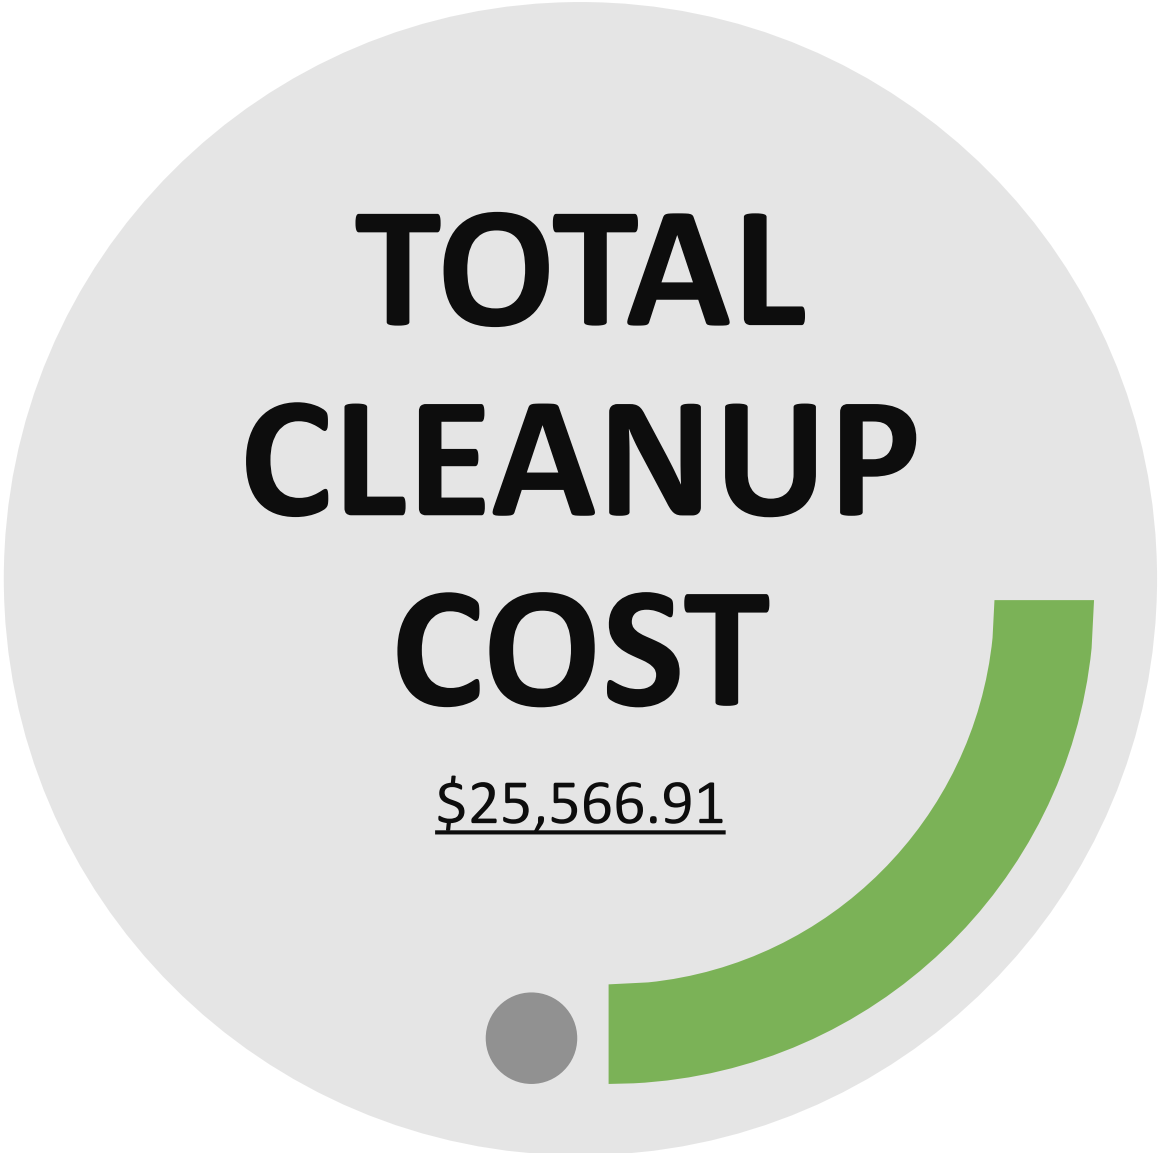
- January 18, 2021: Lab results received confirming Polyvinyl Acetate commonly associated with adhesives was found in the sample.
- According to the chemical list submitted with the Wastewater Discharge Permit Application by “Specialty Adhesives”, polyvinyl acetate is used on site.
- The investigation determined that the material originated from Specialty Adhesives located at 1164 N. Great Southwest .
 - ❑ Citation was issued for failure to clean up the spill.
 - ❑ Held responsible for reimbursement for funds incurred during this incident in accordance with City’s Ordinance.
