RCC (Roller Compacted Concrete) use for Residential Roadways

Travis Attanasio, PE, CFM

NEW INNOVATIONS VS. TRADITIONAL METHODS

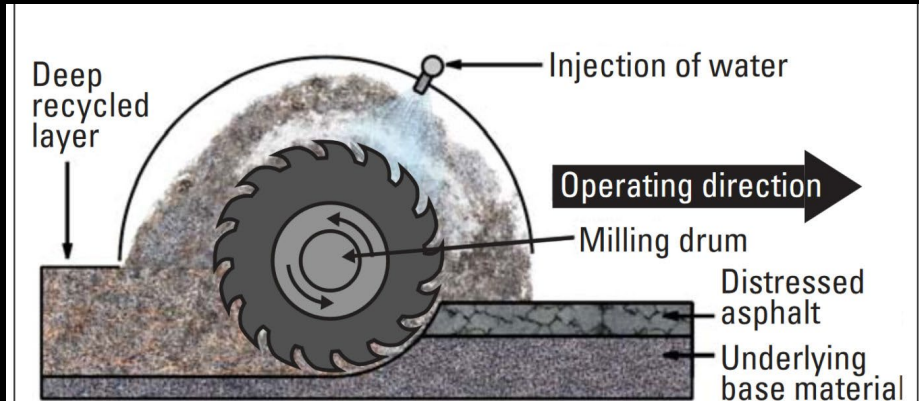
STAGE 1: FULL DEPTH RECLAMATION

- Existing pavement is pulverized and mixed with existing subgrade
- Material is graded to desired elevation and shape
- Cement stabilization mixtures are spread on top of material
- Normal traffic can return to surface at this point prior to final pavement placement
- Recycles existing materials
- TxDOT tested and approved method

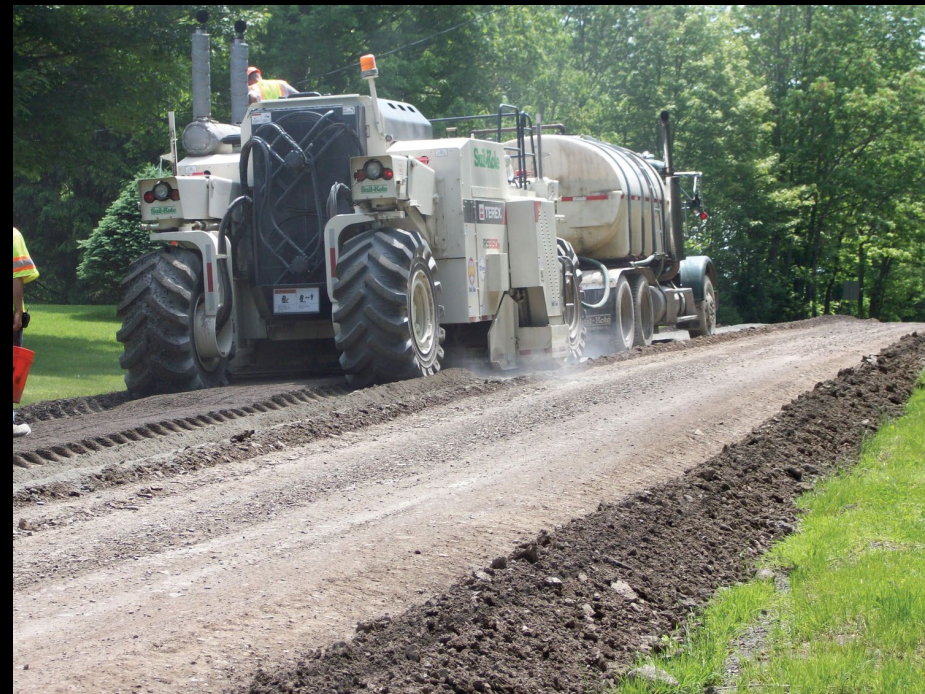
STAGE 2: ROLLER COMPACTED CONCRETE

- A continuous supply of RCC material is placed in the paving machinery
- Placed directly on FDR
- Does not contain steel reinforcement
- Strong dense durable material
- Fast construction cycle (No forms or finishing)
- No costly steel and minimum labor

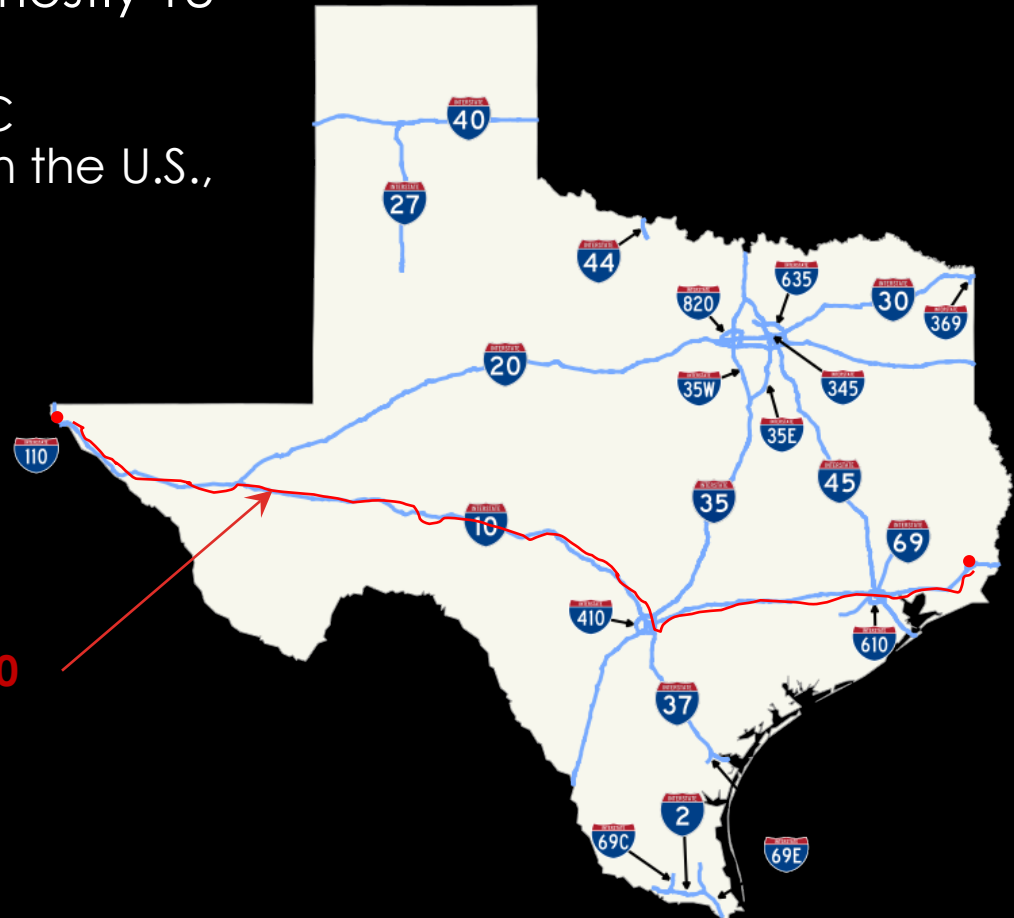
PORT OF HOUSTON

- By 2025, Port of Houston will have 415 acres (2M sq yds) of mostly 18" RCC
 - Collectively, largest RCC pavement installations in the U.S., maybe world

Equivalent to a 6" thick single-lane RCC road that parallels I-10 from Beaumont to El Paso

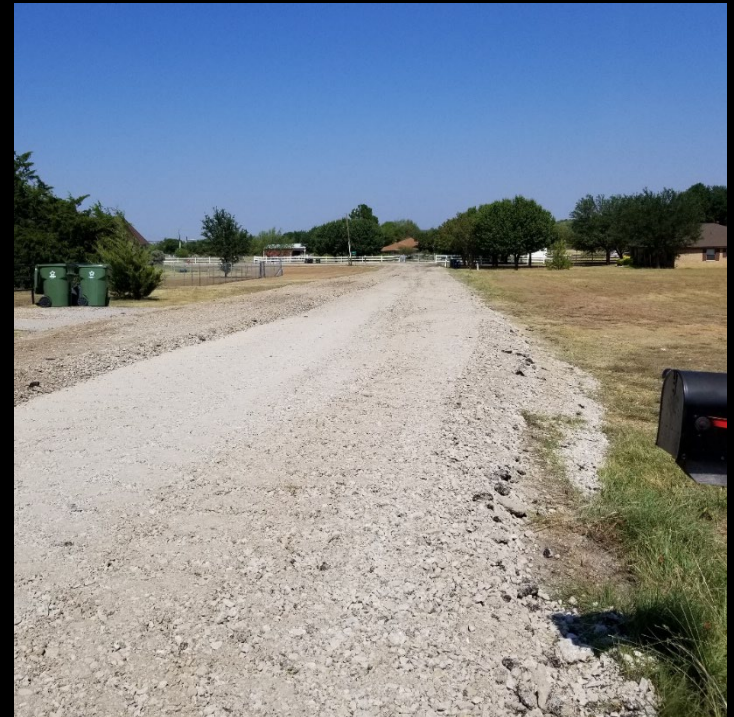
WHAT DID THIS MONTH- LONG DELAY DO?

Average temperature:

June 79.0°

July 88.8°

Max temperature:

June 101°

July 109°

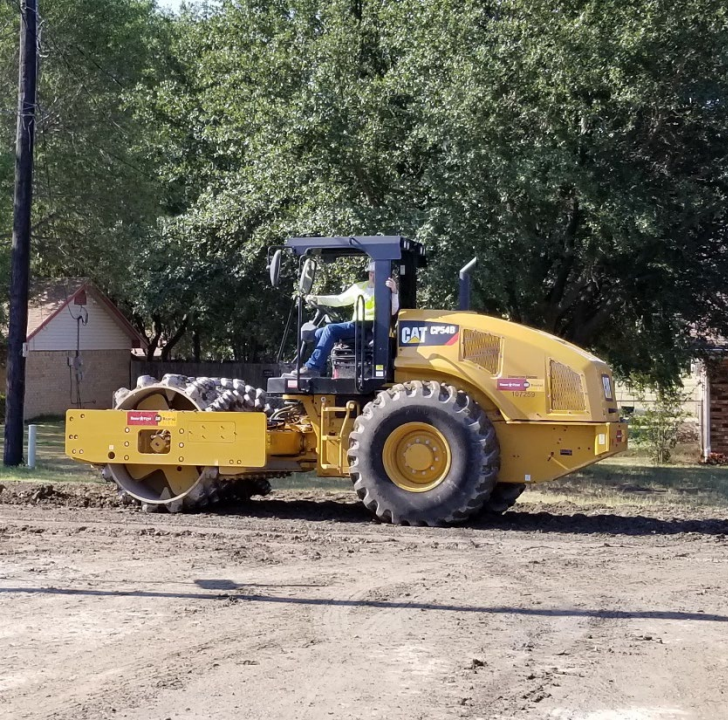
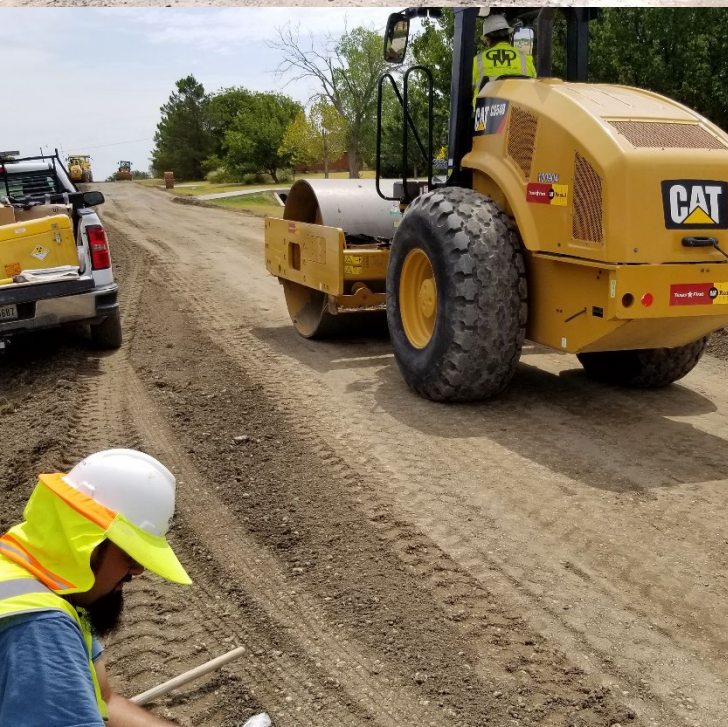
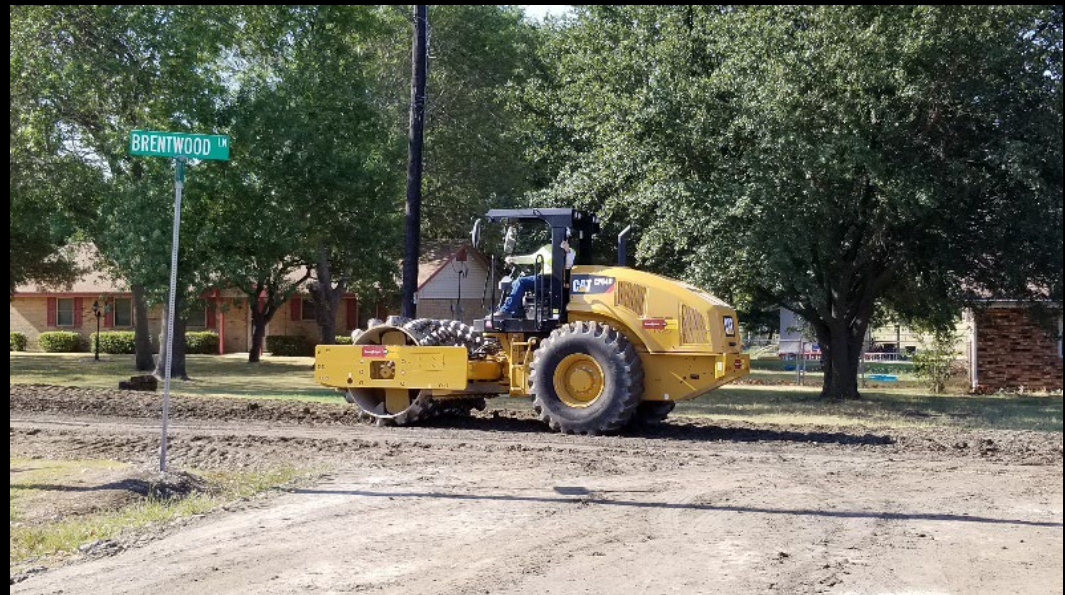
VIBRATORY ROLLERS

Council was briefed that the vibratory rollers were a normal part of road building and that if the base of the road was not solid it could cause premature failures

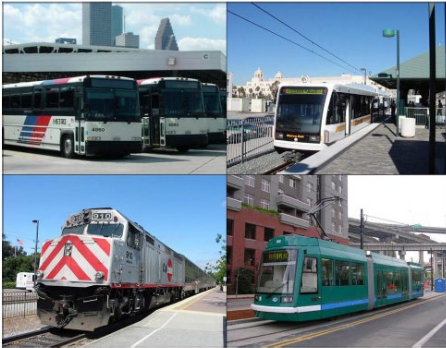
TRANSIT NOISE AND VIBRATION IMPACT ASSESSMENT

- City Engineer had to become educated very quickly
- First question...How do vibratory rollers work? What the wave looked like underground? What was a reasonable level of vibration vs. what could cause damage?
- Luckily, the issue had been researched extensively

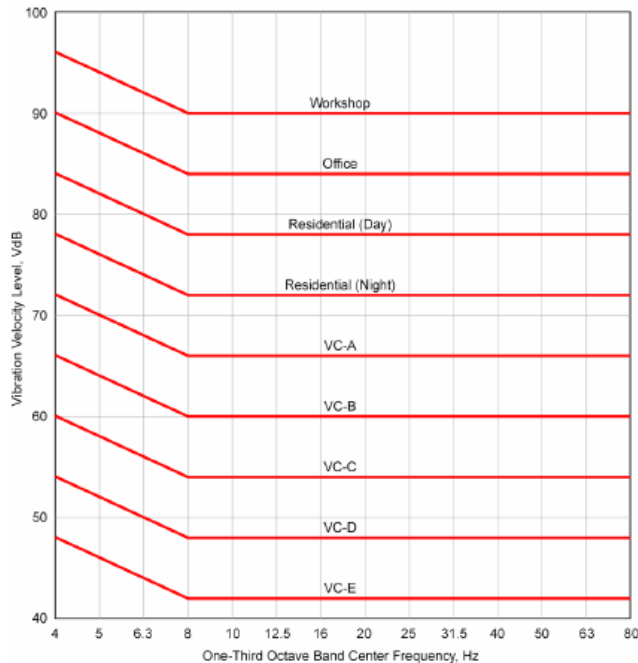
Figure 8-1. Criteria for Detailed Vibration Analysis

Table 8-3. Interpretation of Vibration Criteria for Detailed Analysis

Criterion Curve ¹ (See Figure 8-1)	Max L_v (VdB) ²	Description of Use
Workshop	90	Distinctly feelable vibration. Appropriate to workshops and non-sensitive areas.
Office	84	Feelable vibration. Appropriate to offices and non-sensitive areas.
Residential Day	78	Barely feelable vibration. Adequate for computer equipment and low-power optical microscopes (up to 20X).
Residential Night, Operating Rooms	72	Vibration not feelable, but ground-borne noise may be audible inside quiet rooms. Suitable for medium-power optical microscopes (100X) and other equipment of low sensitivity.
VC-A	66	Adequate for medium- to high-power optical microscopes (400X), microbalances, optical balances, and similar specialized equipment.
VC-B	60	Adequate for high-power optical microscopes (1000X), inspection and lithography equipment to 3 micron line widths.
VC-C	54	Appropriate for most lithography and inspection equipment to 1 micron detail size.

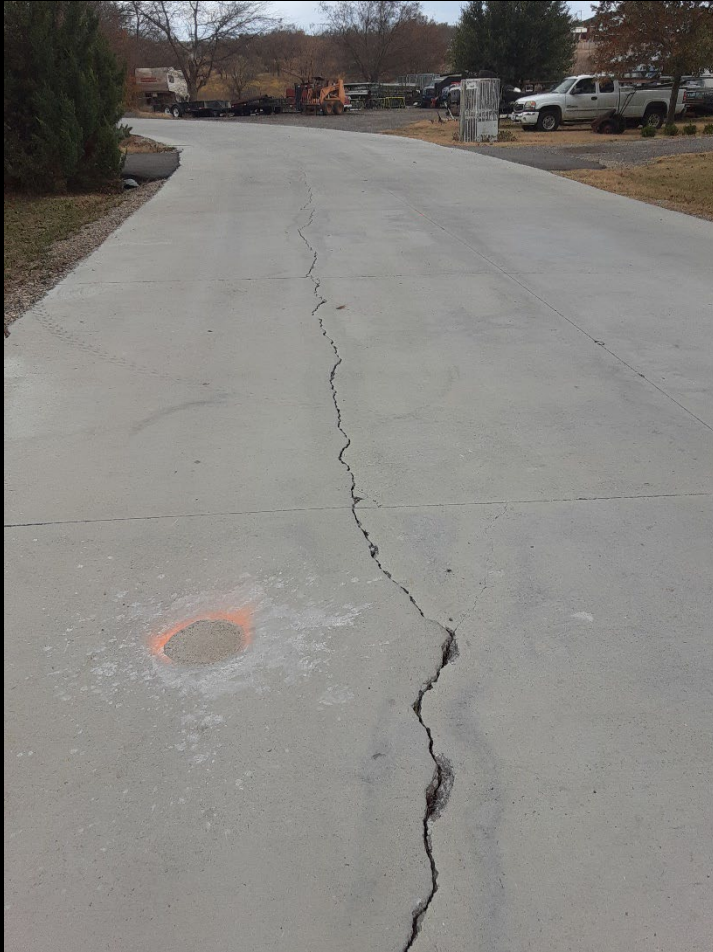
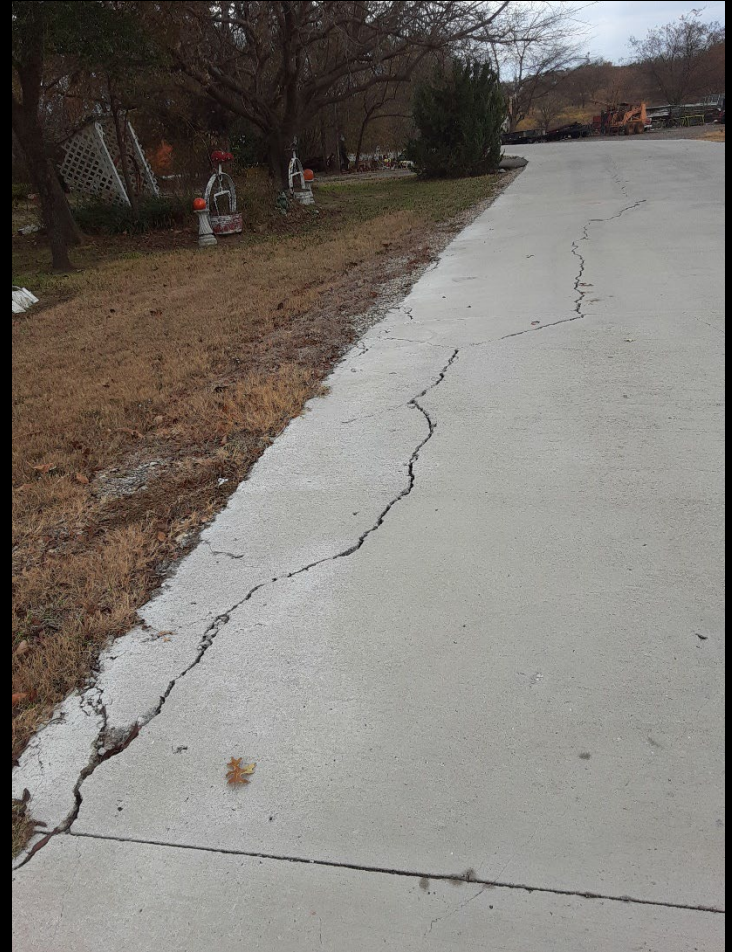
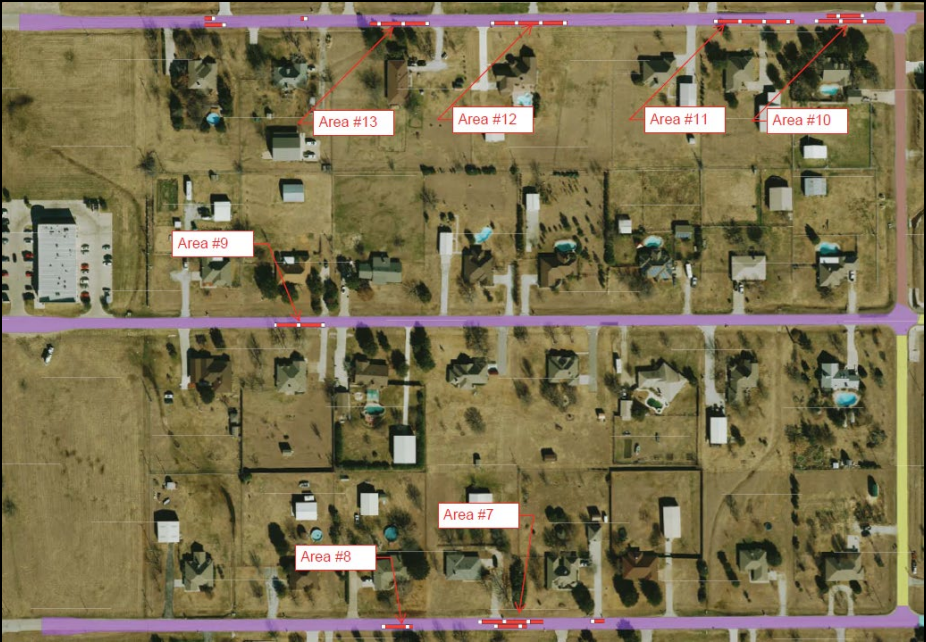
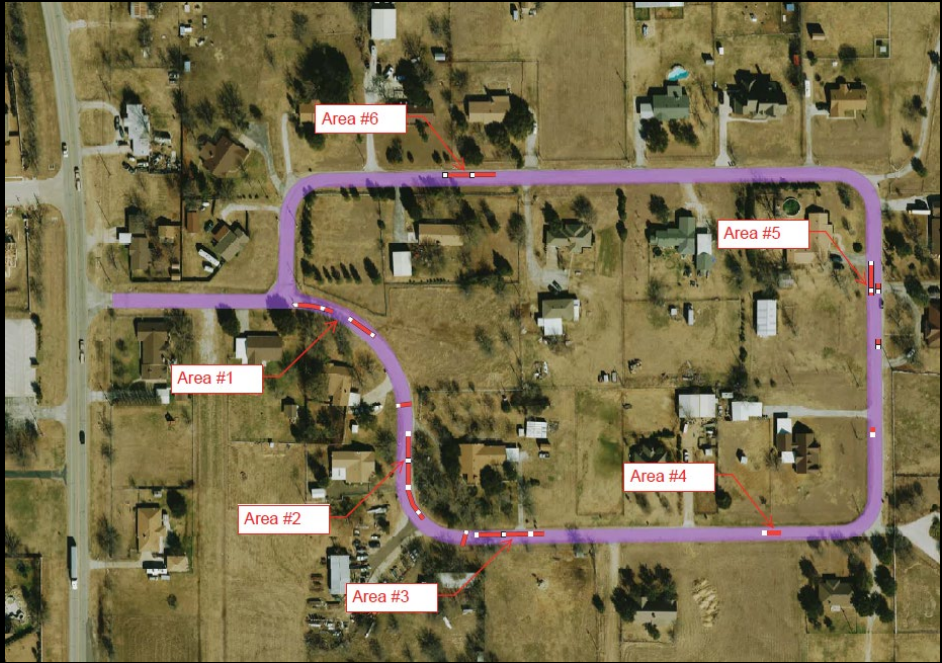
CRACKS START TO DEVELOP

- City Engineer notified in early 2019 that some cracks had started developing
- Minor cracking was expected as the product cured
- What was found however was longitudinal cracks that ran through several panels
- City Engaged Cement Council and a geotechnical firm
- Street cores showed 7.5" of FDR (8" specified) and 6" of concrete (6" specified)
- Areas of cracking were isolated indicating that it was not a widespread problem

- Streets were assessed panel by panel by the City Engineer
- Overall, 90.8% of the RCC showed no signs of distress
- Most cracking occurred within three places:
 - Edges
 - Where side slopes exceeded 2:1
 - Near large vegetation
- Ground outside the limits of paving showed signs of movement
- Unusual level of foundation repair permits in 2019

- Contractor was contacted in late 2019 concerning cracks forming
- Contractor initially pointed to the changed parameters of construction invalidating the maintenance bond but still came out for a site visit
- Contractor and City eventually came to an agreement that most cracks would be routed and sealed and one area that showed severe stress would be replaced with traditional concrete

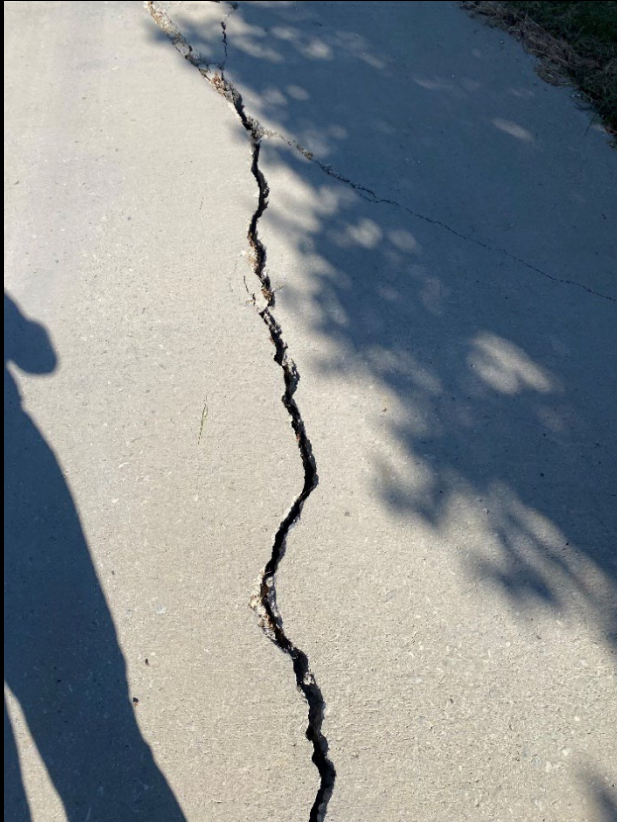
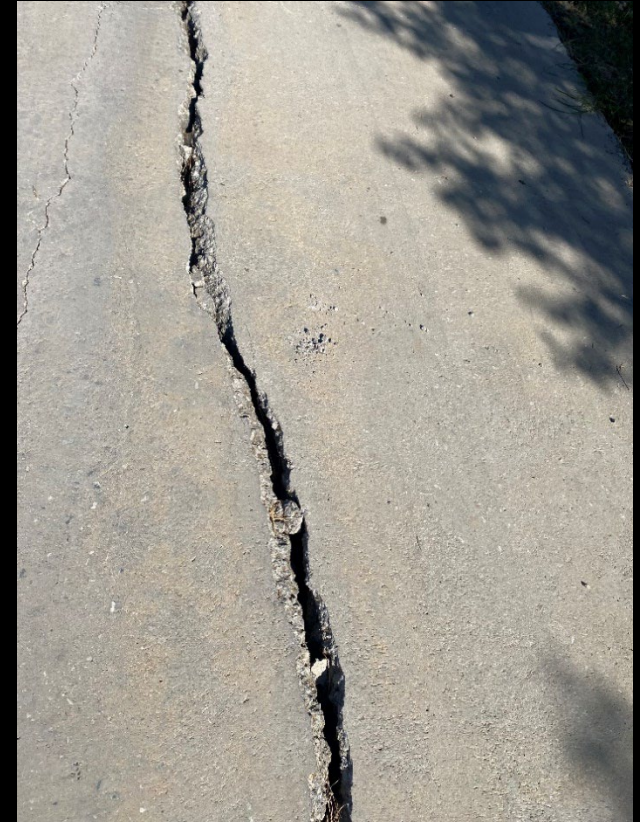
Continued ground movement and
crack spreading

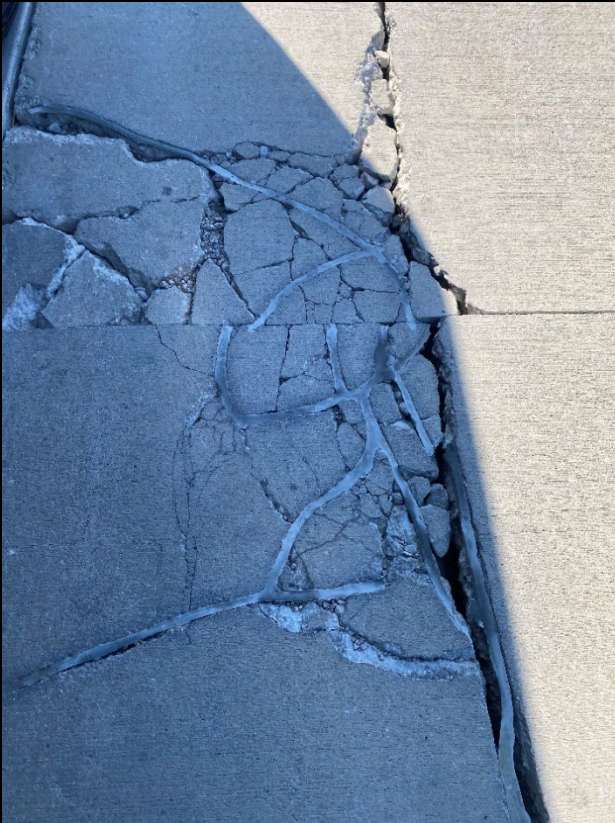
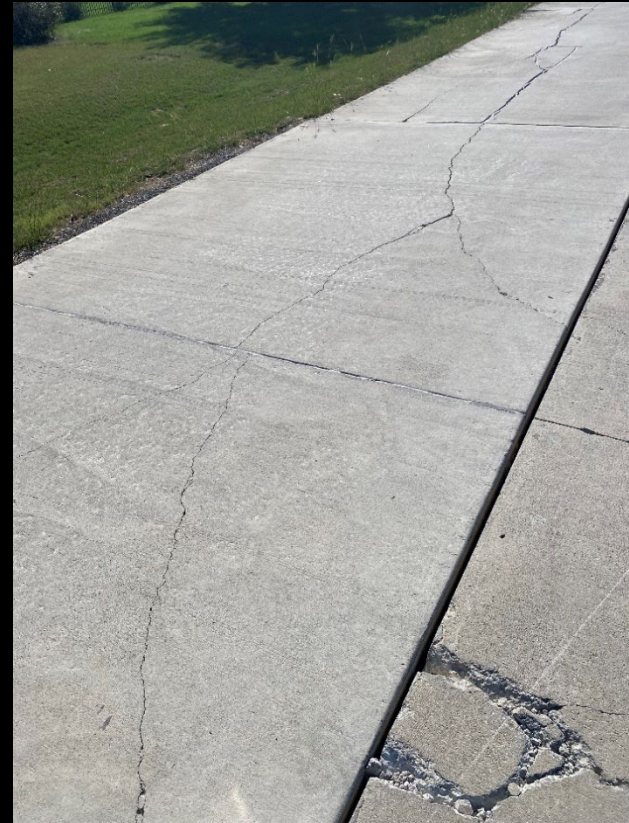
Limited new cracking has developed
but not outside the initial areas

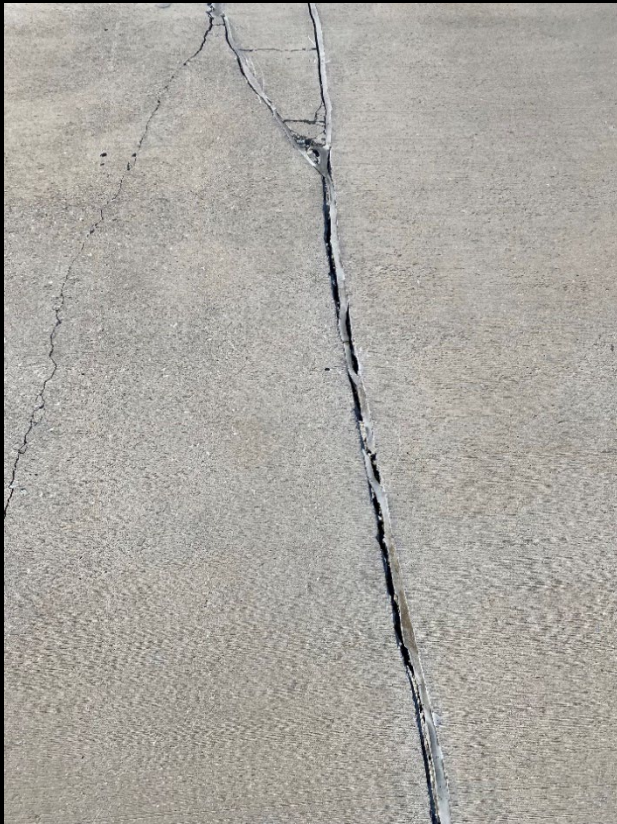
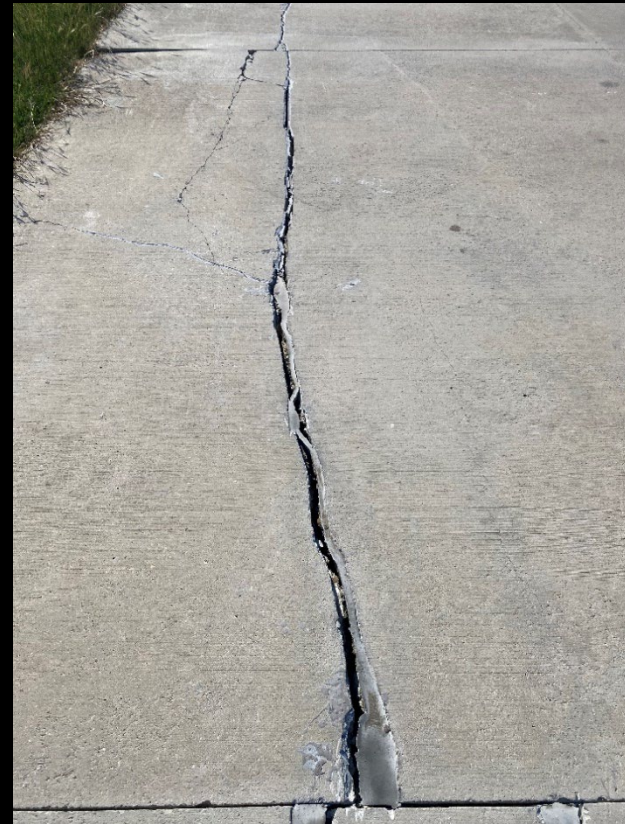
Some cracks continued to widen (note joint sealant)

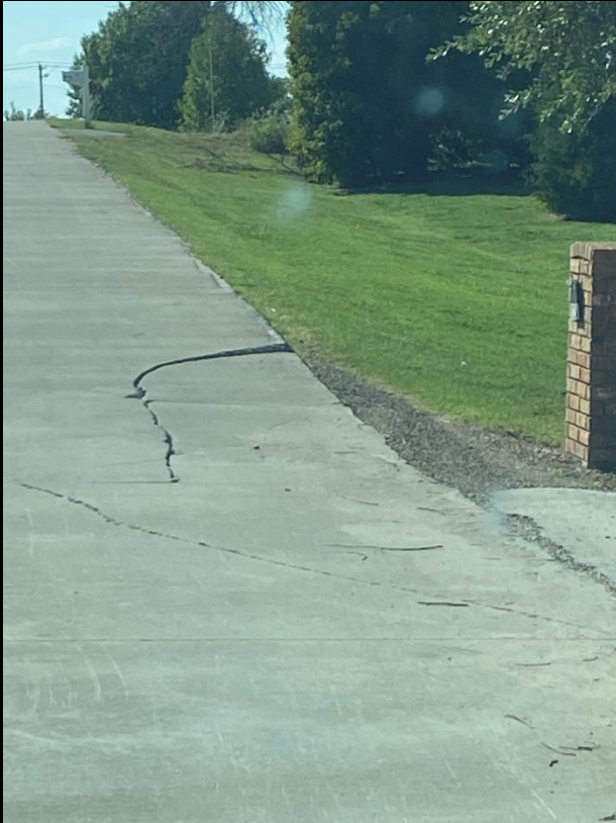
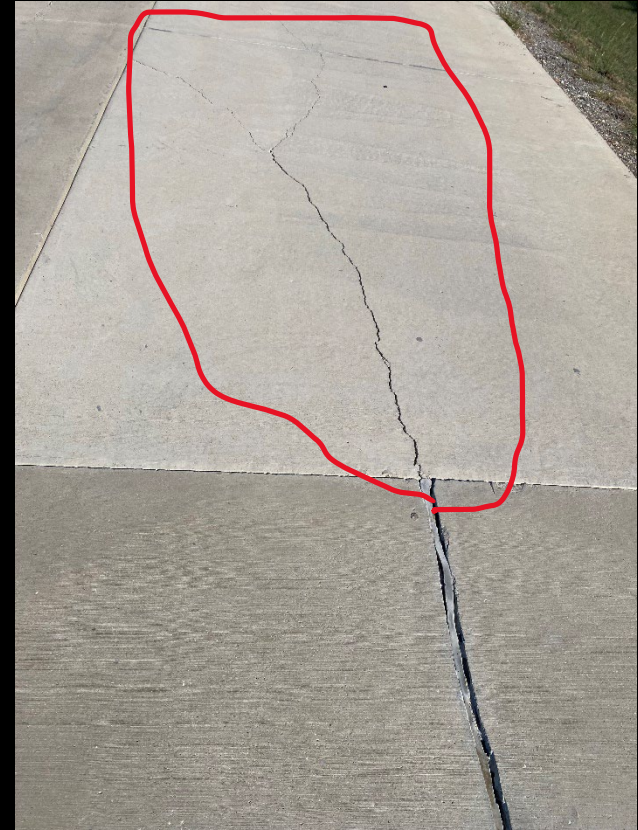
Even the replacement (traditional) concrete cracked

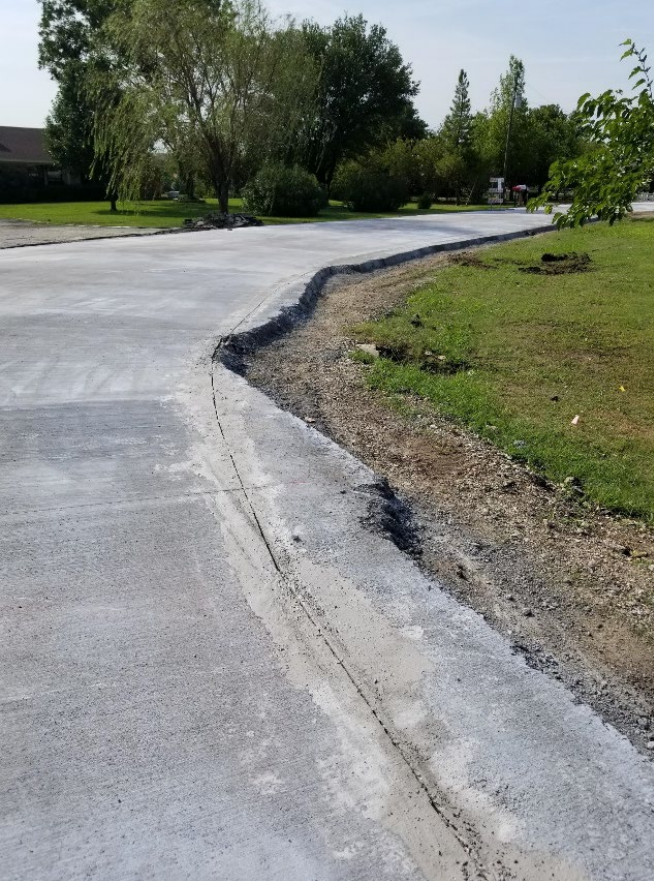
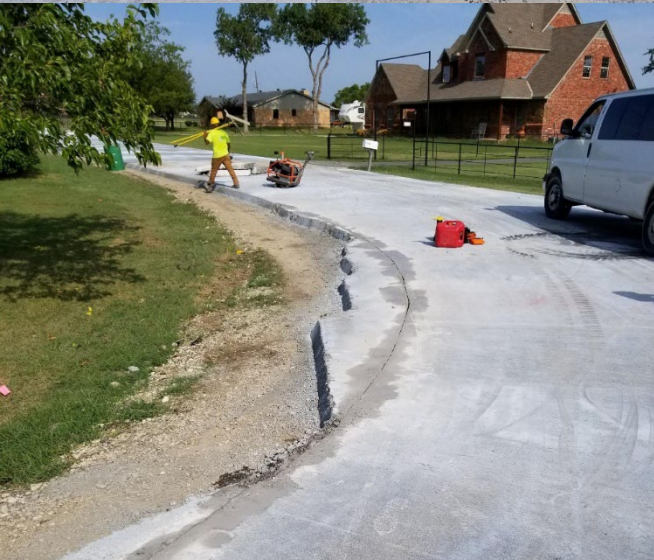
CORNERS

- Paver works well on straight runs or sweeping curves
- Residential curves pose a challenge
- One solution: Over pave and sawcut the radius

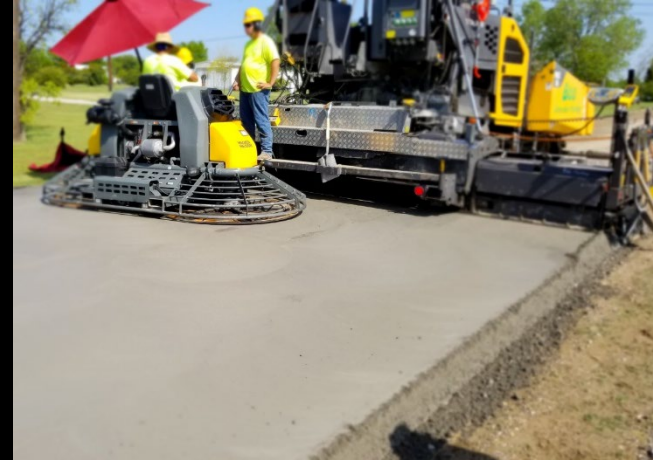
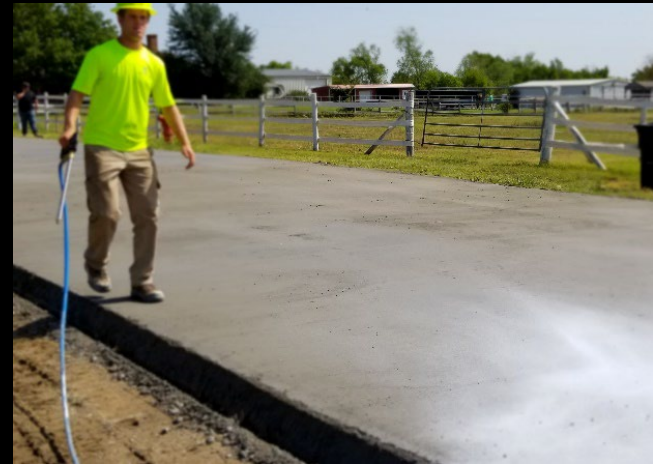
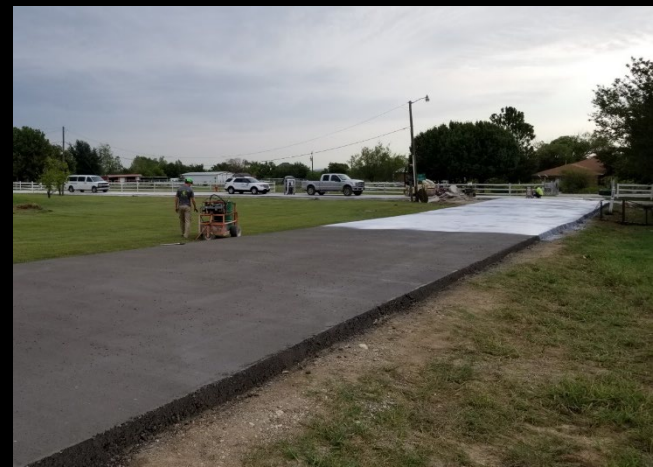
EDGE CONDITION

- Unconfined edge may have been a contributing factor to edge failures
- Consider a thickened edge or tied curbs
