RED BUS LANE TREATMENT EVALUATION

William Carry, Eric Donnell, Zoltan Rado, Martin Hartman, and Steven Scalici
February, 2012

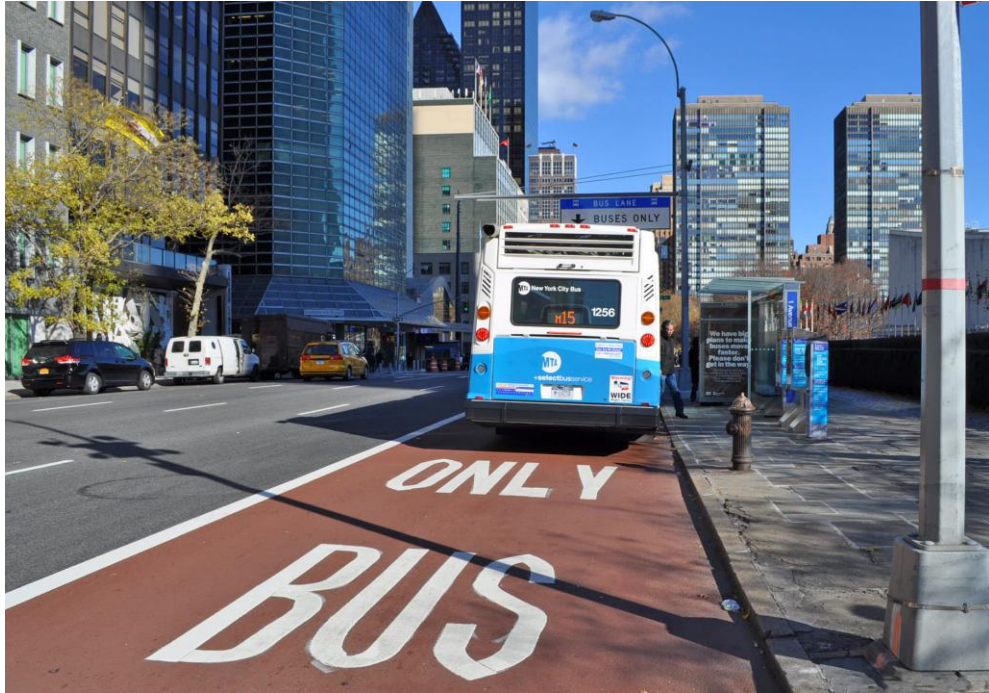
Figure 1. Example of a Red Bus Lane on First Avenue in Midtown Manhattan

Since 2008, the New York City Department of Transportation (NYCDOT) has implemented red-colored bus lanes as part of its collaborative Bus Rapid Transit (BRT) program with MTA New York City Transit (NYCT). The program includes five pilot BRT routes across the city, three of which – the Bx12 Select Bus Service (SBS) on 207th Street in Manhattan and Fordham Road and Pelham Parkway in the Bronx, the M15 SBS on First and Second avenue in Manhattan, and the M34/M34A SBS on 34th Street in Manhattan – are currently in operation. These three SBS routes, as well as other major bus corridors have been outfitted with red bus lanes. An example of a red bus lane is shown in Figure 1.

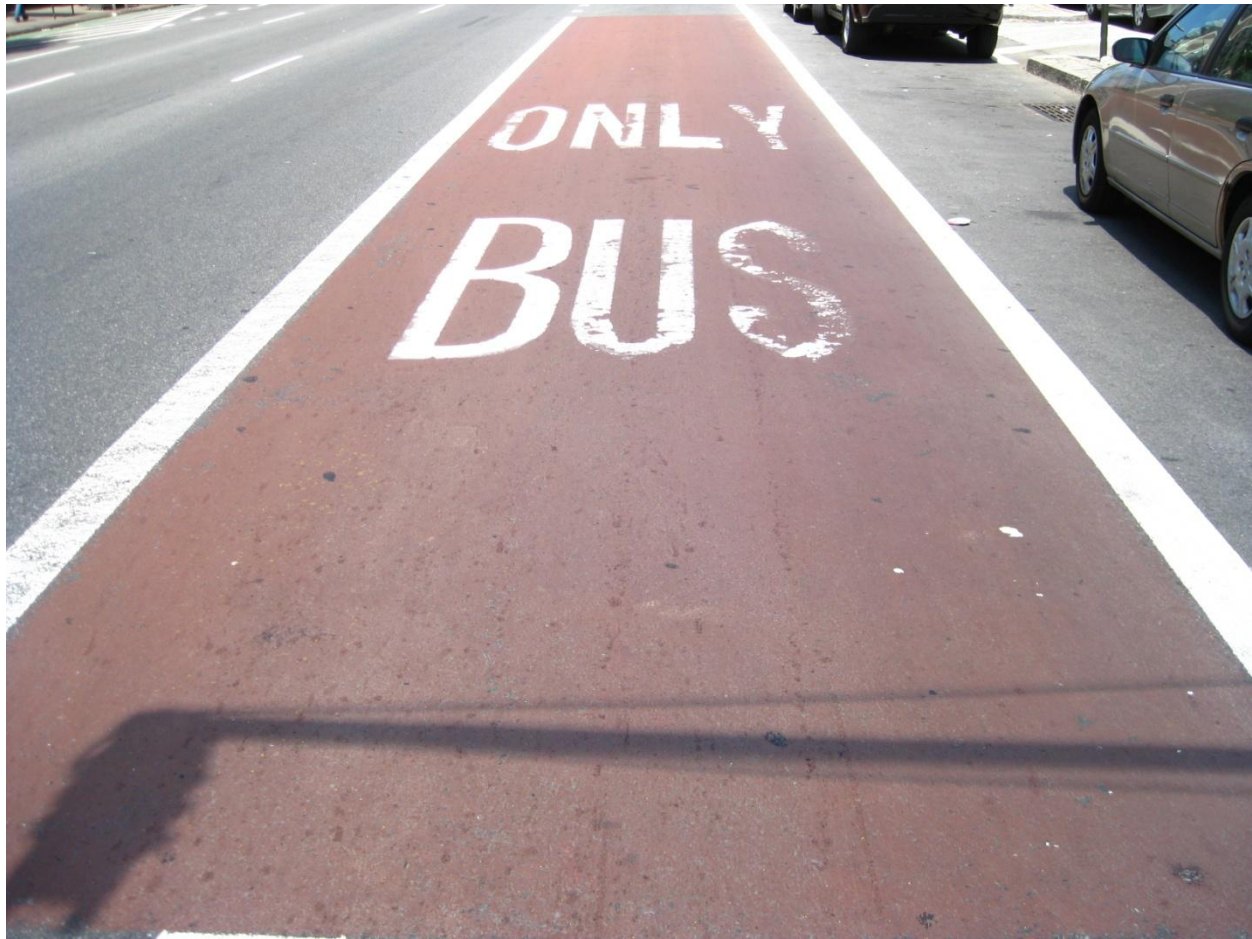
Figure 2. Product ID #1 at First Avenue between 15th and 16th Streets

NYCDOT has extensive experience with applying Product ID #1, marketed as high durability epoxy-based street paint, to asphalt concrete (AC) surfaces. The durability of this product has varied widely depending upon the age and condition of the underlying AC roadway. Overall, NYCDOT has found that Product ID #1 exhibits satisfactory durability when applied to new AC surfaces. Figure 2 shows the condition of a section of Product ID #1 red bus lane on First Avenue between 15th and 16th streets after one year of wear. At this location, the red treatment was applied to newly paved asphalt. As shown in the photo, the red treatment exhibits little chipping, peeling, or fading and is an effective traffic control device. The red treatment does

exhibit some minor staining and marking. Similar durability results were found at other locations where Product ID #1 was applied to freshly laid AC streets.

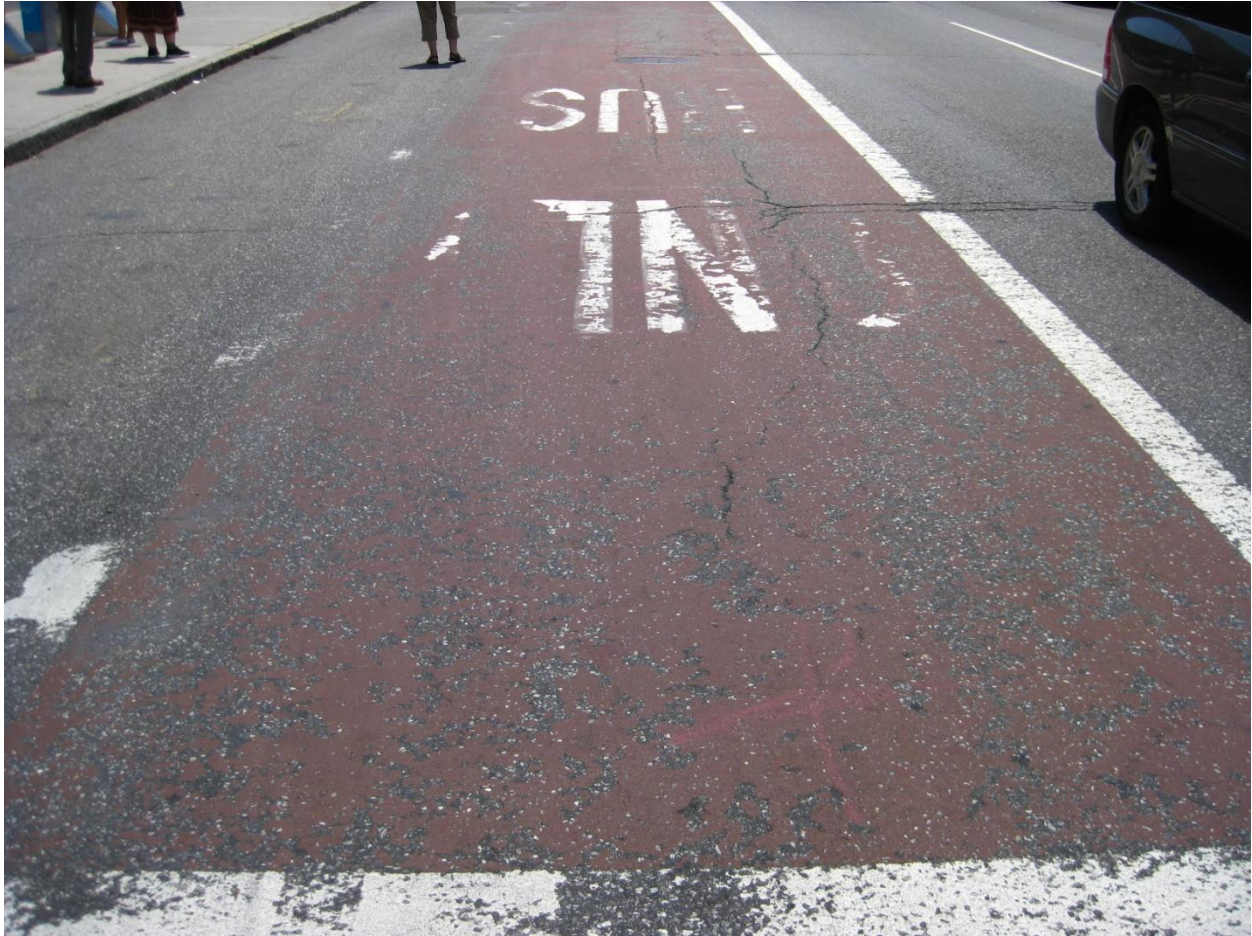
Figure 3. Product ID #1 First Avenue between 14th and 15th Streets

In contrast, NYCDOT has found that Product ID #1 exhibits unsatisfactory durability when applied to existing asphalt, particularly AC roadways in fair to poor condition. Figure 3 shows the condition of a section of Product ID #1 red bus lane on First Avenue between 14th and 15th streets after one year of wear. This section of red bus lane is contiguous with the section shown in Figure 2, and is subject to the same general level of wear by bus and vehicular traffic. This section of red treatment was applied to an AC roadway that was more than five years old. As shown in the photo, the red treatment exhibits significant chipping, peeling, and fading and is therefore less effective as a traffic control device. Similar durability results were found at other locations where Product ID #1 was applied to older AC streets.

In both of the above cases, the red treatment was installed with minimal surface preparation—installation crews simply swept or used compressed air to clear the roadway before application. One possible explanation for the discrepancy in durability is that accumulated oils, dirt, and other debris on the surface of older asphalt roadways hinders street paint adhesion, while the relatively clean surface of a new AC surface provides a more solid base. Surface cracking in older AC roadway surfaces, as shown in Figure 3, may also contribute to poor durability of products like Product ID #1 on these types of surfaces.

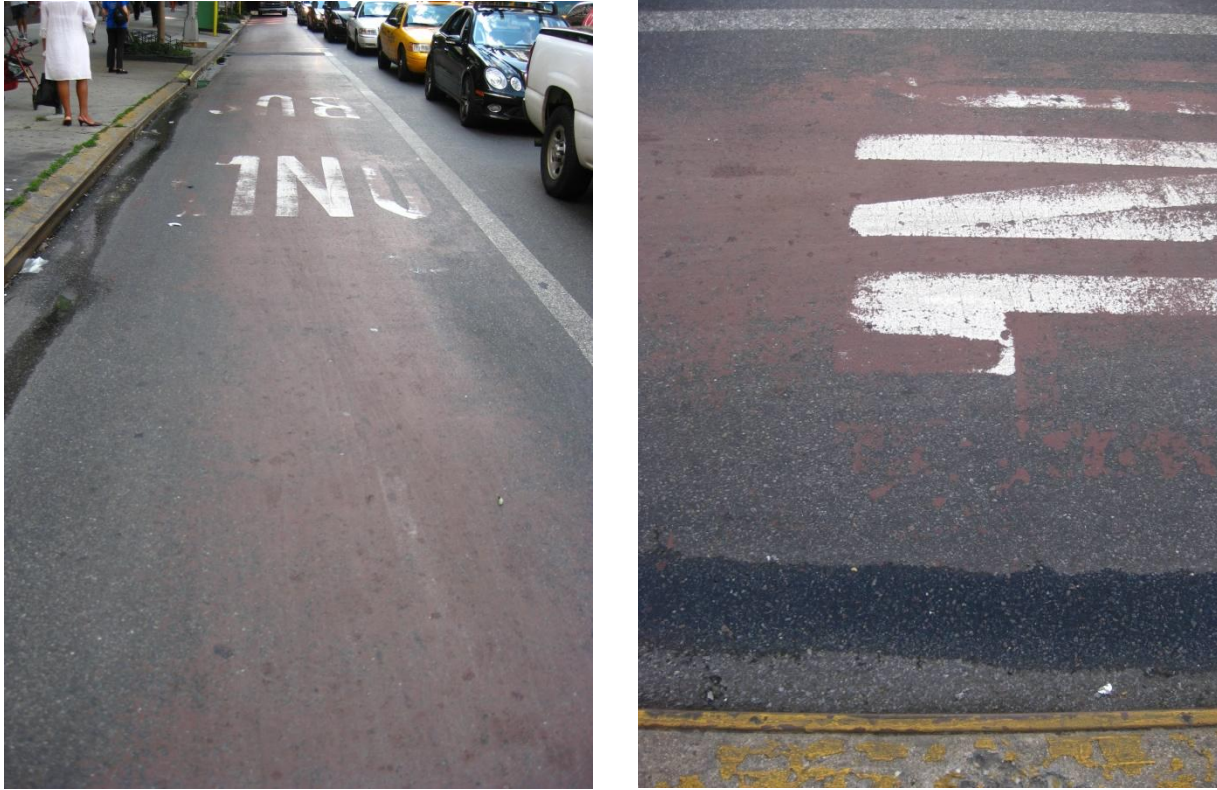
Figure 4. Product ID #1 Wear at a Bus Stop at 34th Street at Second Avenue

Regardless of the age and condition of the AC roadway surface, red treatments are exposed to particularly intense wear at bus stops, where the red treatment is subjected to the friction caused by buses stopping and starting and to prolonged heat exposure from bus engines. Figure 4 shows the condition of the red treatment at a bus stop on 34th Street at Second Avenue after three years of wear. While the non-bus stop sections of the red treatment on 34th Street are typically in satisfactory condition, the bus stop sections have exhibited significant wear, particularly in the wheel tracks. Similar results were found at most bus stops along the 34th Street corridor.

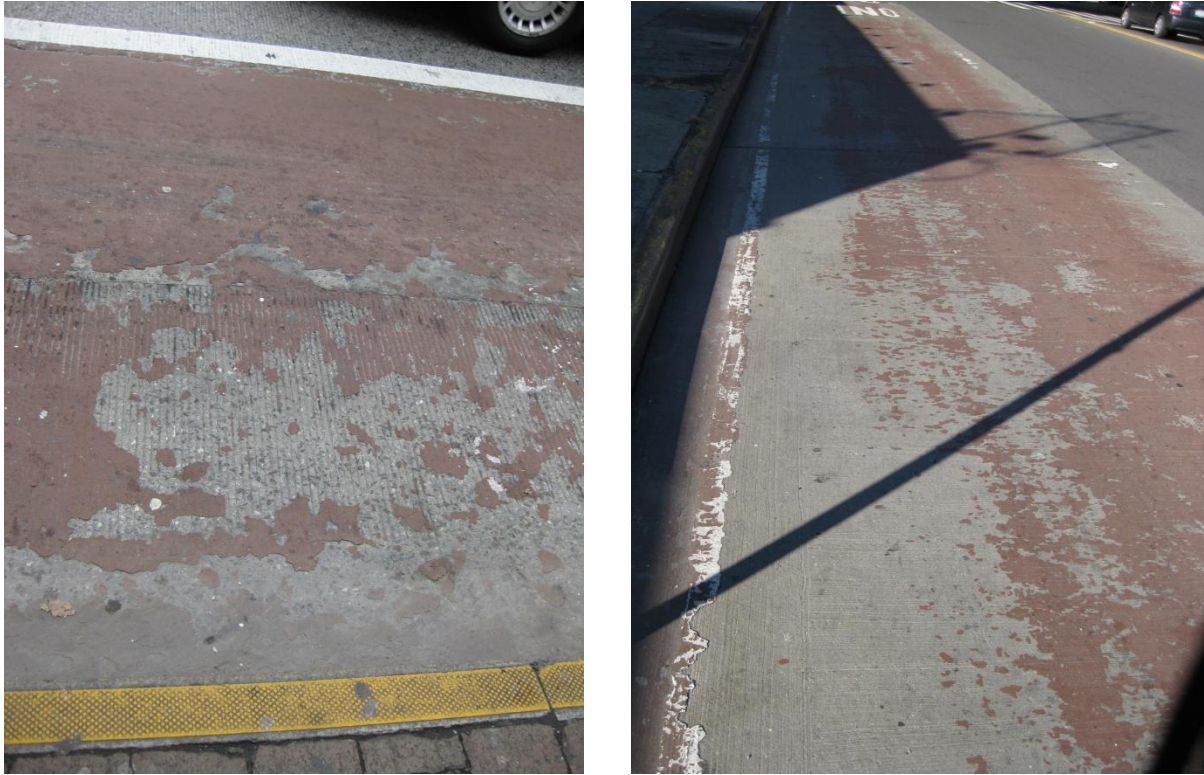
Figure 5. Product ID #1 on concrete roadway in the vicinity of Sedgwick Avenue on Fordham Road after one year (left), red treatment concrete roadway at West 207th Street at Tenth Avenue after one year (right)

Figure 5 shows the condition of red bus lane sections treated with Product ID #1 on concrete roadways along Fordham Road in the Bronx and along 207th Street in Manhattan. After one year, these sections of red treatment exhibited significant chipping and peeling. In both cases, the red treatment was applied to existing concrete roadways that were more than five years old with minimal pre-treatment. The polished surfaces of these concrete roadways may have hindered the adherence of the red treatment.

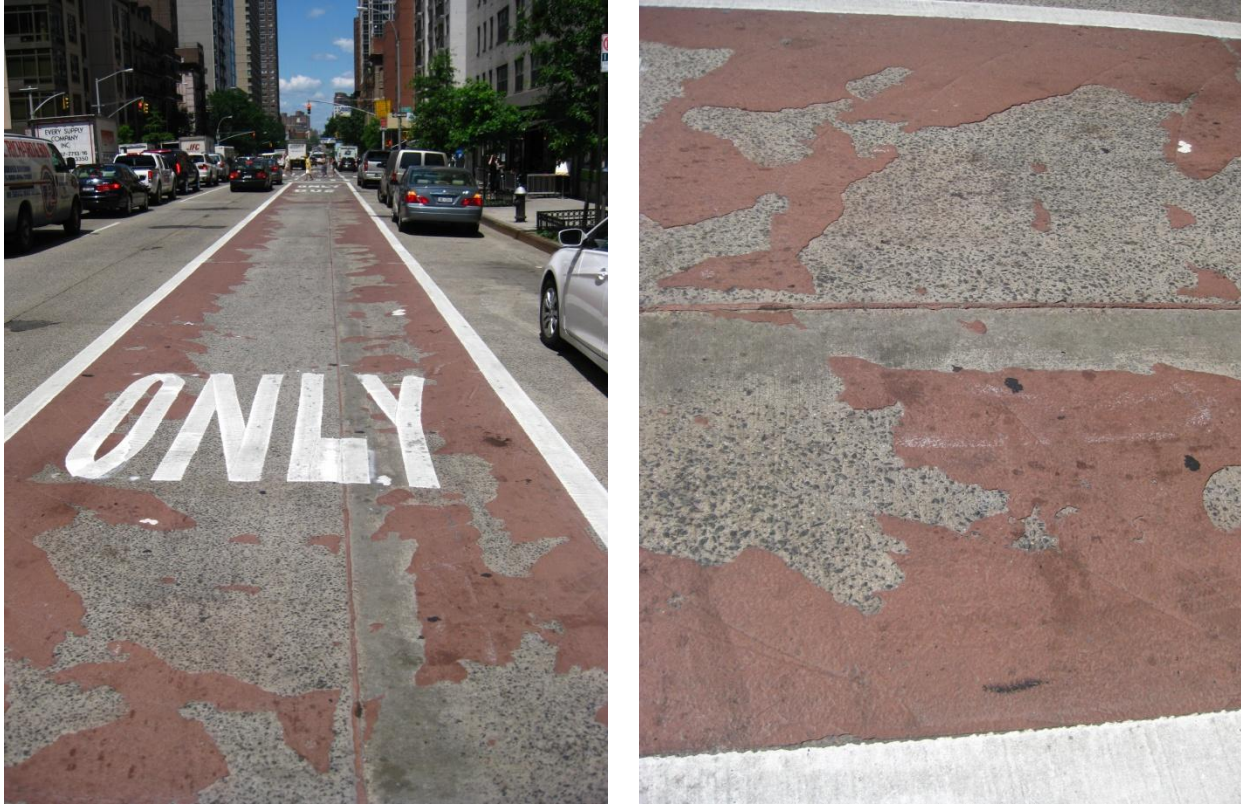
Figure 6. Product ID #6 applied to First Avenue between 88th and 89th Streets after Nine Months

In response to the problems encountered on Fordham Road, NYCDOT experimented with an alternate red treatment on the concrete section of First Avenue (installed as part of the M15 SBS project). NYCDOT used Product ID #6, a Portland cement-based micro surface, instead of a street paint product. Figure 6 shows the condition of the Product ID #6 section of First Avenue after nine months. As shown in the photos, this section of red treatment exhibited extensive chipping and peeling indicating that the product is not effective on existing concrete surfaces.

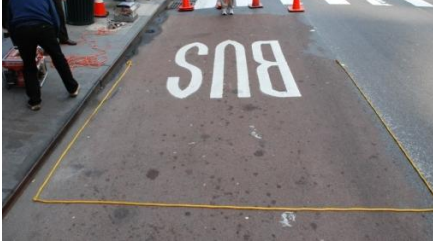
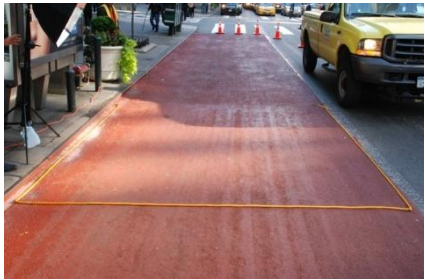
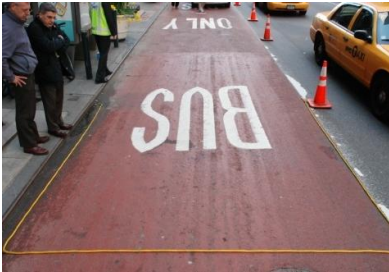
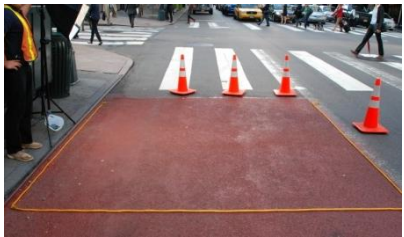
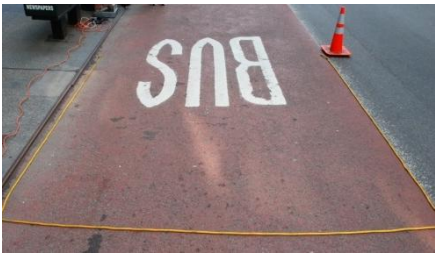
Table 4. Durability Testing Results for Red Bus Lane Treatments

Product ID / Name	October 2010 Photo	April 2011 Photo	% Coverage		% Reduction in Coverage*
			Oct 2010	Apr 2011	
2	 	 	100.0	98.13	1.87
3	 	 	100.0	99.16	0.84
4

100.0	95.41	4.59
5	 	 	100.0	100.0	0.00
6	 	 	100.0	100.0	0.00

100.0	NA	NA
8

100.0	97.01	2.99
9

100.0	99.63	0.37

Table 4 shows the results of the durability analysis. For each product, a digital photograph of the October 2010 field condition is shown next to a digital photograph of the April 2011 field condition. The percent coverage during the April 2011 period is shown in Table 4 along with the percent difference in surface coverage between the October 2010 and April 2011 periods. The percent reduction in the area covered by each red bus lane treatment was computed using the following equation:

Based on the durability results, two products (product ID #5 and #6) did not experience any loss of coverage after a period of six months of traffic wear and weathering. Product ID #6, however, did show evidence of cracking. Upon further visual inspection after nine months of wear and weathering, Product ID #6 showed extensive deterioration. No other products showed significant additional deterioration at month nine based on visual inspection. Three products (product ID #2, #3, and #9) experienced between 0.4 and 1.87 percent loss in area covered by the material on the bus lane.

Product ID #4 and #8 showed slight deterioration, with 2.99 percent and 4.59 percent loss of coverage, respectively. One product (Product ID #7) experienced a significant decrease in coverage (91 percent) after a period of traffic wear and weathering. This result should be discounted, however, as Product ID #7 was subject to the presence of an illegally parked truck prior to the end of the recommended curing time. The presence of the truck on the setting product likely impacted its durability.

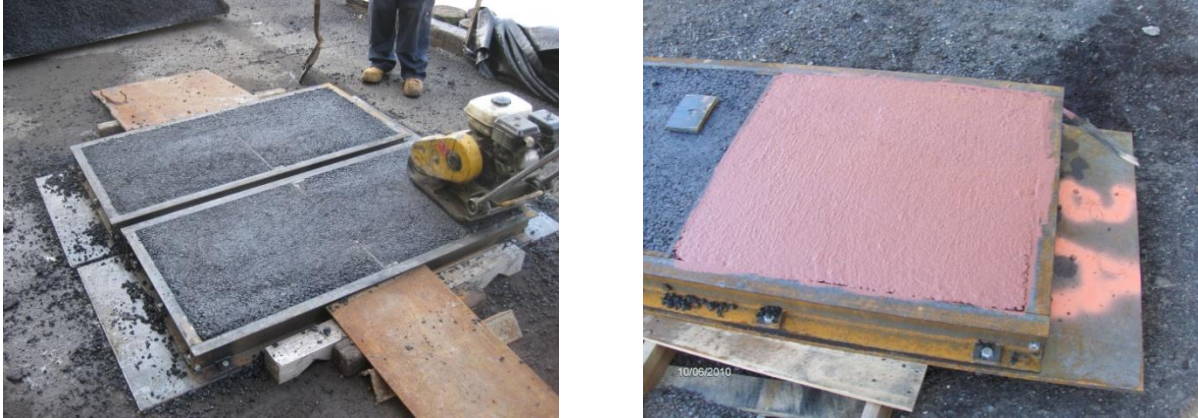
Figure 8. Forms for Red Bus Lane Specimens (left) and Red Bus Lane Product Applied to Asphalt Specimen (right)

Prior to performing the laboratory tests, asphalt test slabs were prepared by the NYCDOT using NYCDOT's standard asphalt cement mix. The slabs were approximately 28- by 28-inches in area, at a depth of approximately five inches (compacted). The test slabs were left outside for two weeks prior to the application of the red treatments to allow for the evaporation of excess surface oils. A sample of each red bus lane treatment was then applied on top of the asphalt test slab by the red bus lane product manufacturers invited to participate in the laboratory testing. An example of a red bus lane product applied on the asphalt specimen is shown in Figure 8.

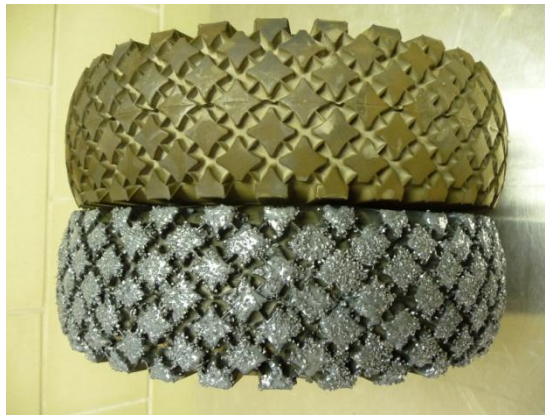
Figure 9. Uncoated Pneumatic Rubber Tire (top) and Silica-Carbide-Coated Tire (bottom)

Testing on each of the red bus lane treatments using the uncoated pneumatic rubber tires found that the products did not degrade after completing 766,500 MMLS cycles. Therefore, all subsequent MMLS testing was performed by coating two of the rubber tires with a silica-carbide material to increase the level of wear on the test slabs. Silica carbide is a powder-like substance, which is commonly used as an abrasive. Figure 9 shows the uncoated pneumatic and silica-carbide-coated tires used for the accelerated testing.
