Illicit Discharge Detection and Elimination

The City of Arlington Case Study

The “Mystery” @Crystal Canyon

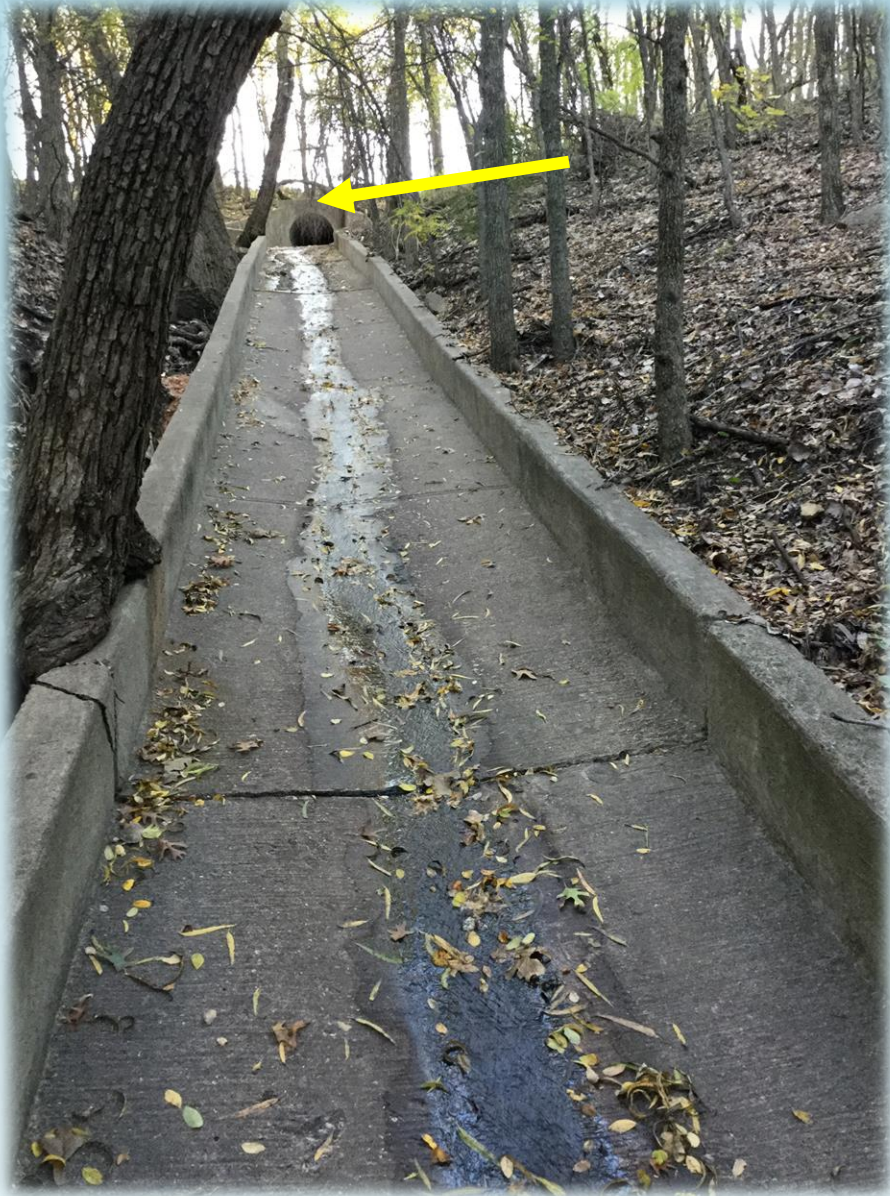
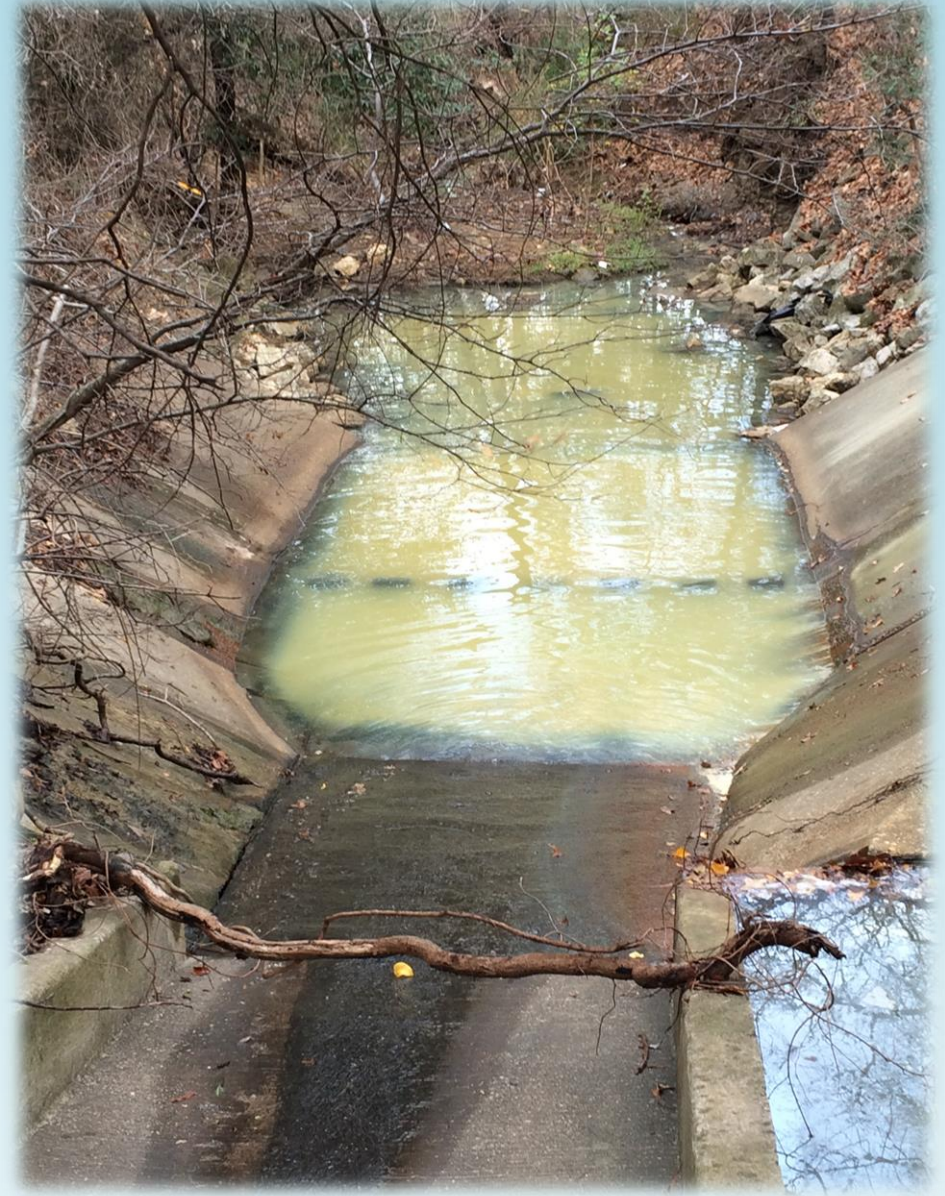
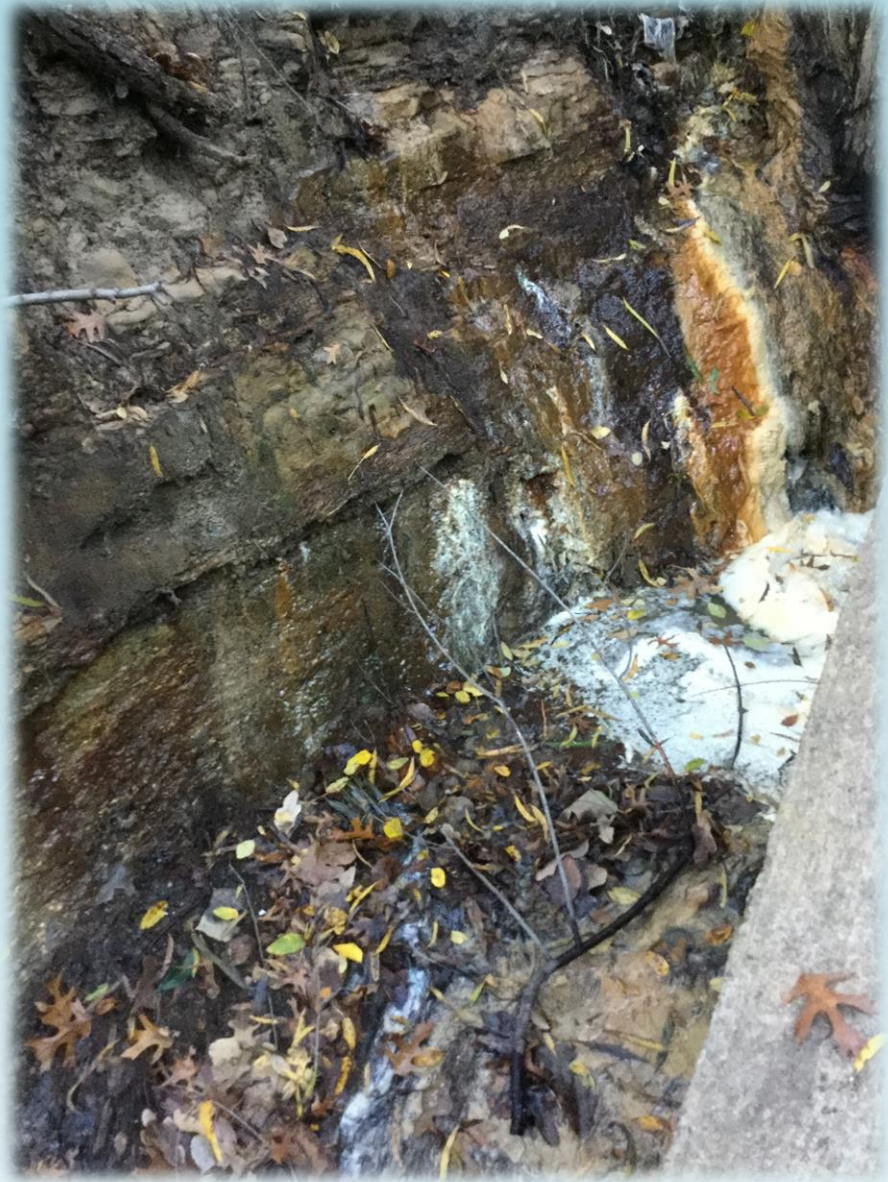
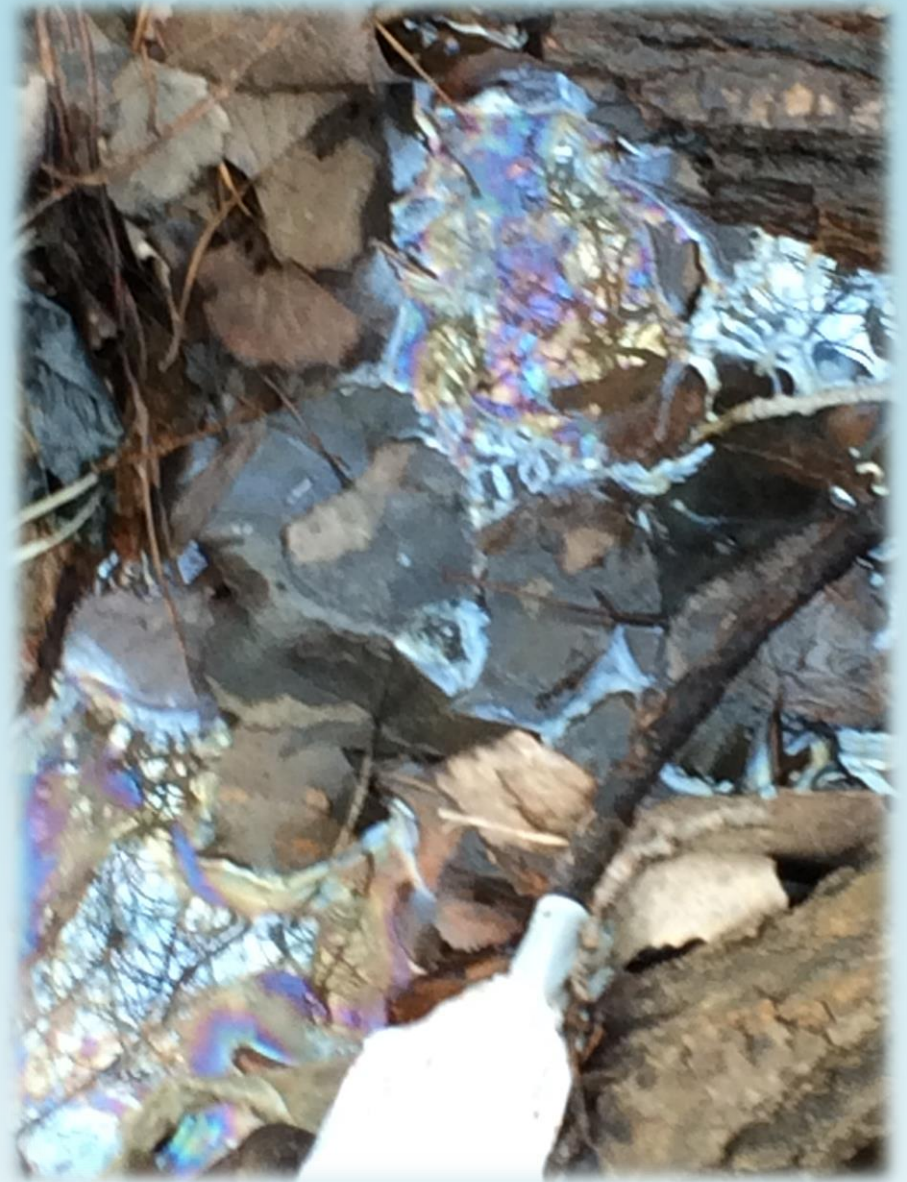
SITE 1:

➤ **Storm inlet located upstream from creek**

- Faint white staining
 - Minimal and not consistent with an excessive dumping

➤ **Outfall**

- Discharges into concrete flume
- Flow observed discharging from outfall at time of assessment
 - Clear, no odor, no white residue
- Water in channel was turbid

➤ **Additional Observations**

- Ditch alongside flume
 - Iridescent film on standing water pocket
 - Reddish-brown iron ore deposits
 - White foamy substance

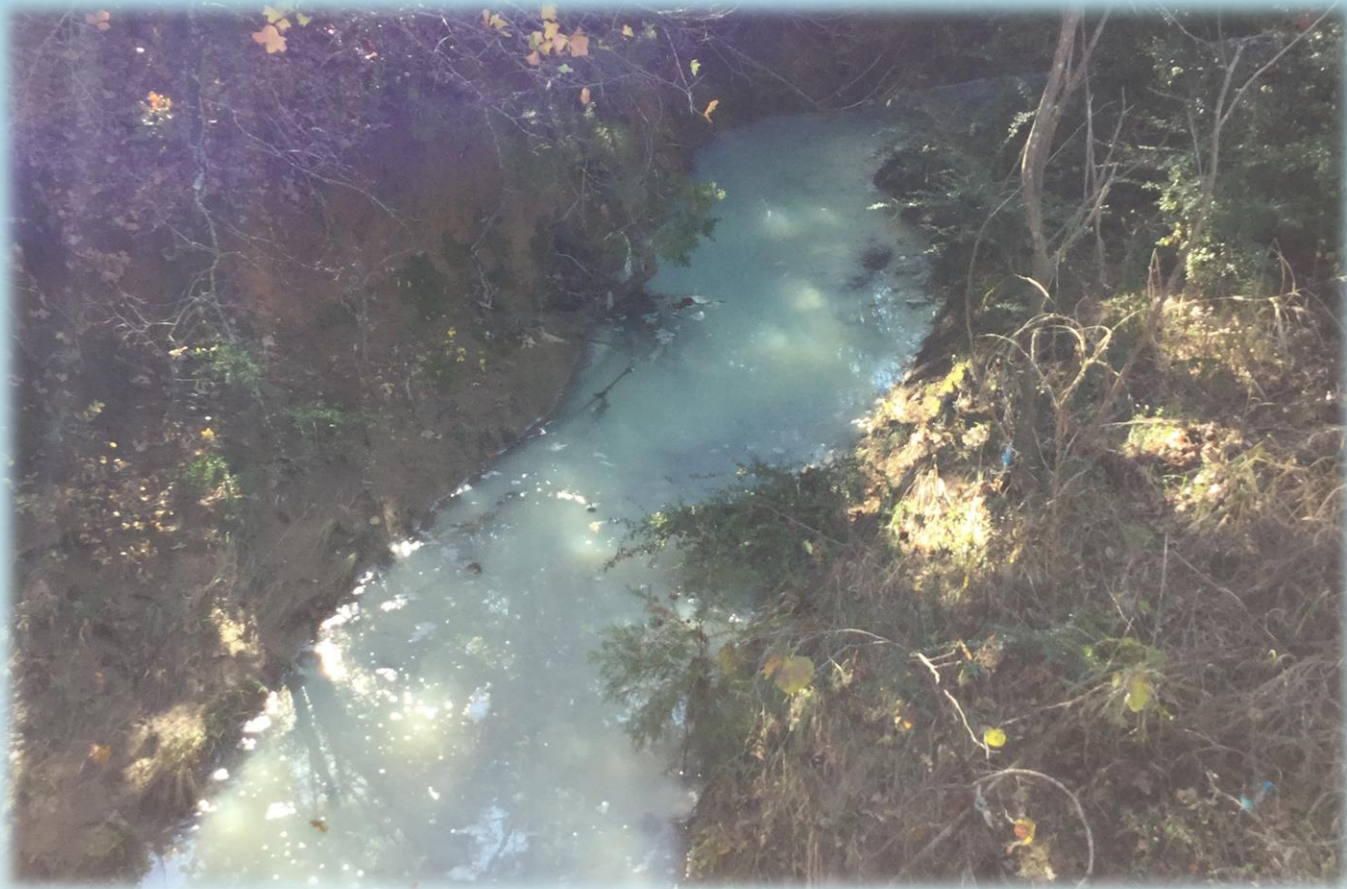
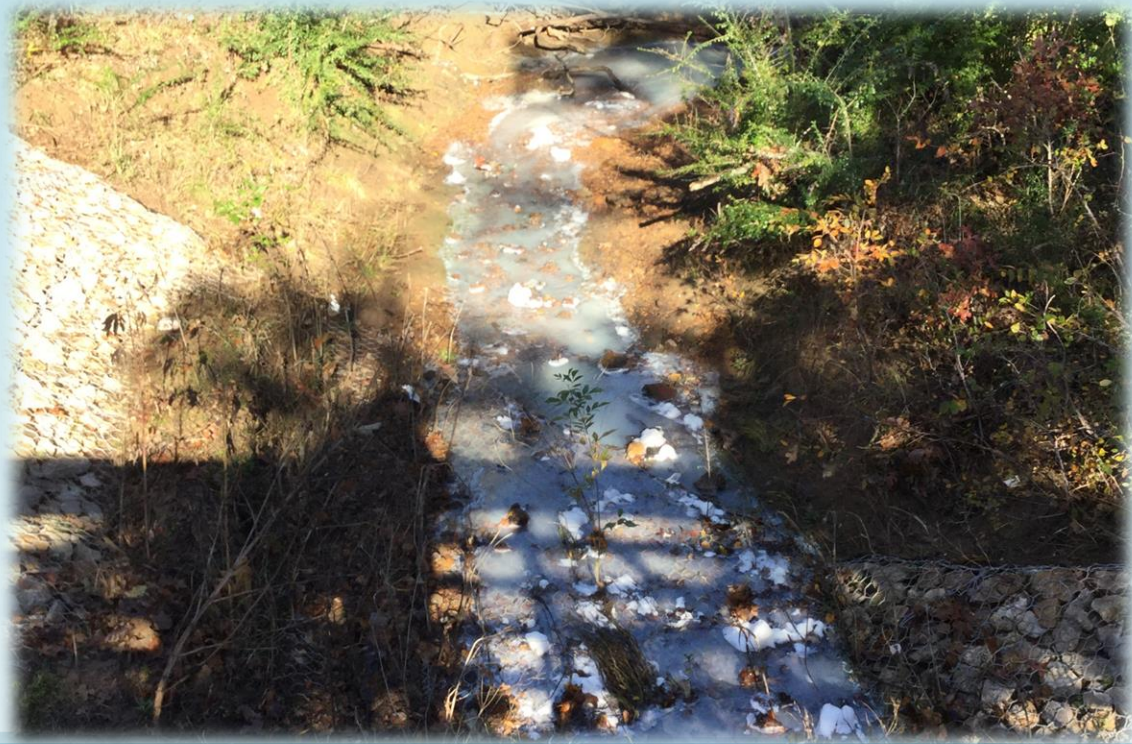
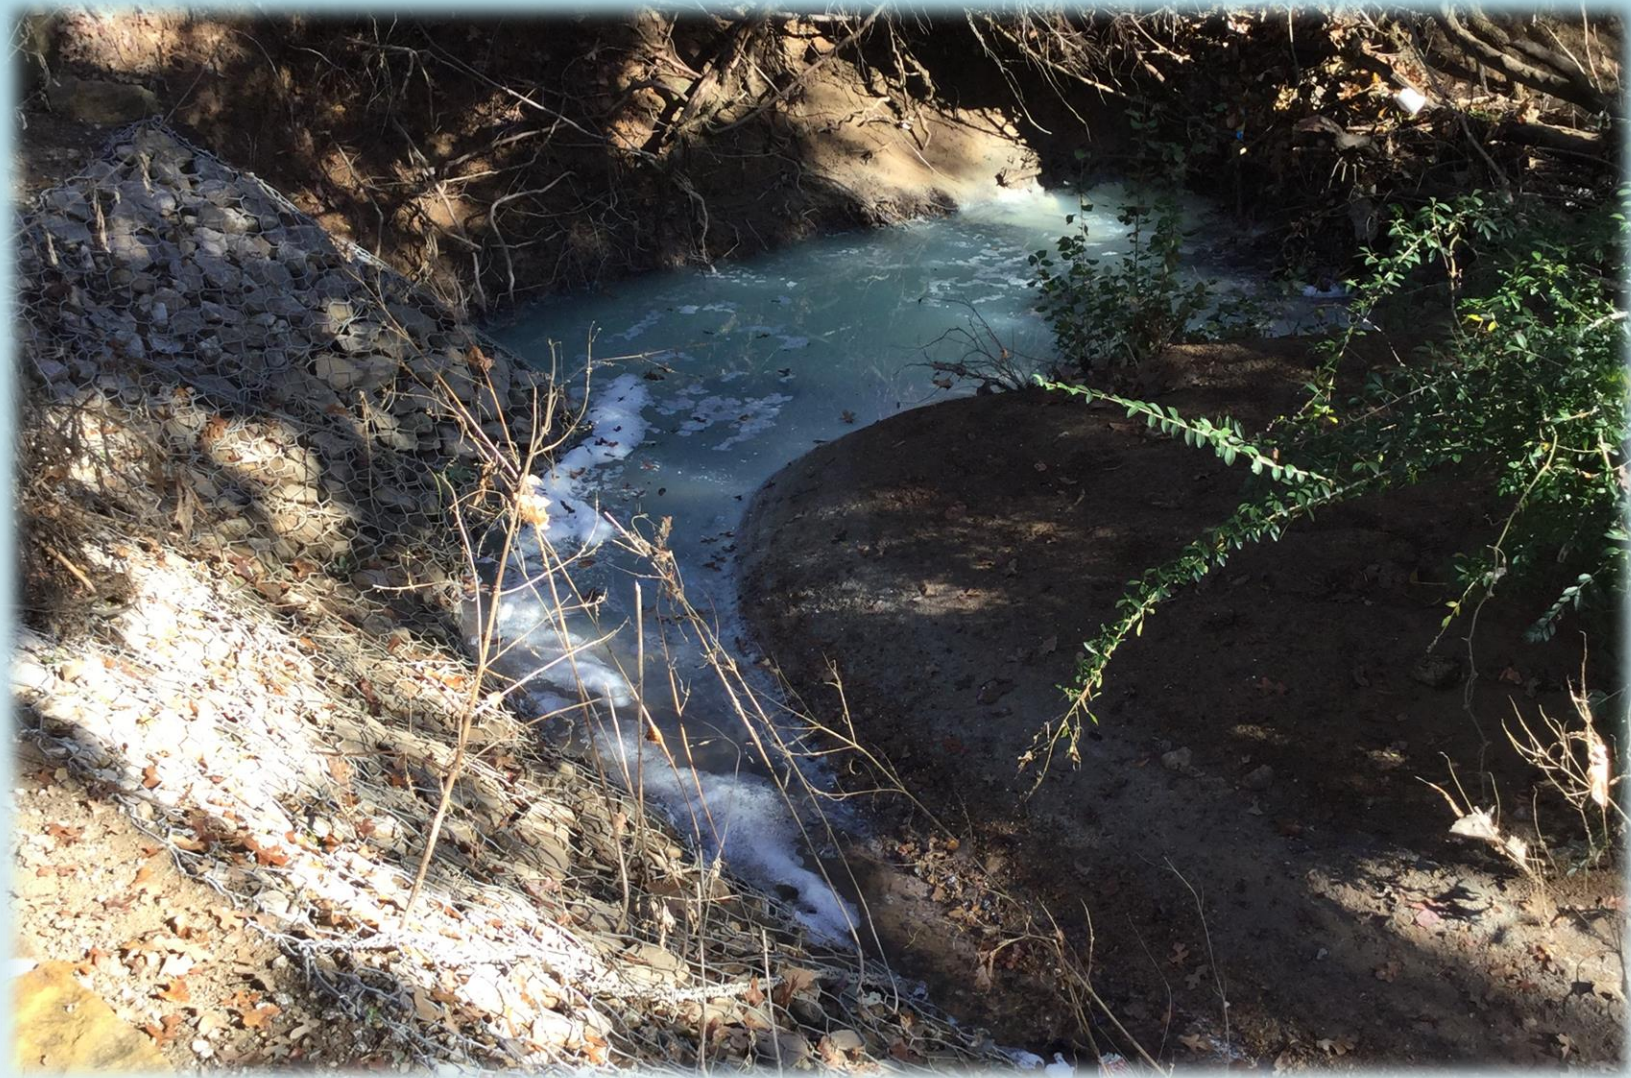
SITE 2:

➤ **Stream inside Crystal Canyon Park**

- White thick foamy accumulations observed
 - Along stream bank and stream bed.
 - Foam is light and not slimy
- Water appears to be a light blue-green color
 - There is no odor

- **Water discoloration due to geochemical reactions between groundwater and mineral rich geology of the area**
- **White foamy substance**
 - Due to the high concentrations of Manganese and Magnesium in the groundwater seeping into the stream
- **Prior to 2015, the DFW Metroplex had been in a drought for years**
- **Record rainfall in 2015 raised groundwater levels**
 - Many groundwater seeps and springs were being reactivated all throughout the city.
 - SO in conclusion, the white accumulations and discoloration was due to geochemical reactions between groundwater and the mineral rich geology of the area.
- **RECOMMENDATIONS**
 - Post signage informing citizens of the geomorphology of the area.
- **Environmental continues to monitor the site periodically**

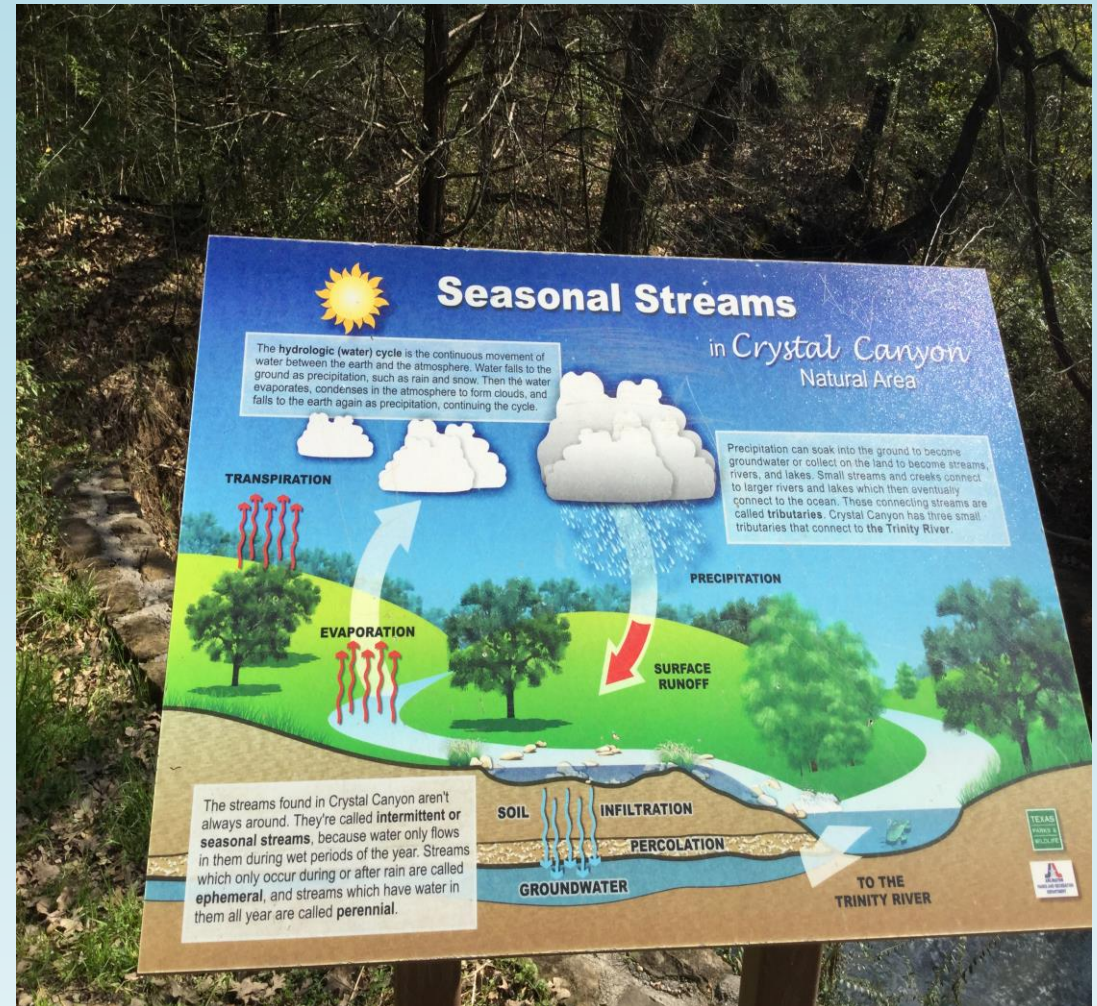
- Streams in Crystal Canyon aren't always around.
 - Intermittent or "Seasonal" Streams
 - Water only flows during wet periods of the year
- 2015 was the wettest year on record for DFW, exceeding the "normal" annual rainfall by nearly 300%
- Wettest May on record
 - Total: 17.55 inches
- Wettest November on record
 - Total: 11.05 inches

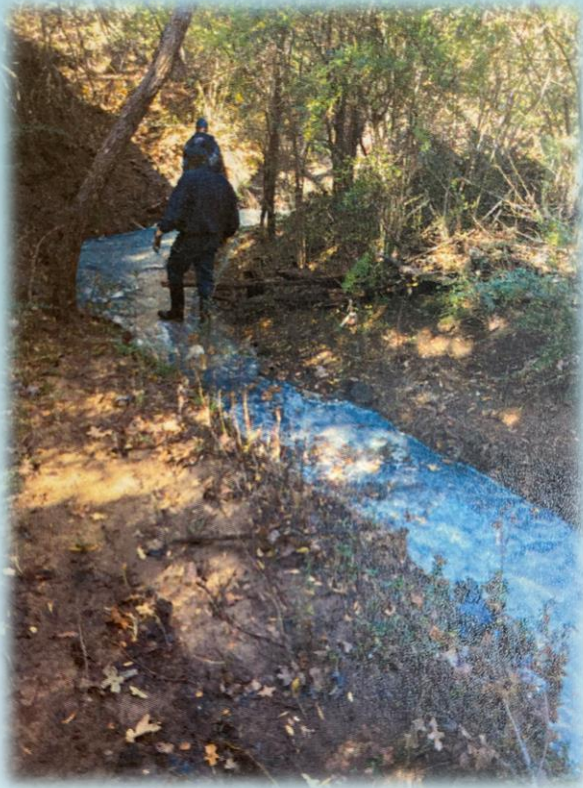
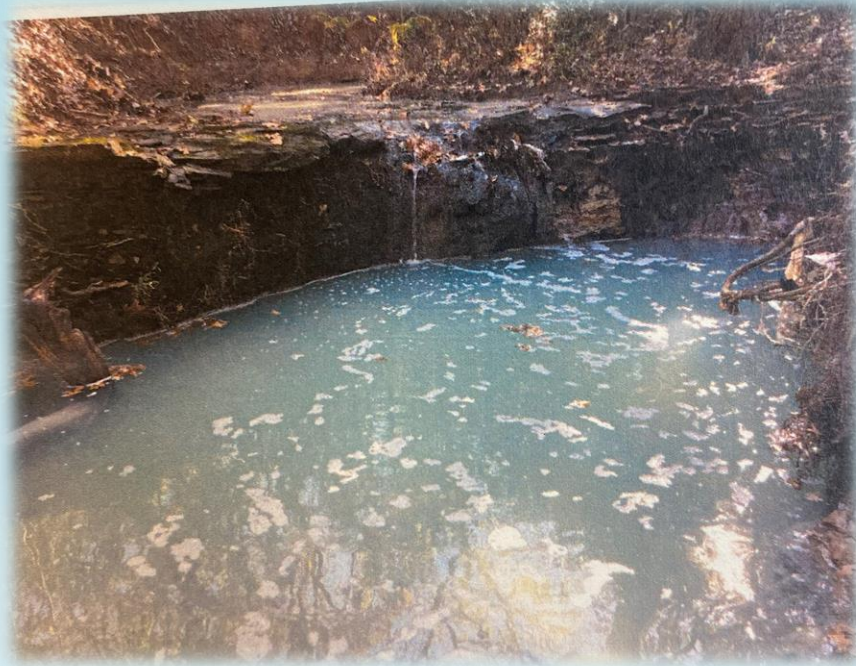
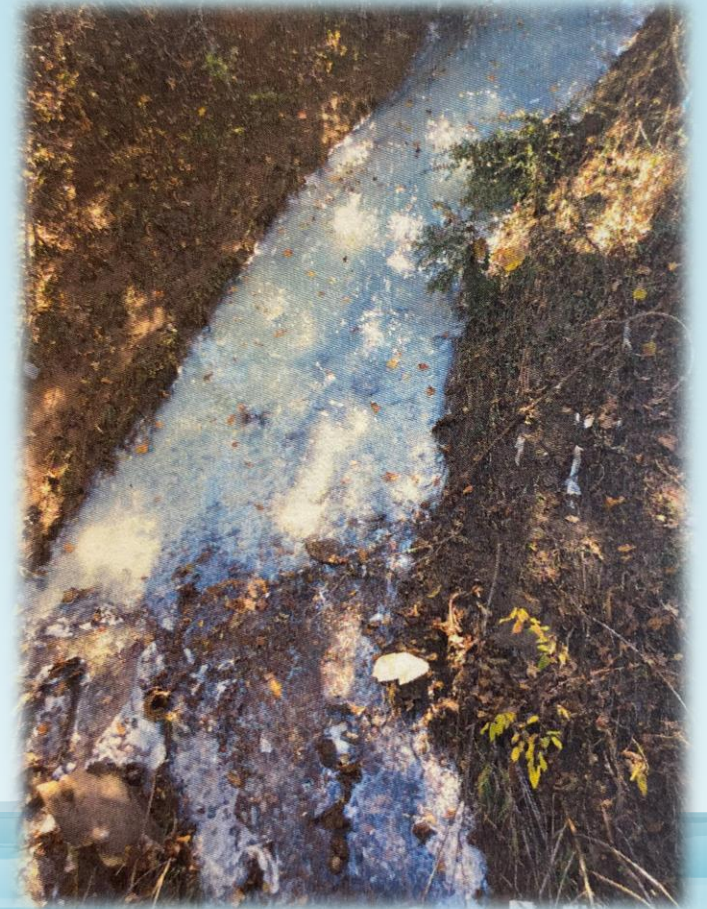
December 4, 2015

- Conducted a channel walk with the assistance of Parks department
- About 1/2 a mile into walk, we start observing:
 - White foamy accumulations along the bank
 - Limestone deposits along exposed bedrock areas
- Water had blue-greenish hue to it.

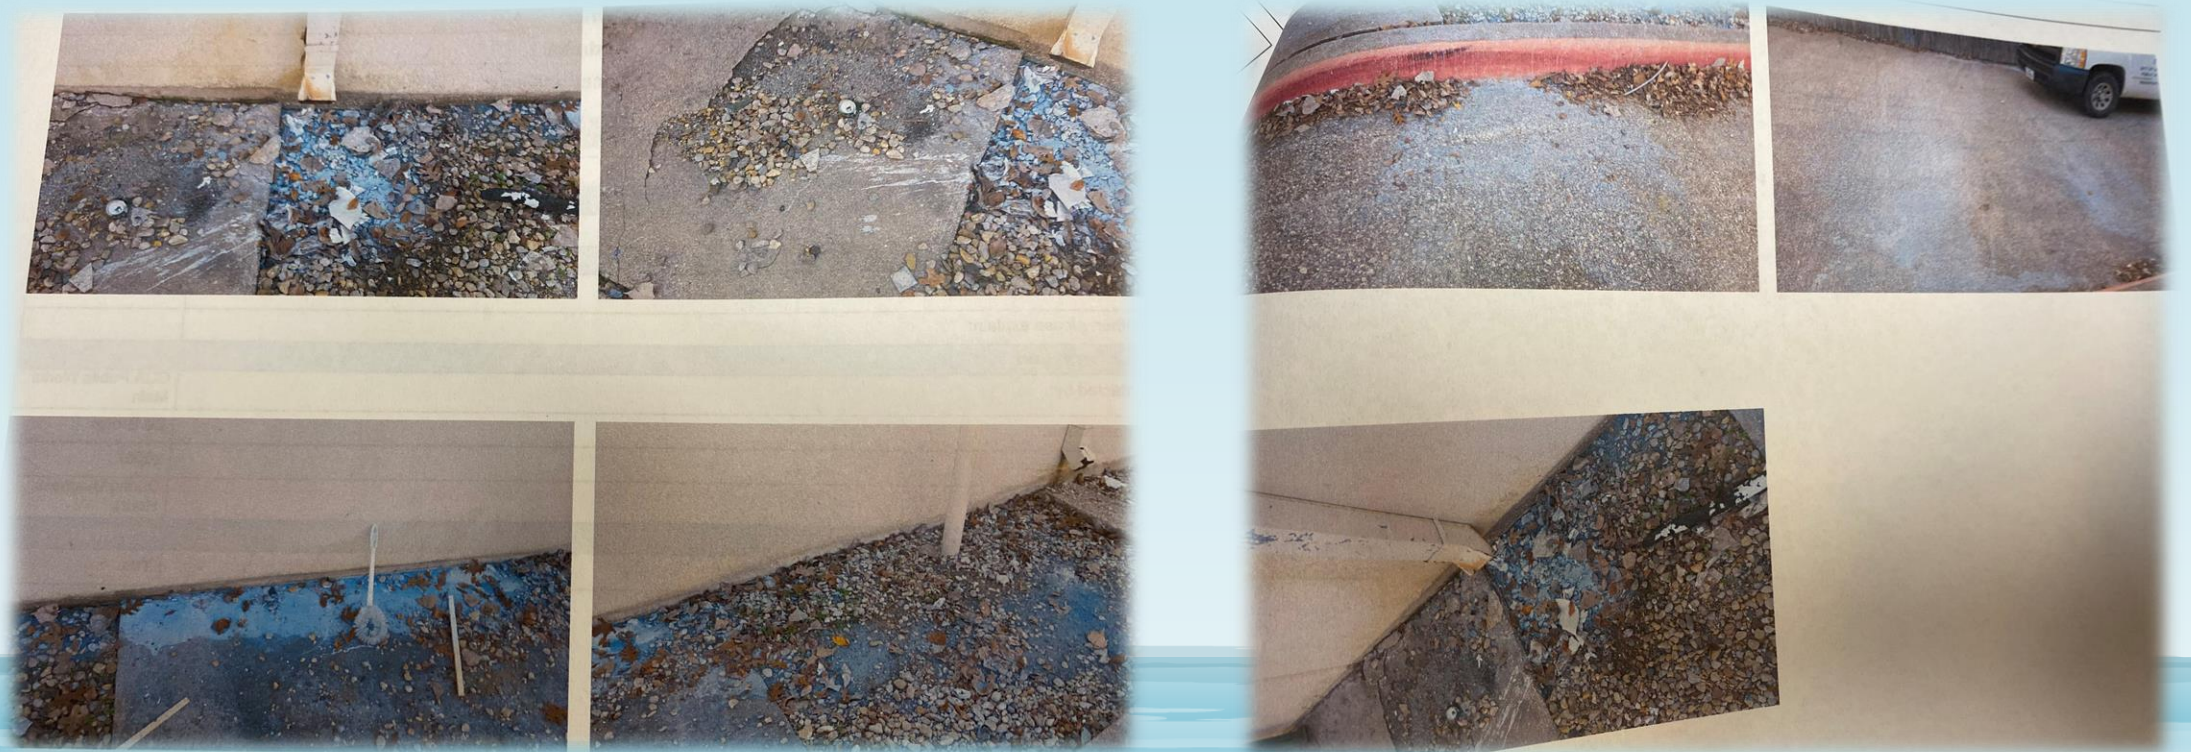
December 4, 2015

➤ **2nd call-out regarding possible pollution source**

- Renovation occurring at nearby commercial facility
 - Observed blue paint being dumped behind the facility
- No evidence of tracking or discharge of waste material outside of dumping area
 - Massive permanent vegetative buffer between dump location and stream
 - Highly unlikely this was the source
