Fish Kill from Hyper-Chlorinated Line Flush

A Tale of Illicit Discharge Detection and Elimination!

Matthew Hendrix, CPESC
Stormwater Specialist
City of Denton – Watershed Protection

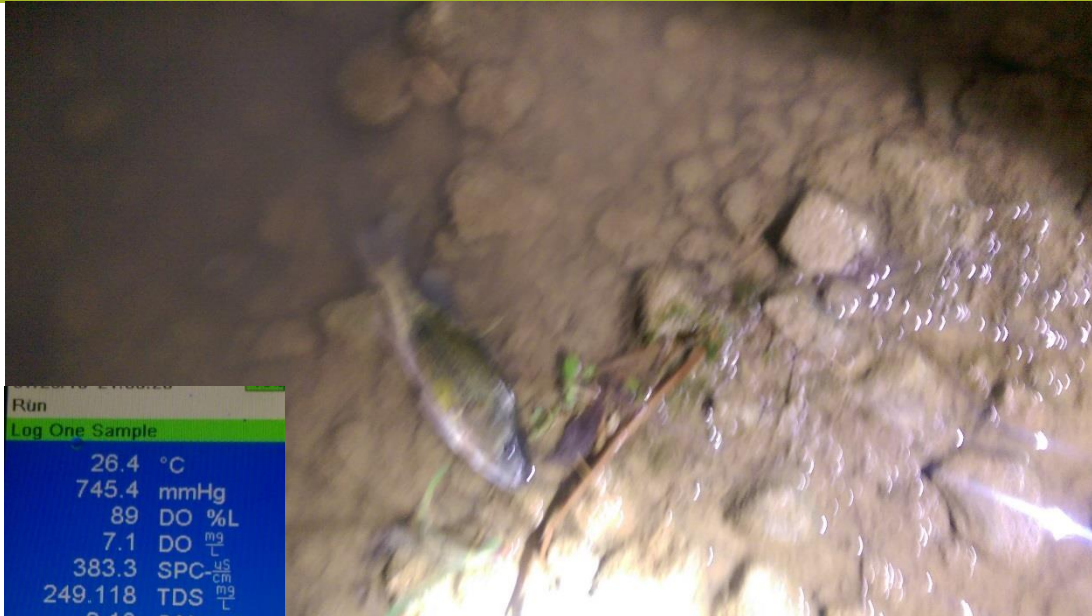
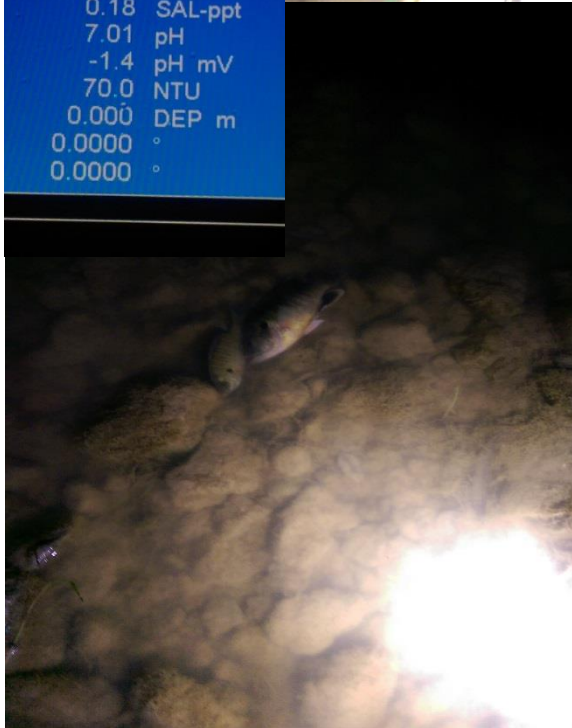
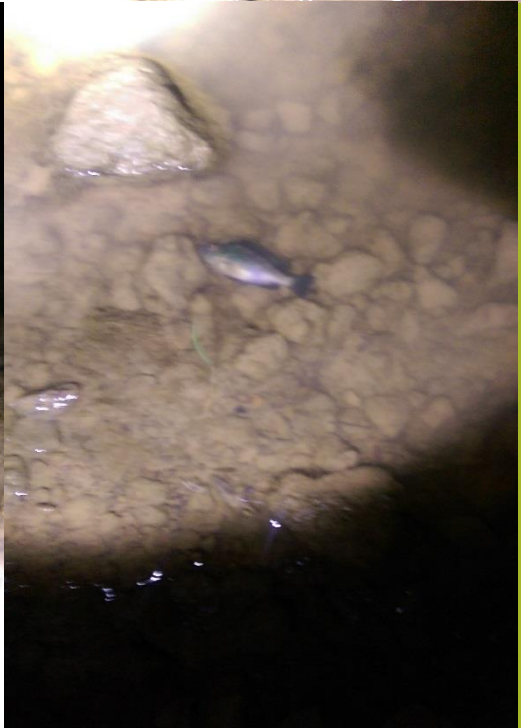
- During the initial Investigation staff discovered slightly turbid or cloudy water, several dead fish and no appreciable flow over base flow.
- Dead fish were that were noted at the site:
 - 3 Bluegill 3-6" in Length
 - 1 Catfish (head only) medium sized
 - 1 Black Bass, 6" in length.
- Water Quality was taken at site with YSI ProDSS data sonde:
 - Temp: 26.4°C
 - pH: 7.01
 - Conductivity: 383 us
 - Turbidity: 70 NTU
 - Average at monitoring site just upstream of this event: 9.4NTU, Median: 3.5NTU, 75%ile 8.7NTU
 - Based on City of Denton long-term monitoring 2001-2016).
 - Staff walked some distance (approximately 50 meters) upstream and downstream of site but was unable to see any additional impacts.
- At this point it was not ascertained whether there was an illicit discharge and the decision was made to investigate further next morning.

Run	
Log One Sample	
26.4	°C
745.4	mmHg
89	DO %L
7.1	DO mg/L
383.3	SPC $\frac{us}{cm}$
249.118	TDS $\frac{mg}{L}$
0.18	SAL-ppt
7.01	pH
-1.4	pH mV
70.0	NTU
0.000	DEP m
0.0000	°
0.0000	°

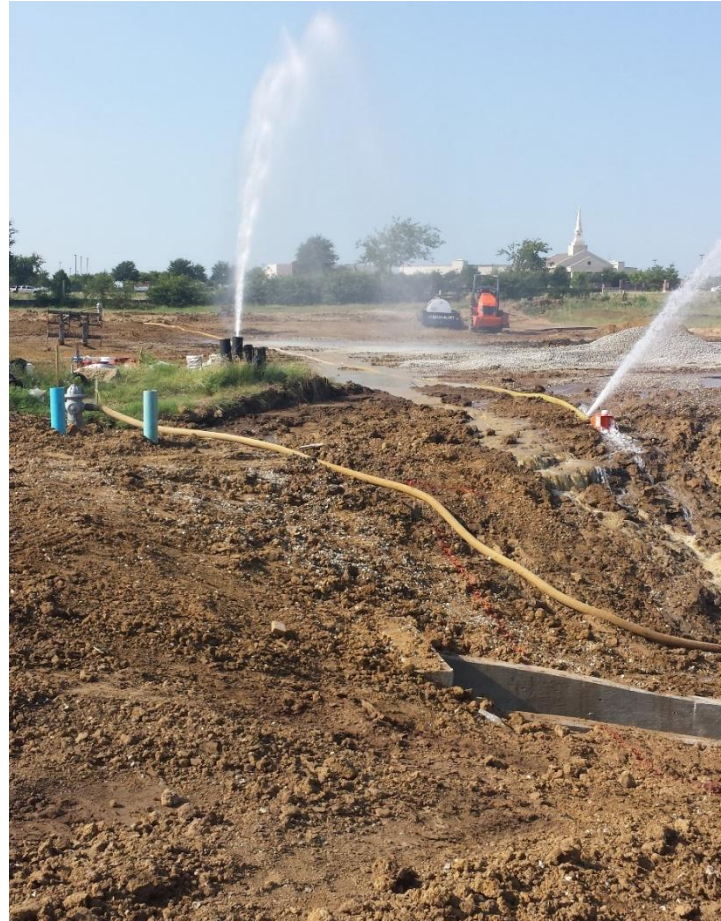
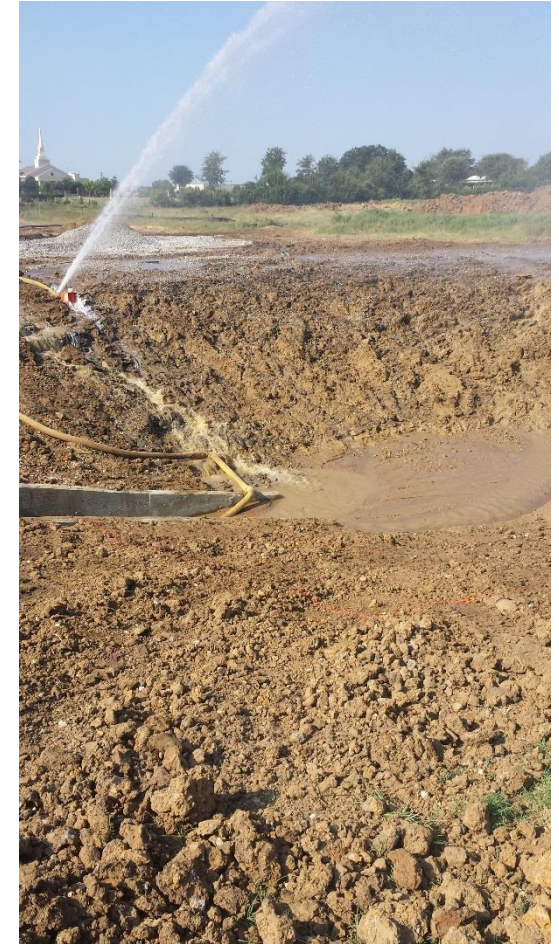
- Flow was followed upstream from this outfall
 - Checked a couple of manholes and quickly assessed the likely location: TPDES Permitted Construction Site (>5 acres)
- On-site, staff noted
 - (1) Hose discharging water into an un-stabilized drainage channel (leading to the new inlet for storm sewer line)
 - (2) Two ripped sections of hose discharging into the air with great force
 - (3) De-chlorinating device at end of hose
- Staff inquired as to whether or not water was being tested during discharge
 - Operators were unaware if testing was being done

- With BMPs pulled to allow water to pass through: TRIPLE WHAMMY!!
- Site Operator was immediately directed to shut down water discharge.
- Staff instructed site operator to verify discharge information (dechlorination) upon any restart of discharge and to monitor downstream.

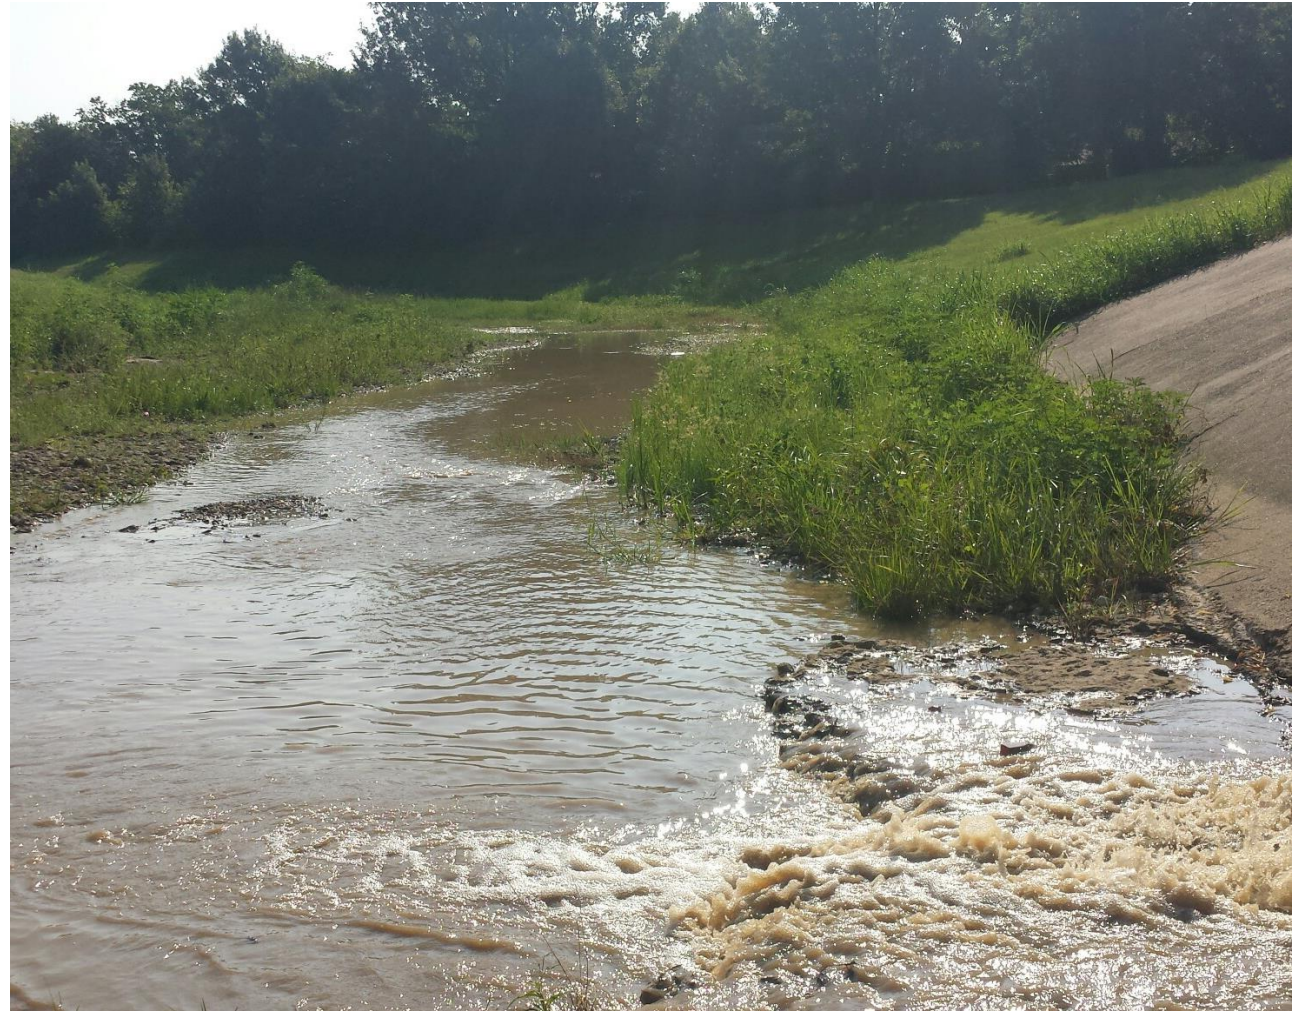
- Hyper-chlorinated line (>100ppm chlorine, which is more than twice what is necessary/normal) was being pumped out of line and through de-chlorinating box,

- BUT no one was watching the sodium thiosulfate deoxidizers tablets to make sure they were still “there,” nor checking discharge for residuals;
 - And of course the hose was ripped in multiple places and a lot of still-hyperchlorinated water was discharging via surface flow into the open inlet

- Chlorine tests by staff showed positive Chlorine (approximately 1.5mg/L)
- Additional WQ Testing and Assessment of fish mortality was conducted.

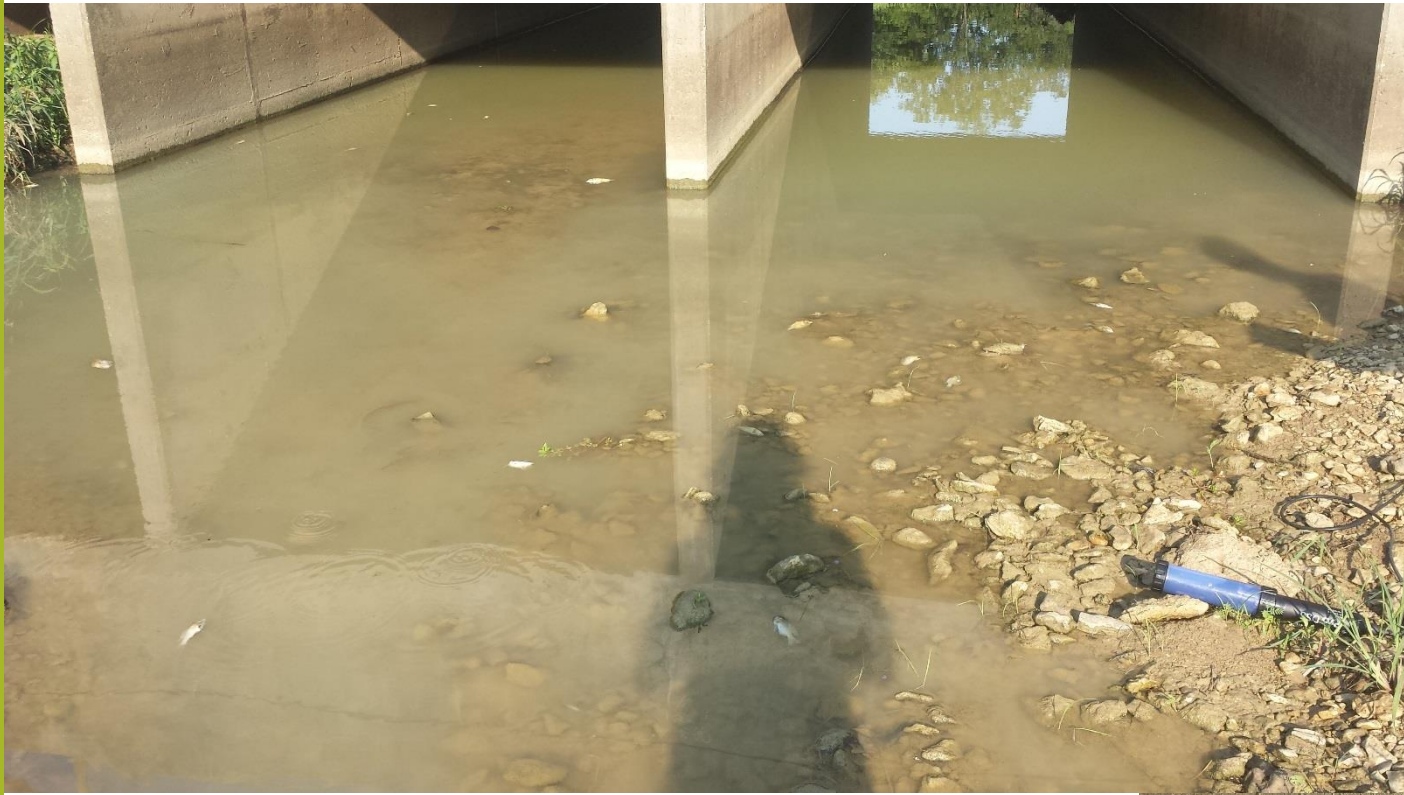
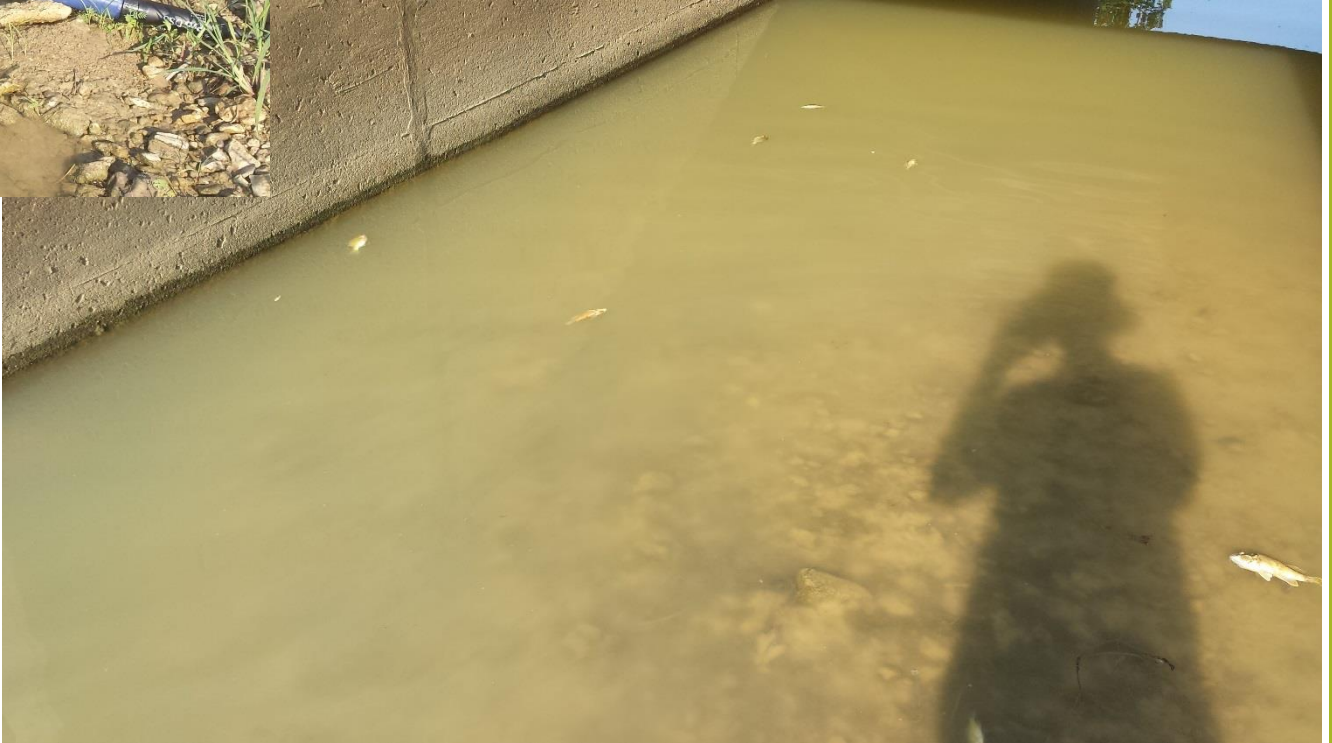
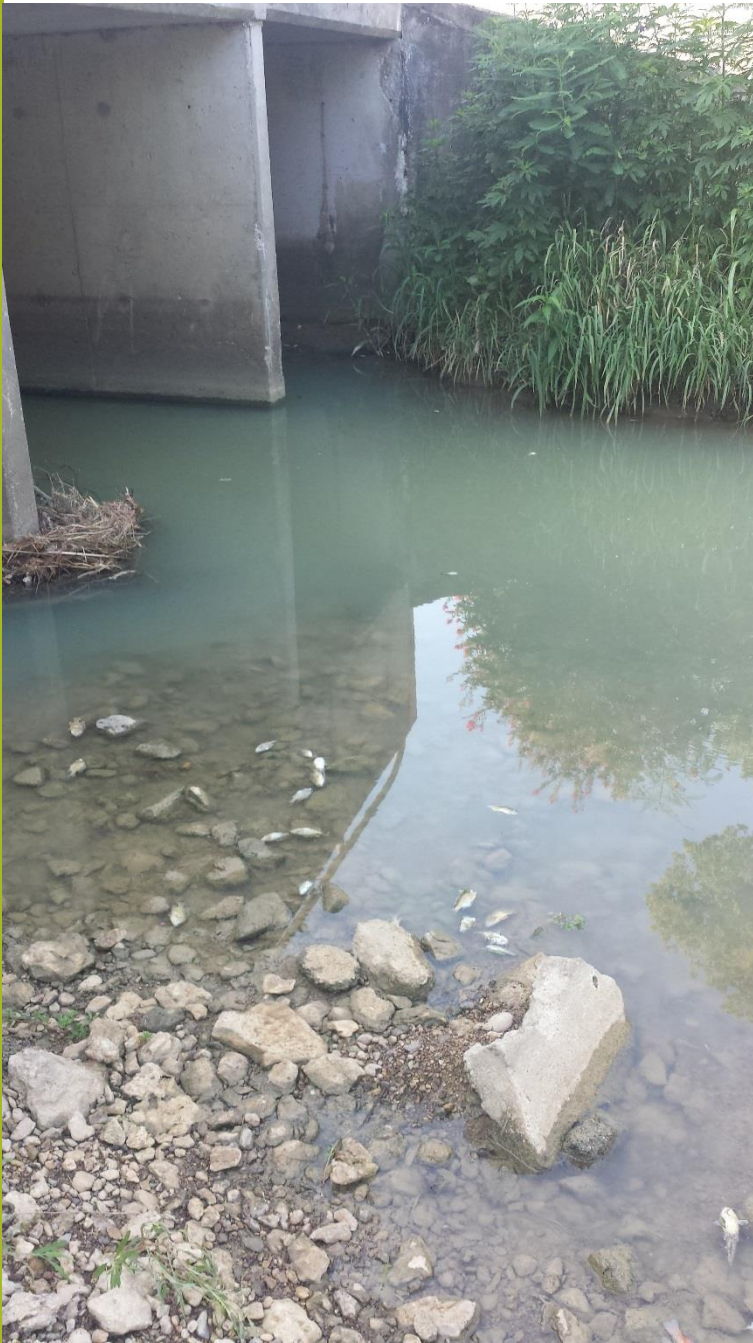
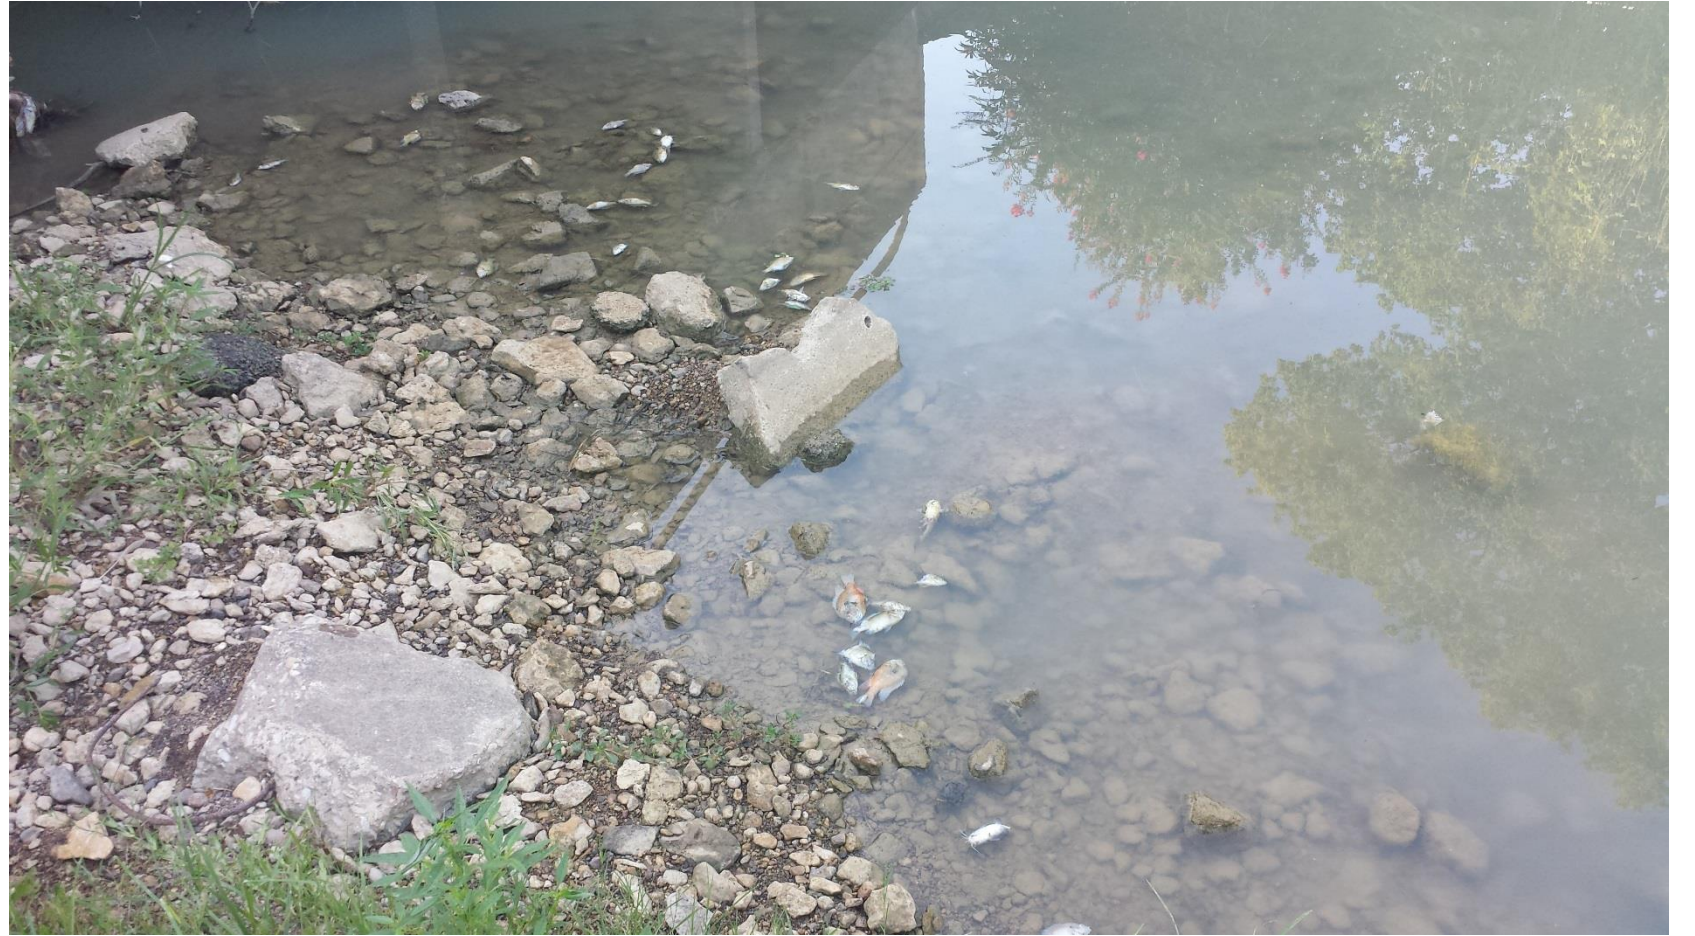
Species	Counts
Carp	3
Blue Gill	36
Catfish	11
Sunfish	16
Bass	21
TOTAL	87
