# NCTCOG Road Safety Audit, Safe Routes to School, and Demonstration Activity

- Project Overview
- Roadway Safety Audits (RSA)
- Safe Routes to School (SRTS)
- Demonstration Activity
- Questions

- SS4A funding awarded in 2023 to support safety planning
- RSAs were conducted to evaluate conditions and identify improvements along high-injury corridors
- SRTS plans were completed to provide recommendations for schools near high-injury corridors
- Demonstration activities were implemented to evaluate speed reduction strategies

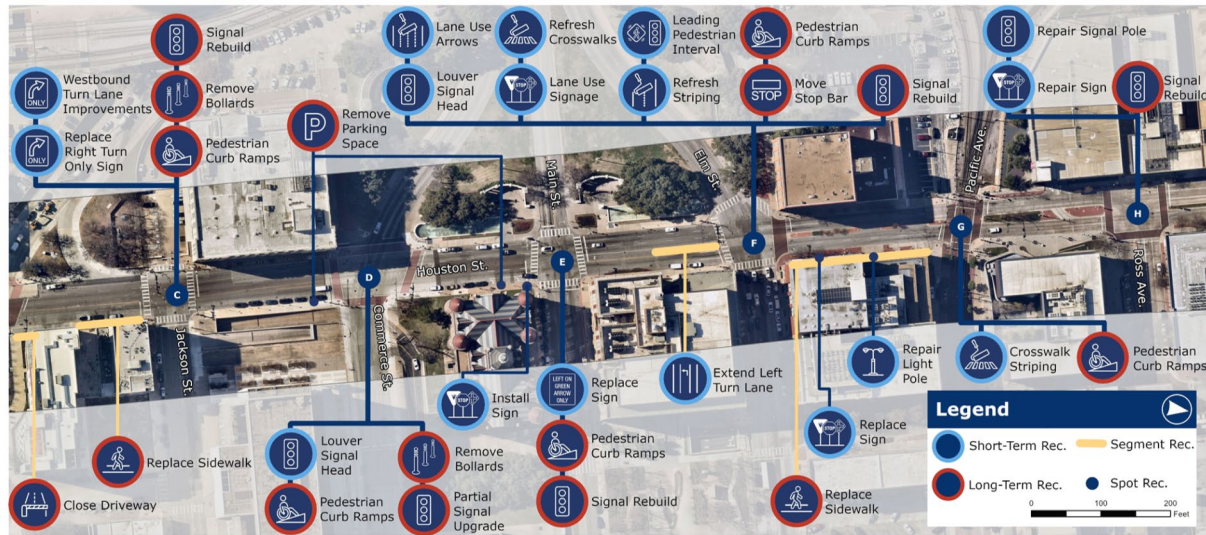
## Recommendations Exhibit | Limits: Houston St. Viaduct to McKinney Ave.

Refresh Striping   Road Reconfiguration   Retroreflective Backplates

### Recommendations for Houston St. from Houston St. Viaduct to McKinney Ave. in Dallas, TX

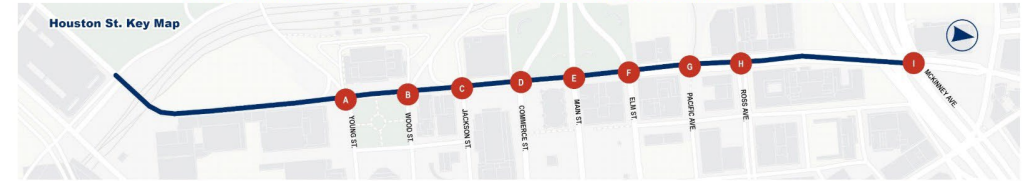
| ID | Study Corridor | Context | Location | Timeline | Simplified Recommendation | Detailed Observation/Recommendation | Countermeasure On Page |
|---|---|---|---|---|---|---|---|
| B.6 | Houston St | Intersection | Wood St | Long | Drainage Issues | <p><b>Observation:</b> The pavement on the northwest corner has created a ponding issue in front of the pedestrian curb ramp</p> <p><b>Recommendation:</b> Fix panel of crosswalk and roadway pavement to allow for positive drainage</p> | Sheet 1 of 3 |
| BC.1 | Houston St | Segment | Northeast Corner of Wood St/Houston St | Long | Close Driveway | <p><b>Observation:</b> Driveway on southside of hotel is not used and is in close proximity to the intersection</p> <p><b>Recommendation:</b> Work with property owner to potentially close driveway to prevent any confusion at intersection</p> | Sheet 2 of 3 |
| BC.2 | Houston St | Segment | East side of Houston St | Long | Replace Sidewalk | <p><b>Observation:</b> Approximately 100' of sidewalk is cracked in several spots</p> <p><b>Recommendation:</b> Replace approximately 100' sidewalk</p> | Sheet 2 of 3 |
| C.1 | Houston St | Intersection | Jackson St | Short | Replace Right Turn Only Sign | <p><b>Observation:</b> "RIGHT TURN ONLY" sign on southeast corner of intersection is rotated away from eastbound approach and is damaged</p> <p><b>Recommendation:</b> Replace and place "RIGHT TURN ONLY" sign to face traffic exiting the parking on the west side of the intersection</p> | Sheet 2 of 3 |
| C.2 | Houston St | Intersection | Jackson St | Short | Westbound Turn Lane Improvements | <p><b>Observation:</b> The westbound movement appears to have a right-turn lane from Jackson onto northbound Houston Street. The lane use sign on the mast arm does not match the lane geometry</p> <p><b>Recommendation:</b> Add turn lane arrows on the westbound right lane. Remove the existing lane use sign on the mast arm and replace with updated lane use sign that matches the approach geometry</p> | Sheet 2 of 3 |
| C.3 | Houston St | Intersection | Jackson St | Long | Pedestrian Curb Ramps | <p><b>Observation:</b> Pedestrian curb ramps, on the southeast and northwest corners, are not directional</p> <p><b>Recommendation:</b> Reconstruct the southeast and northwest corners with directional curb ramps</p> | Sheet 2 of 3 |
| C.4 | Houston St | Intersection | Jackson St | Long | Remove Bollards | <p><b>Observation:</b> There are bollards in front of the Federal Building. The bollards closest to the intersection do not provide adequate space for pedestrians</p> <p><b>Recommendation:</b> Consider removal of 2-3 bollards at the intersection, with coordination with property owner, to allow adequate space for pedestrians</p> | Sheet 2 of 3 |
| C.5 | Houston St | Intersection | Jackson St | Long | Signal Rebuild | <p><b>Observation:</b> Traffic signals are post mounted with outdated equipment and missing push buttons.</p> <p><b>Recommendation:</b> Full signal rebuild with considerations of the following equipment:</p> <ul style="list-style-type: none"> <li>New poles and mast arms</li> <li>New signal heads with retroreflective backplates</li> <li>APS push buttons for all crossings</li> <li>Pedestrian countdown heads</li> <li>Luminaires on the corners (assuming no conflict with overhead utilities)</li> </ul> | Sheet 2 of 3 |
