The San Antonio River Basin TMDL Program Thursday, May 4, 2023

Upper San Antonio River (USAR) TMDL

Lower San Antonio River (LSAR) TMDL

USAR TMDL I-Plan

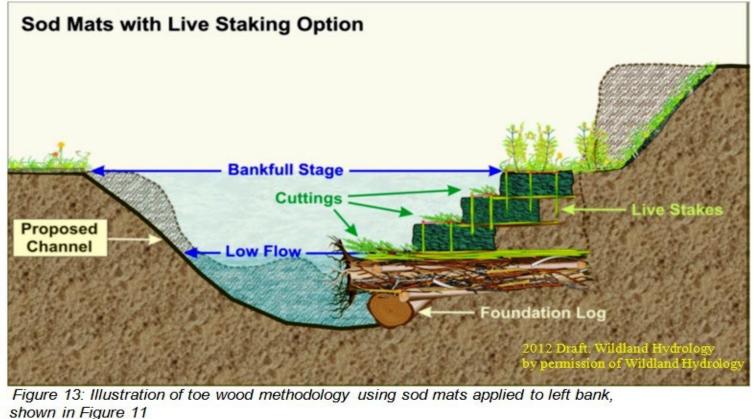
Natural Channel Design

- Bank structural restoration using toe wood
- Habitat restoration
- Reduced
 sediment load

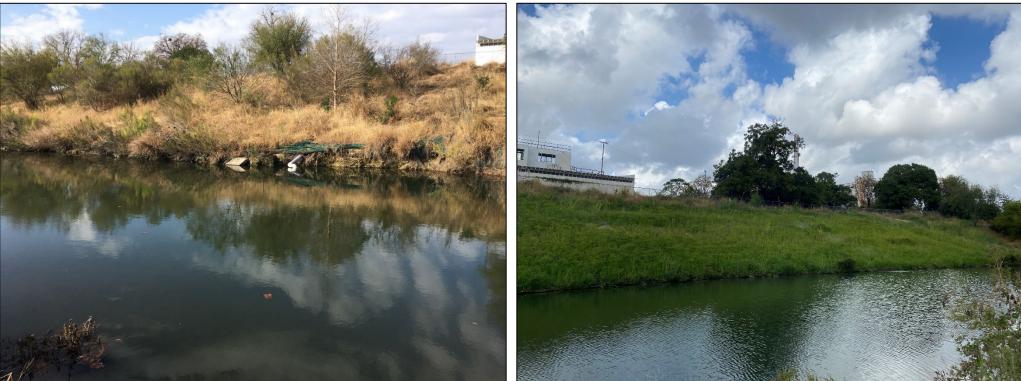
Before

Construction: May – July 2020
