U.S. Department
of Transportation
**Federal Highway
Administration**

Road Safety Audit Akard and Ervay Streets Dallas, TX

MARCH 28, 2022

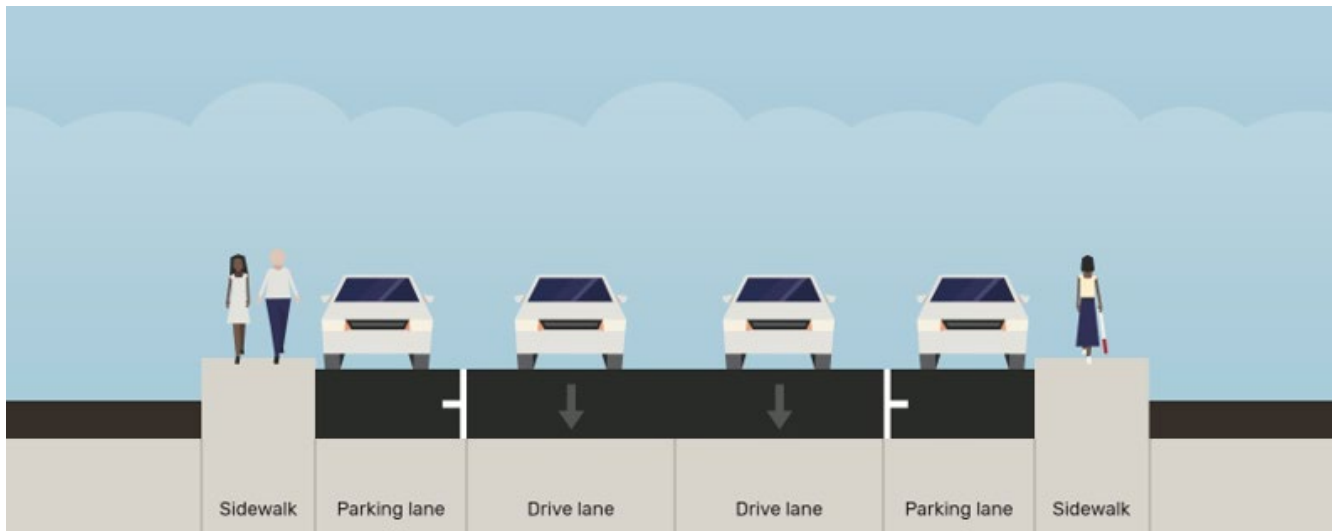
Figure 6: Rendering of potential cross-section described above

- During our field visits, the RSA Team did not observe capacity issues related to parking utilization. The City could consider changing the Akard cross-section to two through lanes to meet capacity demands. Remaining roadway

width could then be used for other priorities, including wider sidewalks and dedicated parking lanes with possible bulbouts or turn-lanes where appropriate to improve safety and turning operations. Bulbouts extend the sidewalk into the parking lane and reduce the crossing distance for pedestrians. Bulbouts reduce speed of turning vehicles, encourage pedestrians to cross at designated locations, shorten the crossing distance, and prevent vehicles from parking at corners. Bulbouts can also improve sight triangles, which could help locations like Federal Street which has low visibility. The City could consider rideshare curbs near high activity areas where appropriate, similar to existing downtown example on North Harwood Street. Timeline: Medium- to long-term. Where the City decides to continue to allow parking, unambiguous stall pavement markings should be installed per City standard (Standard Construction Details 251D sheet 5011). Timeline: Medium- to long-term.

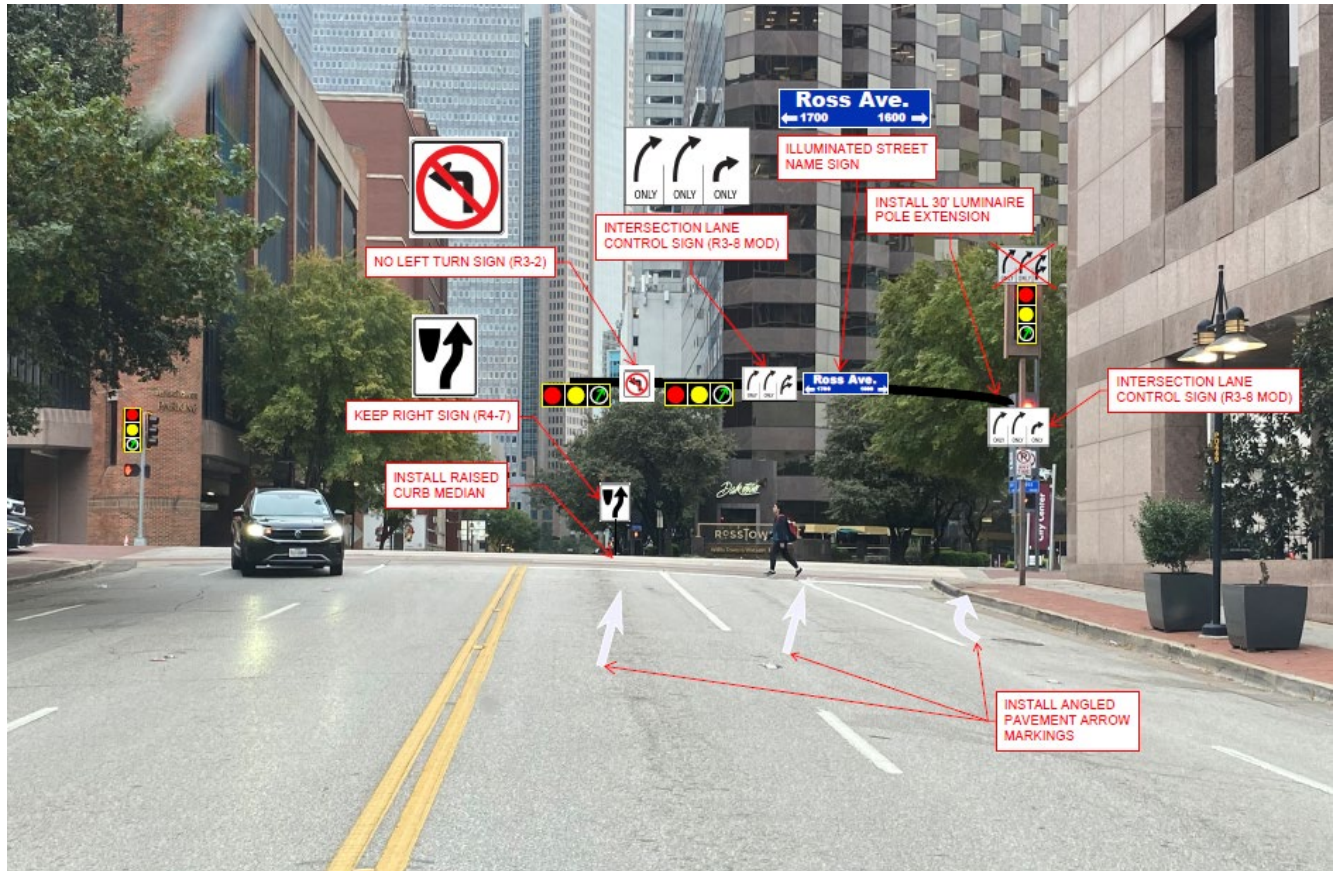
Figure 8: Rendering of potential improvements for Akard/Erway/Ross

- **Observation:** The RSA Team observed many conflicts between drivers, often due to drivers deviating from their lane assignments as they traveled through the intersection. Drivers often conflicted in the right two lanes south of the intersection where the rightmost lane then allows for parking. The RSA Team also noted a history of right-angle crashes and sideswipe crashes: the last five years of crash data showed 43 crashes at this intersection, 23 of which were right-angle crashes and five of which were sideswipe crashes. The RSA Team observed that for drivers traveling southbound through the intersection, a variety of factors contributed to visibility issues.

Recommendation: Install and/or refresh signage and pavement markings, and consider signal upgrades. Upgrading to the City's current standard of mast arm signals would provide more conspicuous signal head placement and would better accommodate this larger intersection. Green arrow indications in lieu of circular green signal indications would provide more visual guidance to the driver about the upcoming horizontal curve, as would angled arrow pavement markings. Intersection lane control signs, possibly located on mast arms, would be more conspicuous and a supplemental sign on the near side that is located below the signal would reinforce the message. Pavement marking extensions through the intersection (“puppy tracks”) could be installed. South of the intersection, installing a raised curb median for the northbound Erway Street to southbound Akard Street U-turn movement would provide positive guidance and separation for southbound traffic. **Timeline:** Short-term for pavement marking and signage improvements that could be installed in an interim condition, otherwise medium- to long-term.

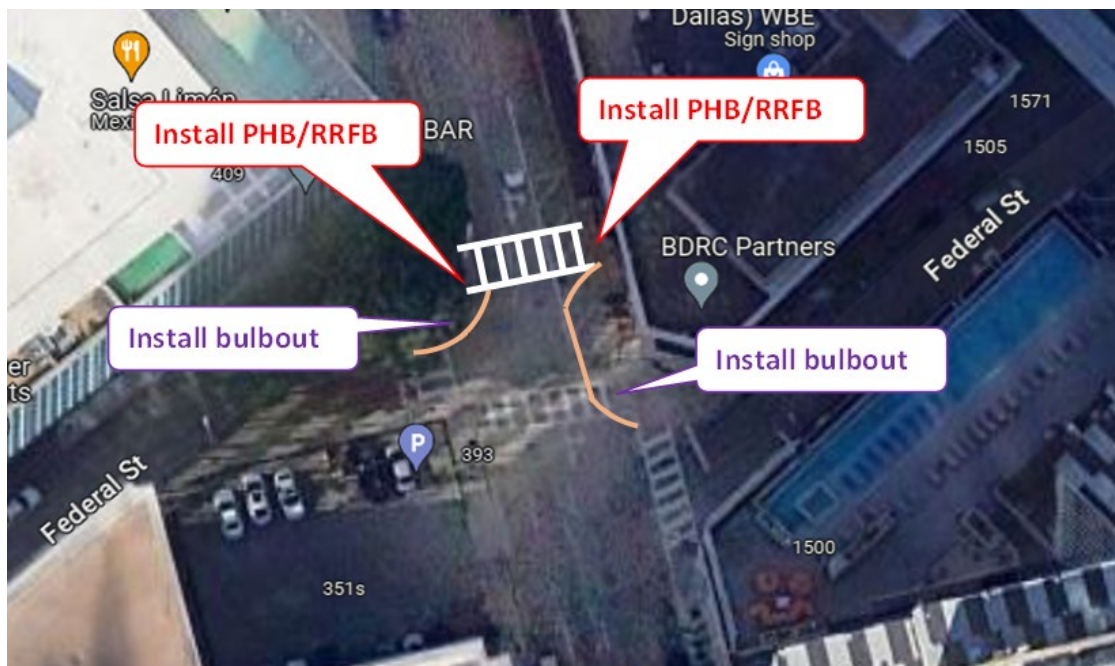
Figure 12: Rendering of potential improvements at Akard/Federal

- **Observation:** The RSA Team observed many conflicts between pedestrians crossing Akard Street (using the marked crosswalk or otherwise) and drivers making the eastbound through movement continuing on Federal Street. Due to the skewed configuration, drivers continuing eastbound on Federal Street tended to focus on looking for oncoming vehicular traffic on Akard. This often led to drivers not looking for pedestrians using the marked crosswalk. The RSA Team observed some pedestrians preferring to cross Akard Street north of the existing crosswalk, likely desiring to avoid the conflict with eastbound Federal Street drivers.

Recommendation: The crosswalk could be relocated with enhanced pedestrian improvements, which would remove the conflict with pedestrians crossing Akard Street and drivers making the through eastbound Federal movement. Enhanced pedestrian improvements to the crosswalk could be the addition of a [Pedestrian Hybrid Beacon](#), [Rectangular Rapid Flashing Beacon](#), or [Crosswalk Visibility](#)

Enhancements. **Timeline:** Short-term for pavement markings; medium-term for other enhancements.

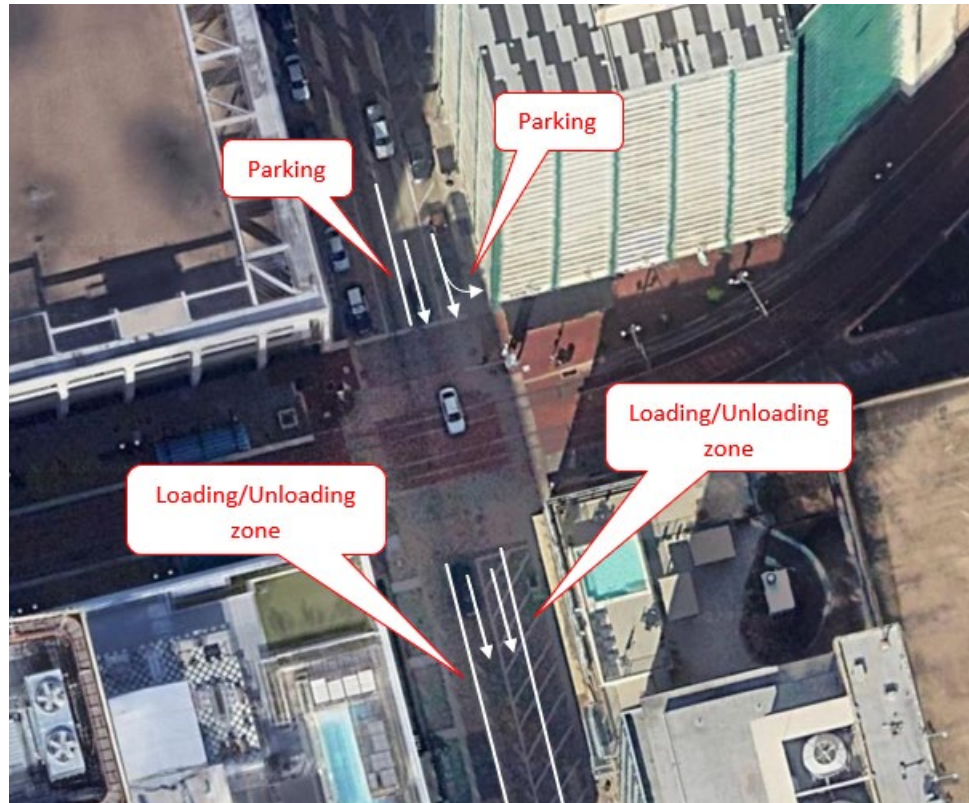
Figure 17: Rendering of potential improvements at Akard/Pacific and Akard/Elm

- **Observation:** During the field visits, curb management in this location was impacting safety and operations. The RSA Team observed very low utilization of the rightmost through lane on the northwest side of the intersection. Issues at this location were further hindered by operational issues at Akard Street at Elm Street location, as noted below.

On the northwest side, rush hour parking restrictions were in place but were often ineffective, and no enforcement was observed during the field visits. This resulted in an effective cross-section of one through lane and one left-turn lane.

Recommendation: The two travel lanes could be shifted to the east for the majority of the block and tapered back to the west approaching Elm Street, and one crosshatched lane could be installed on both the east and the west sides. This would allow for vehicles to stay in the street, and valet operations could occur in the crosshatched area with one lane for each of the 1505 Elm Street residences and The National building. **Timeline:** Medium- to long-term.

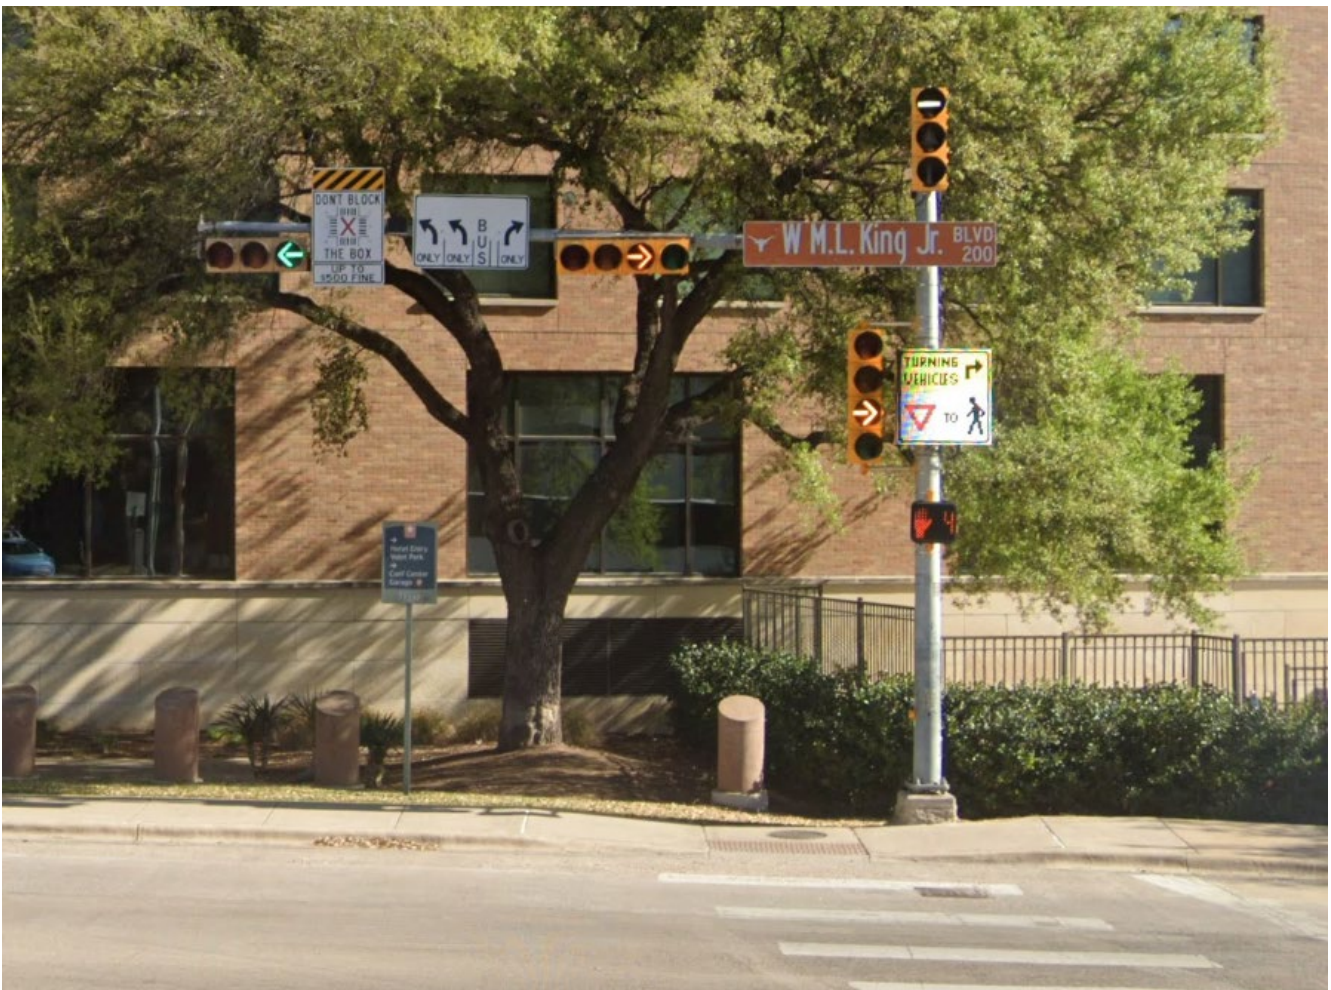
- **Observation:** This is an area of high pedestrian activity. Conflicts between pedestrians and drivers were observed between pedestrians on the west side of the intersection and drivers traveling from southbound Akard Street to westbound Elm Street. **Recommendation:** Conflicts between pedestrian movement and driver right-turns likely warrant an upgraded investment in signal technology at this location. Consider implementing the emerging trend of using Flashing Yellow Arrow for pedestrian conflicts instead of circular green signal indication. Some municipalities, including Austin (example shown in Figure 17 below) and Houston, have been using the Flashing Yellow Arrow in areas with pedestrian conflicts. Research indicates that the Flashing Yellow Arrow increases yielding behavior and “fails safe” in that drivers stop when they are unsure what to do while with a circular green signal indication drivers tend to go when they are unsure what to do. Akard Street at Elm Street might be a particular location for further study, with a protected green for right-turns and a pedestrian phase with Flashing Yellow Arrow right-turn indication to encourage yielding behavior. While the City is considering the Flashing Yellow Arrow, a

Figure 18: Example of Flashing Yellow Arrow for pedestrian conflicts ([Google Street View](#)). Note that Austin frequently uses dynamic ITS signs for these treatments, and the sign appearing here as Turning Vehicles Yield to Pedestrians (R10-15) is one of them.

more immediate temporary Turning Vehicles Stop for Pedestrians signs (R10-15) on both the far side and near side of the intersection could be installed.

Timeline: Medium- to long-term for new equipment. For signage and pavement markings while the City considers and/or plans for Flashing Yellow Arrow, short-term.
