U.S. Department
of Transportation
**Federal Highway
Administration**

Vickery Meadow Pedestrian Road Safety Assessment (PRSA)

**Conducted:
February 24-26, 2015**

**At the Request of:
City of Dallas**

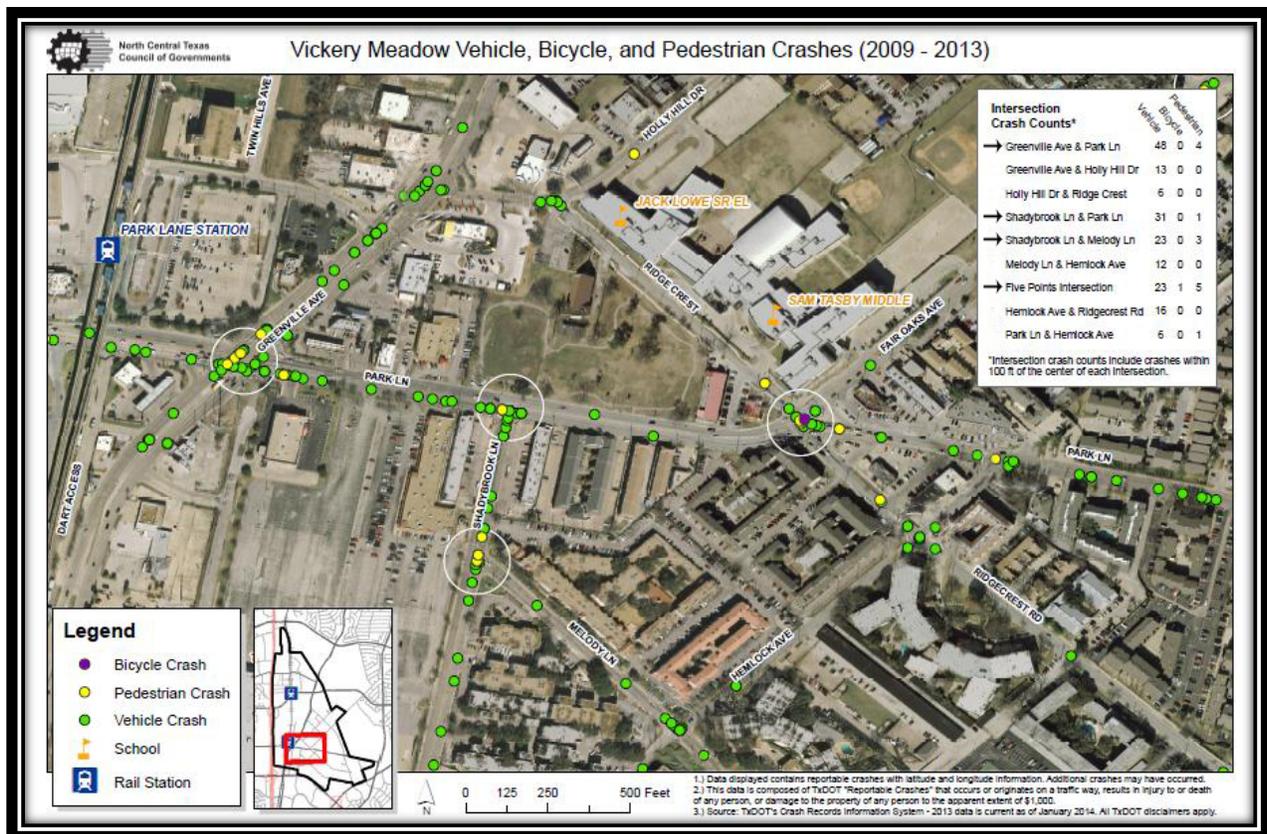
Map 1: Vickery Meadow Neighborhood

Prior to the PRSA the NCTCOG provided crash maps of the Vickery Meadow Neighborhood. Although the PRSA team would assess more than what's shown on Map 1, a decision was made to focus the PRSA to the following areas:

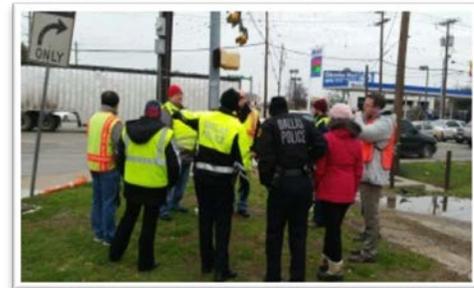
Figure 2: PRSA team site visit

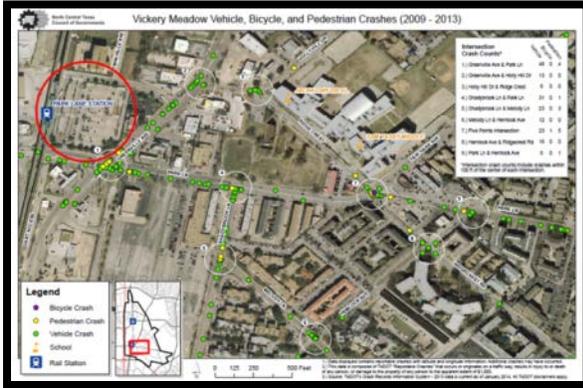
Map 2: DART Park Lane Station

Lane where pedestrians wait to finish the crossing.

- Suggestion 1: Extend the pedestrian bridge across Park Lane from the elevated train platform. This would be the most direct path, therefore a higher probability it will be used. A similar design was constructed at the Downtown Carrollton DART Station (Figure 17).
- Suggestion 2: Evaluate installing a marked crosswalk with a Rectangular Rapid Flashing Beacon (RRFB) or Pedestrian Hybrid Beacon (PHB) enhancement where pedestrians are currently crossing.

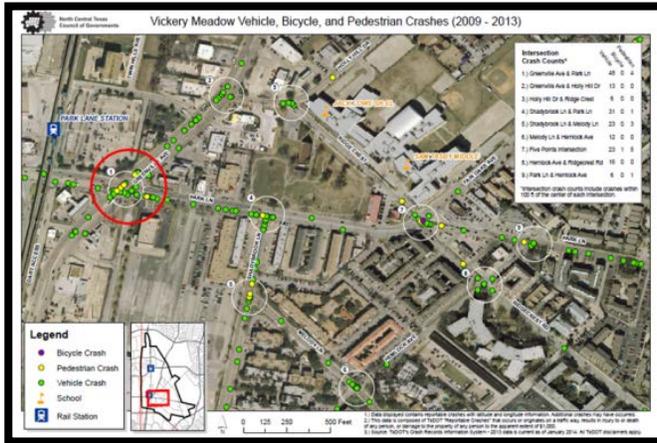
Map 4: Intersection of Greenville Ave and Park Lane

4. Three street lights were within 25 feet of the intersection. The nighttime review revealed lighting could be improved at and near the intersection. On the northwest corner of the intersection there were tree branches which made the corner even darker at night. The tree branches also housed many birds which also took care of “business” directly over where people would be waiting for the pedestrian signal.

- Suggestions: Check and repair all the push buttons and pedestrian signals heads that are not working properly. Place a sticker on poles to who can be contacted if buttons and signals do not seem to be working
- Evaluate accessibility design standards for push buttons and curb ramps. If locations cannot be fixed right away be sure to add the locations in the city’s ADA transition plan.
- Timeframe: Short to Long
- Cost: Medium to High

- Suggestion: Add street lighting per the recommendation of FHWA-HRT-08-053 April 2008 Informational Report on Lighting Design for Midblock Crosswalks (Figure 25)
- Suggestion: Trim tree branches to improve lighting and not housing birds directly over the sidewalk area (Figure 26).
- Timeframe: Short to Intermediate
- Cost: Lighting–Intermediate to High; Tree trimming–Low

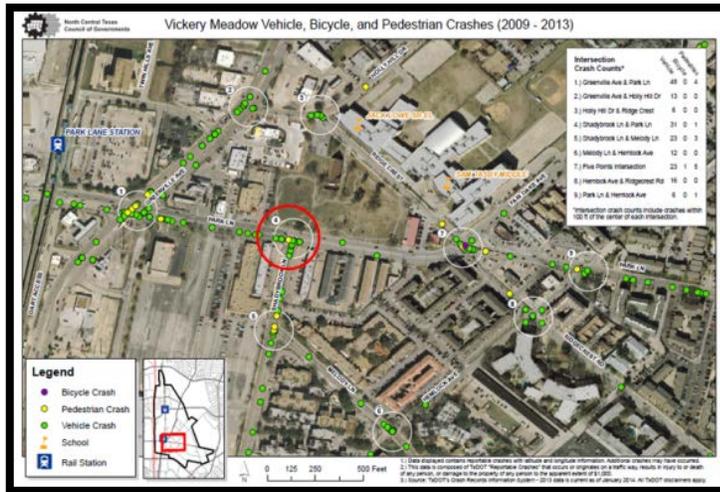
Map 7: Park Lane and Shady Brook Lane Intersection

2. There were crosswalks at the T-Intersection; however there were no curb ramps on the north side of Park Lane at the ends of two of the three crosswalks. (Figure 28) This makes it very difficult for people with disabilities to cross at these signalized locations. The curb ramp on the southwest corner had a large hole (Figure 29), therefore making it unusable for a person in a wheelchair, but also tripping hazards for both sight able and disabled pedestrians. The pedestrian push buttons were also placed at locations and heights that made it difficult or impossible for a person in a wheelchair to access. Truncated domes or detectable warnings are required to indicate to the blind where the edge of the sidewalk is located and that a curb ramp exists.

4. The review team observed a high number of turning movements at this intersection.

- Suggestion: Add street lighting at the intersection per the recommendation of FHWA-HRT-08-053 April 2008 Informational Report on Lighting Design for Midblock Crosswalks
- Timeframe: Intermediate to Long
- Cost: Medium to High

- Suggestion: Consider implementing a Leading Pedestrian Interval (LPI) (Figure 30). An LPI is when the pedestrian gets a head start before the vehicles. This is implemented by giving the pedestrian signal a walk 3-4 seconds typically before the vehicles get the green. This allows pedestrians to establish themselves in the crosswalk before vehicles start moving. Yield or Stop for pedestrian in-street signs could be installed on lower speed roadways in conjunction with this implementation.

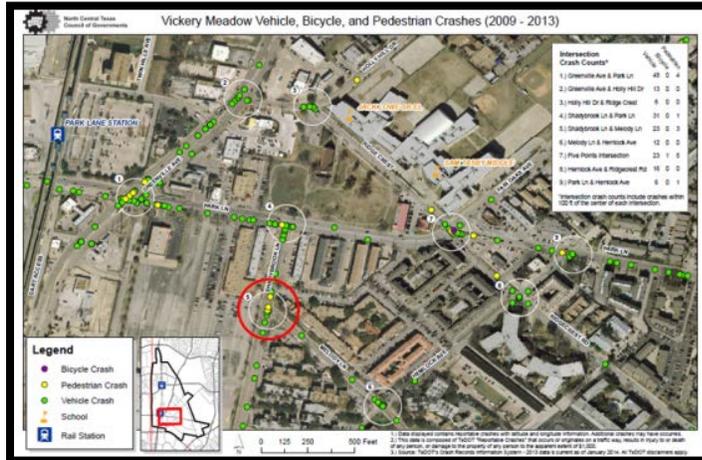
Map 9: Intersection of Shady Brook Lane and Melody Lane

1. A couple of the pedestrian push button and signals were located a fair distance away from the curb ramp and do not conform to ADA standards (Figure 31). This causes two issues, one is the signal timing and the other is visibility of the pedestrian signal. The signal timing should include the time a person in a wheelchair would push the button, get to the curb ramp and cross the roadway. The visibility of the signal head was difficult to see due to the angle and expected location of the pedestrian signal head (Figure 32 yellow circle).

2. Some street lighting was observed but could be improved for pedestrians.

3. Although curb ramps exist, they do not meet current ADA standards. Curb ramps need a level 4'x4' level landing at the top of the ramp so a person in a wheelchair can wait on a level surface and also maneuver a turn (Figure 34). Although single curb ramps are discouraged, if they are installed a 4'x4' level landing is required at the bottom of the ramp as well to maneuver a turn into the correct direction (Figure 35). Truncated domes are also required to indicate to the blind where the edge of the sidewalk is located and that a curb ramp exists.

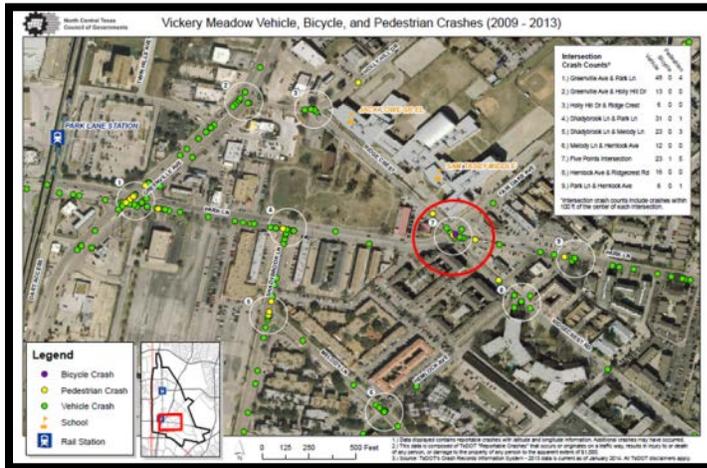
Map 11: 5-Points Intersection

2. The pedestrian signal head and push buttons controlling the crossing of Ridgecrest Road were not operating properly. When crossing certain legs of the intersection the countdown went to zero as we stepped onto the sidewalk.

- Suggestion: Evaluate different intersection designs that would improve pedestrian flow, such as a modern roundabout. Roundabouts have fewer conflict points, and also can be more efficient than a signalized intersection in many situations.
- Timeframe: Intermediate to Long
- Cost: Intermediate
