Illicit Discharge Detection and Elimination

City of Denton – January, 2020

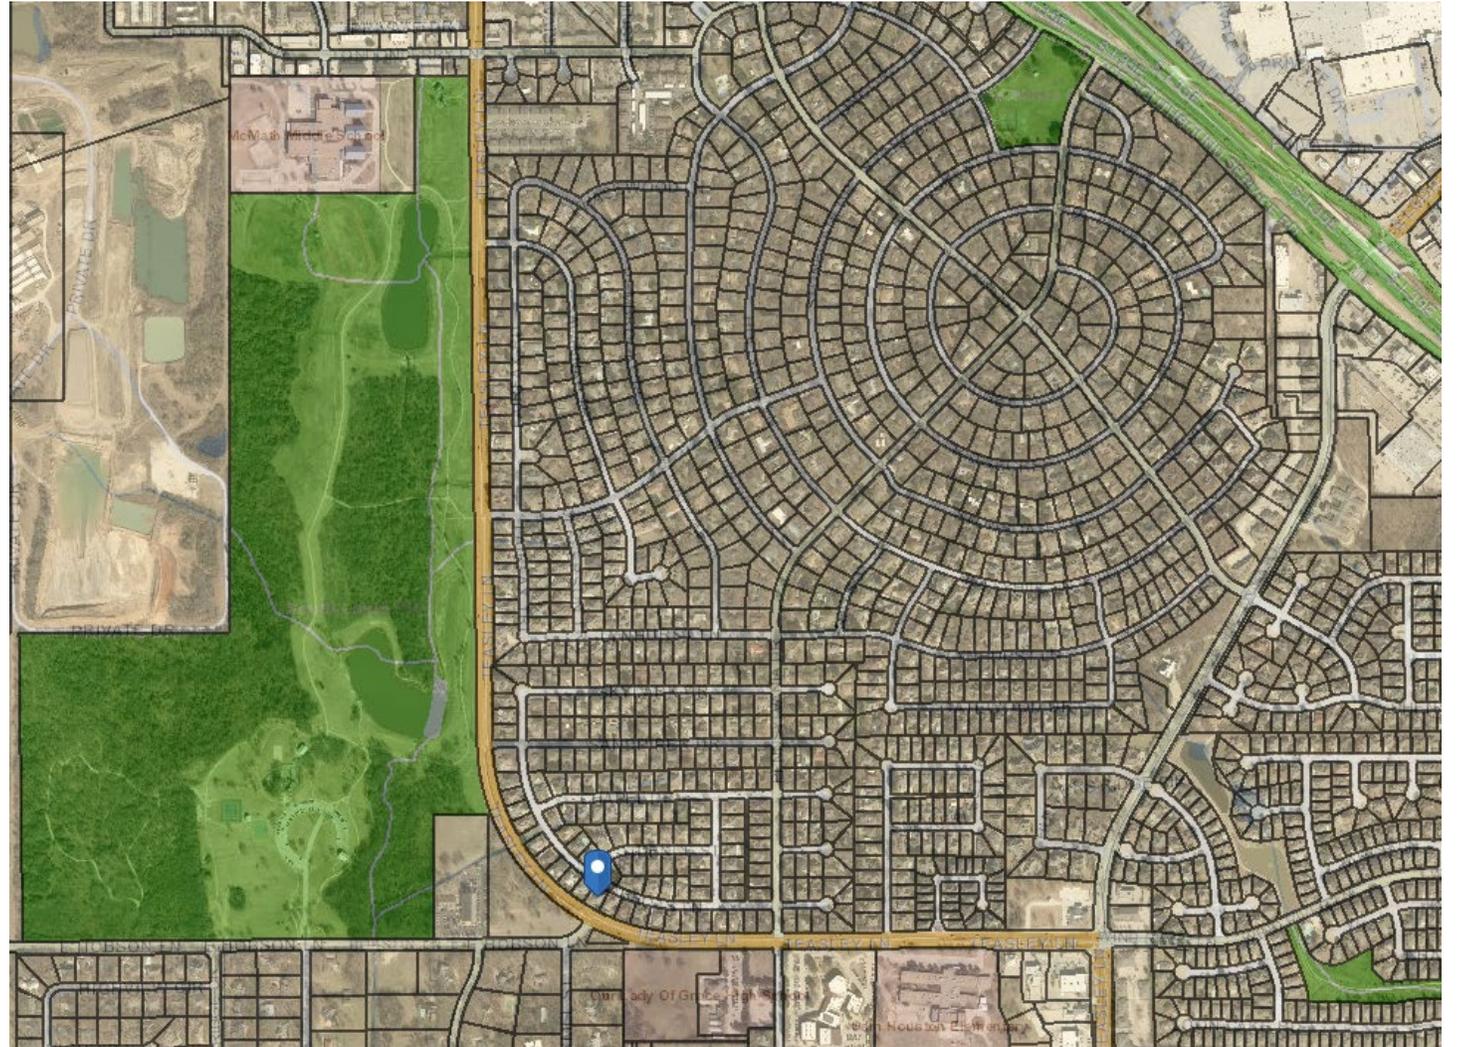
- Received complaint from citizen January 2020
- Bubbling in storm sewer, sewage smell
- Storm sewer draining from residential area
- Daylights at culvert under road

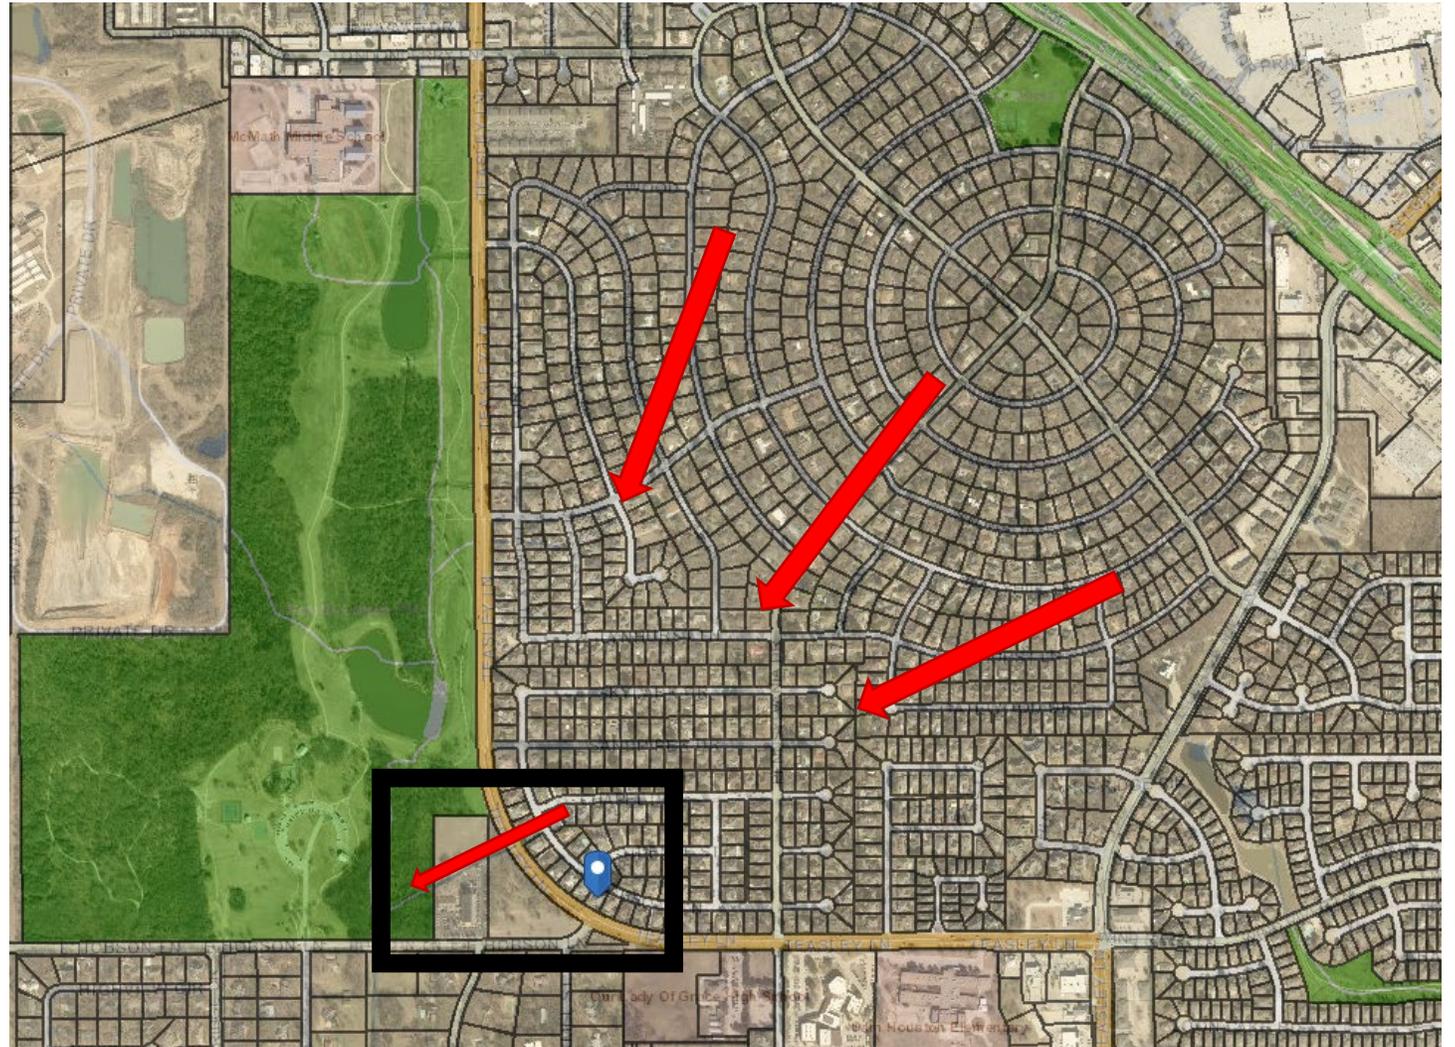
- Received complaint from citizen January 2020
- Bubbling in storm sewer, sewage smell
- Storm sewer draining from residential area
- Daylights at culvert under road
