Illicit Discharge in an Industrial Park

Dry Weather Outfall Field Screening Discovery

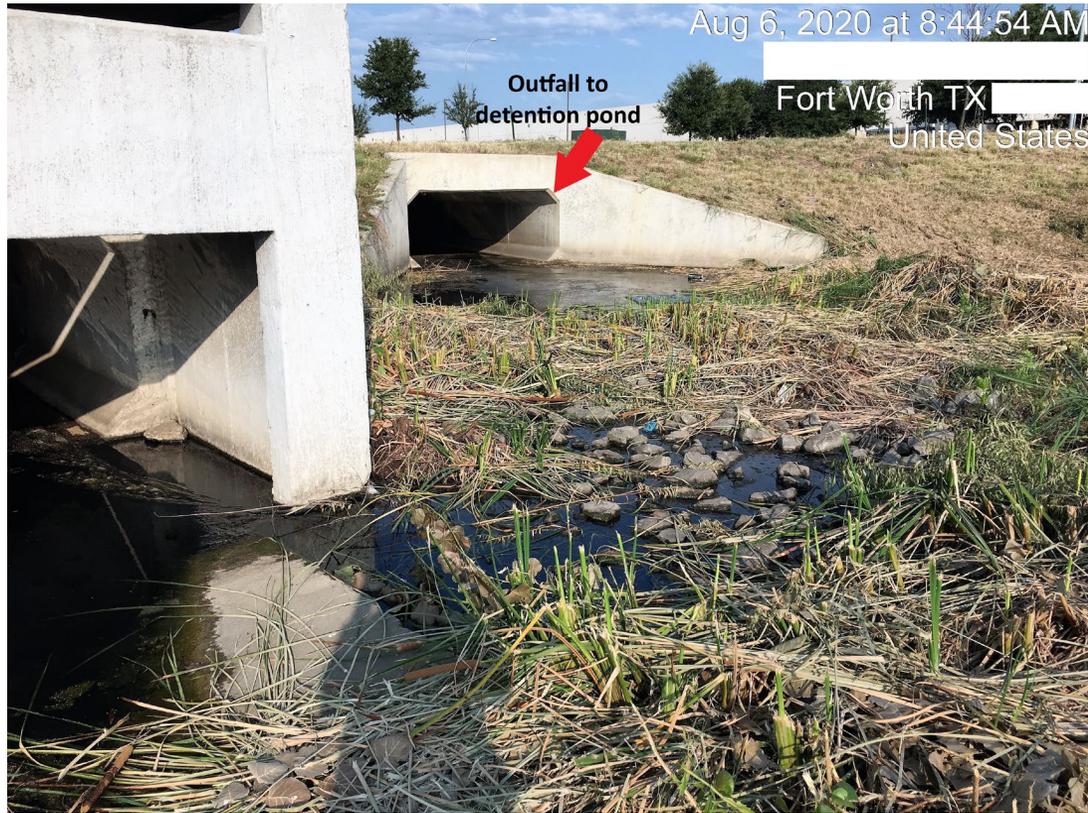
Private outfall, secondary test site

- Traceback was initiated through the detention pond
- There were two flows observed above the original detention pond contributing to the outfall drainage:
 - an above ground water leak leading to a drop inlet
 - the outfall to the second detention pond had above trigger levels for detergent, ammonia and phenol. Also noted was strong sewage odor, and gray water appearance.

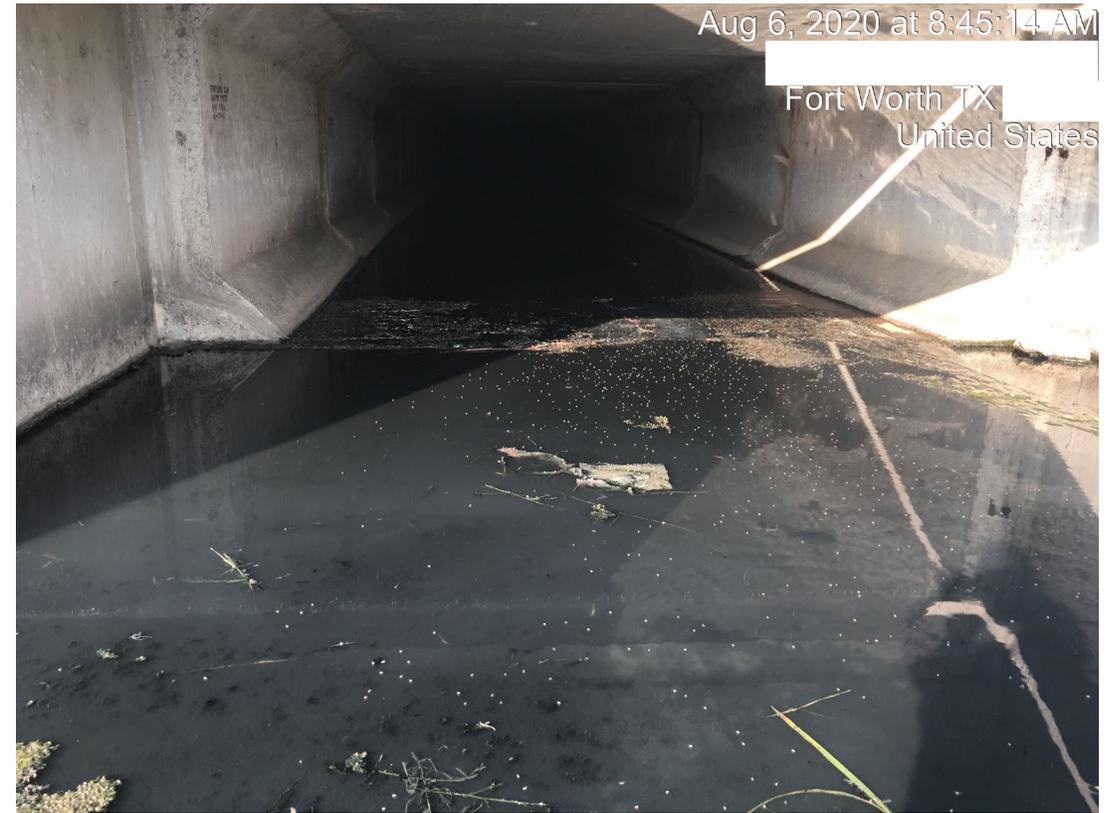
DWFS outfall, original test site

- During scheduled Dry Weather Field Screening, a flow was observed during the second site visit.
- Sample results indicated detergent at above trigger levels (over 0.2 mg/L)
