IDDE

At DART Rail Right-of-Way (ROW)

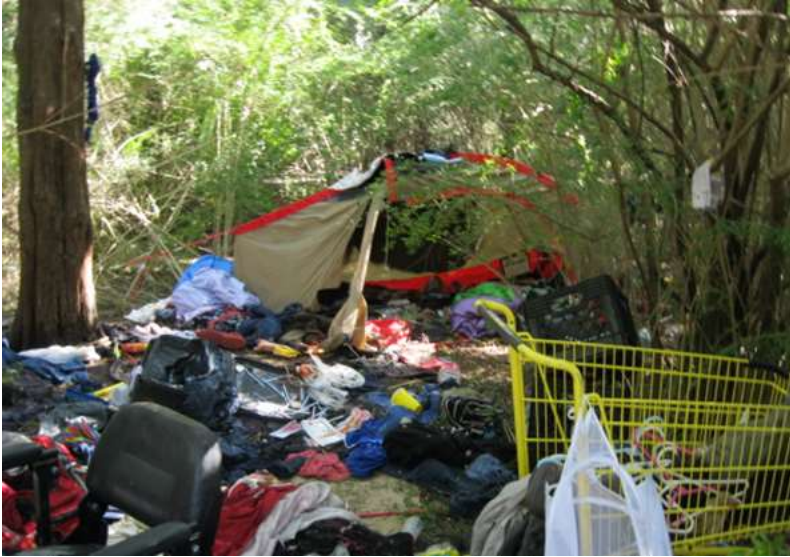
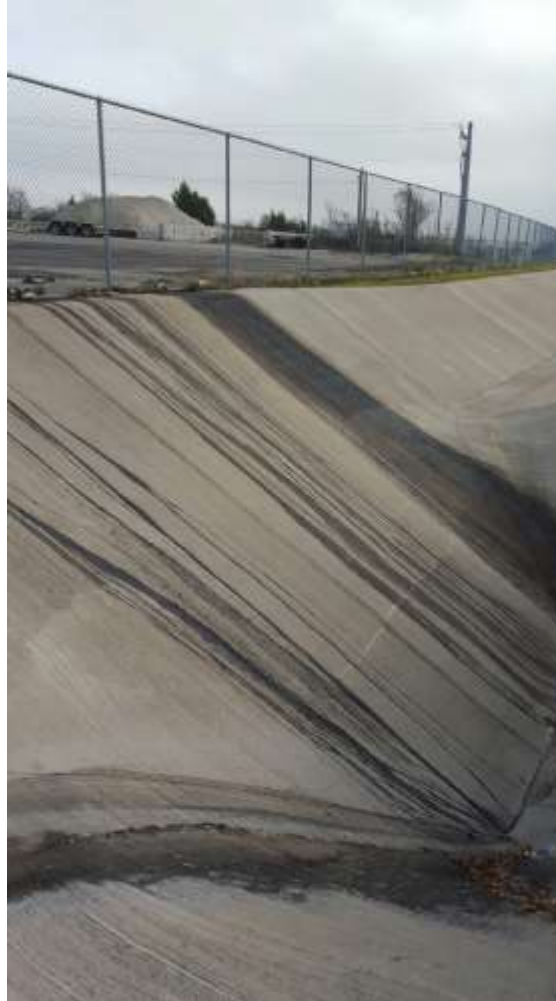
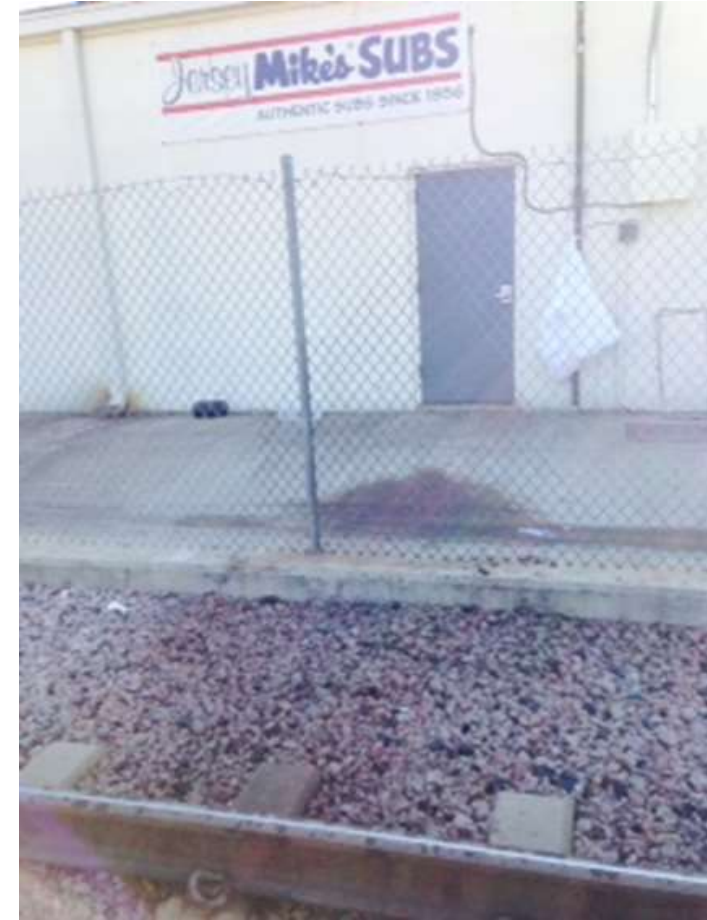
Discharges onto DART are usually simple to determine the source. Examples: Homeless camps and dumping on the ROW. / Oil stains coming from an equipment storage lot. / Overflowing grease traps or restaurant dumping their grease out the back door...

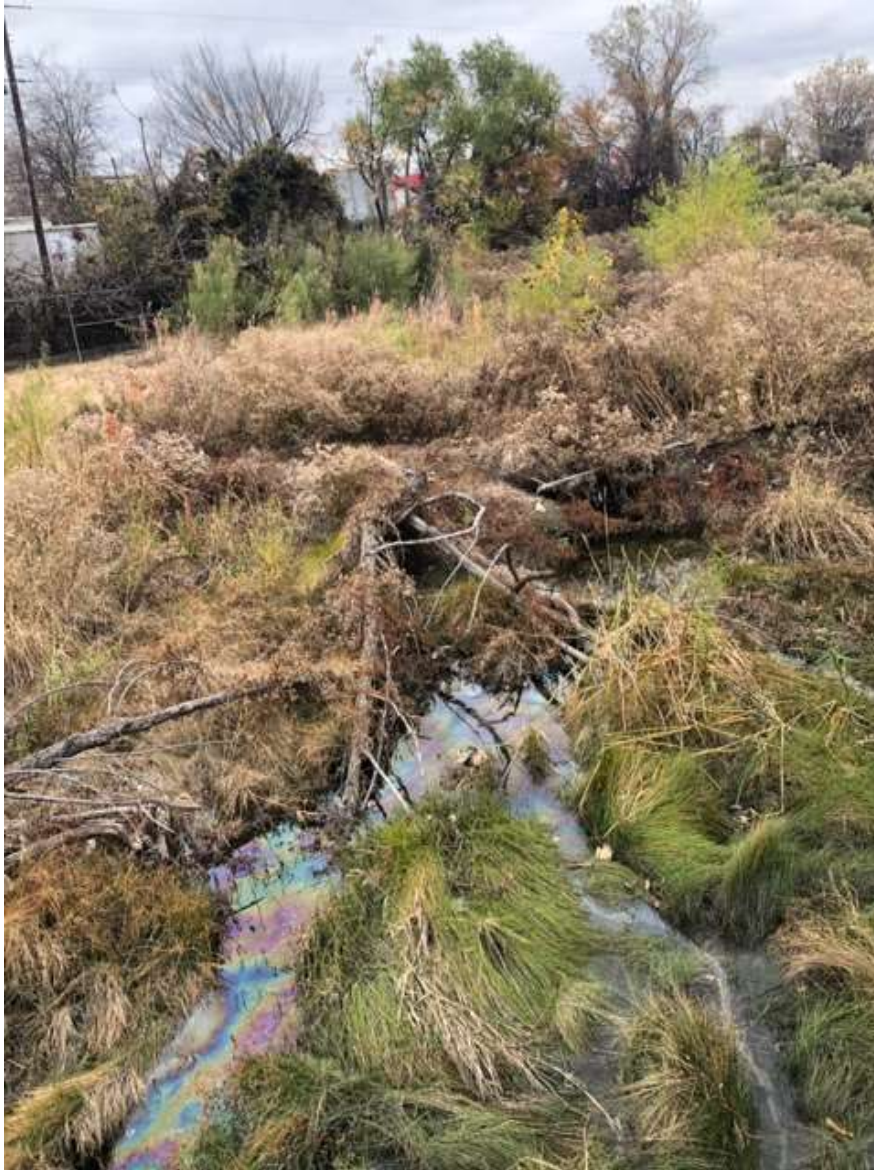
- 11/30/2018: DART track inspector discovers sheen on creek flowing onto DART ROW.
- Inspector reports the sheen to his supervisor; and calls DART Environmental.
- DART Environmental conducts on-site inspection and determines source of sheen appears to be from northern property. Call Garland Stormwater to help locate source. Meet onsite with Garland stormwater representative to initiate off-site investigation.
